## CONDITION REPORT

Report No: 2016201503

MFC Auction House  
M57 Pretoria Rd, Glenmarais, KEMPTON PARK  
Gauteng

| Manufacturer | MAZDA | Registration Number | FJK005L |

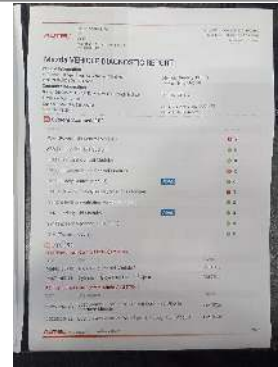
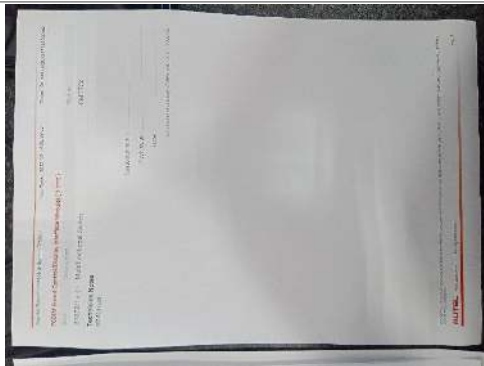
Diagnostic test

During the diagnostic no active error messages were detected. (See also attached Diagnostic Report. For more information regarding the Fault Codes (DTC) and the recommended rectifications please contact the workshops of the vehicle manufacture).

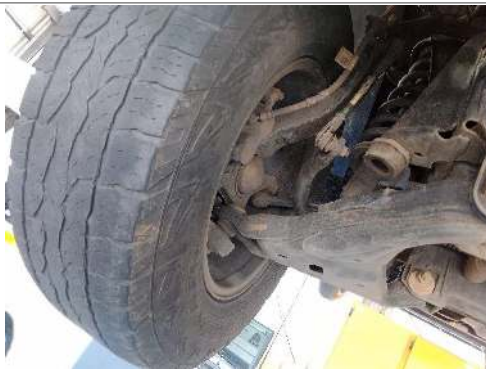
LF TYRE TREAD

| | Size | Load/Speed Index | Manufacture | Model | Type* | Production Date | Tread Depth (mm) |
|---|---|---|---|---|---|---|---|
| Front Left | 265/65R17 | 112S | Dunlop | Grandtrek | V | 1821 | 3 mm |

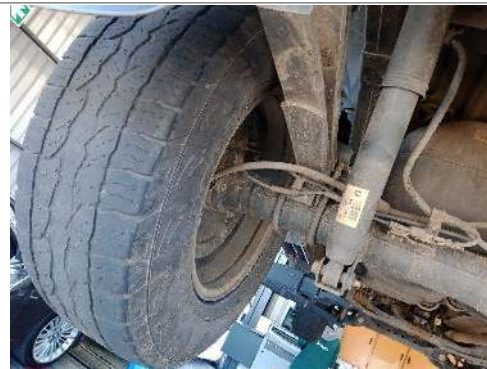
LR TYRE TREAD

| | Size | Load/Speed Index | Manufacture | Model | Type* | Production Date | Tread Depth (mm) |
|---|---|---|---|---|---|---|---|
| Rear Left | 265/65R17 | 112S | Dunlop | Grandtrek | V | 1821 | 3 mm |

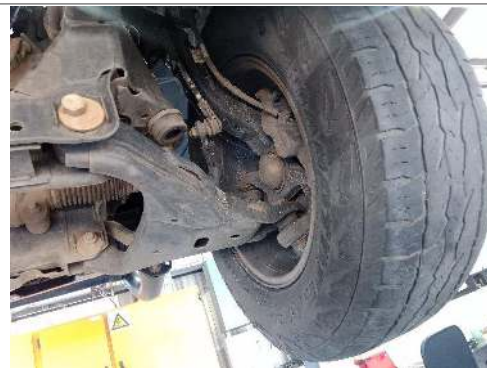
RF TYRE TREAD

| | Size | Load/Speed Index | Manufacture | Model | Type* | Production Date | Tread Depth (mm) |
|---|---|---|---|---|---|---|---|
| Front Right | 265/65R17 | 112S | Dunlop | Grandtrek | V | 1821 | 3 mm |

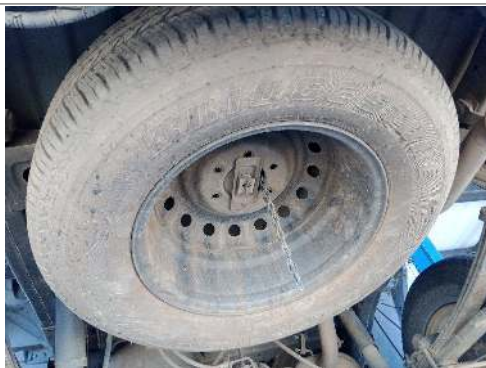
Sparewheel

| | Size | Load/Speed Index | Manufacture | Model | Type* | Production Date | Tread Depth (mm) |
|---|---|---|---|---|---|---|---|
| Spare | 265/65R17 | 112T | Bridgestone | Dueler | V | /////// | 7 mm |
