MFC Auction House
M57 Pretoria Rd, Glenmarais, KEMPTON PARK
Gauteng

Vehicle Type	PASSENGER VEHICLE	Registered Owner	MFC
Manufacturer	FORD	Registration Number	FMP866MP
Model	FIESTA	Register Number	
VIN	MNBAXXARJAAB17048	Date Of First Licensing	
Engine Number		Last COR	
Doors	4	License Expiry Date	30/06/2024
Color	SILVER	Power / Displacement	
Year Model		Paint Finish	M - METALLIC
Km Reading	138,045 KM	Fuel	PETROL
Cab / Body Type	SEDAN	Transmission	MANUAL

CONDITION REPORT

Report No: 2016209457

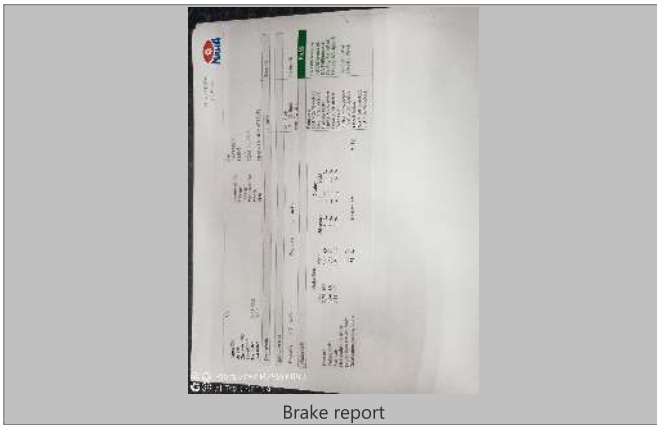
Brake report

Left	Right	Axle Weight [KG]	Deceleration [m/s ²]
	Braking Force [KN]	Braking Force [KN]		
Front	2.7	2.5	-	
Rear	2.1	1.9	-	
Emergency / Parking	1.6	1.7	-

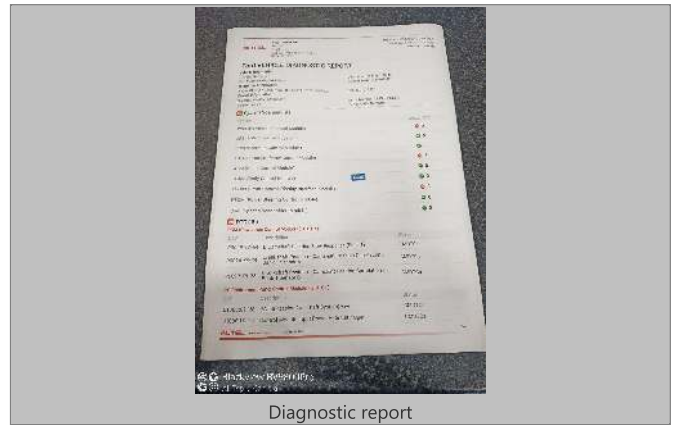
Diagnostic report

During the diagnostic no active error messages were detected. (See also attached Diagnostic Report. For more information regarding the Fault Codes (DTC) and the recommended rectifications please contact the workshops of the vehicle manufacture).

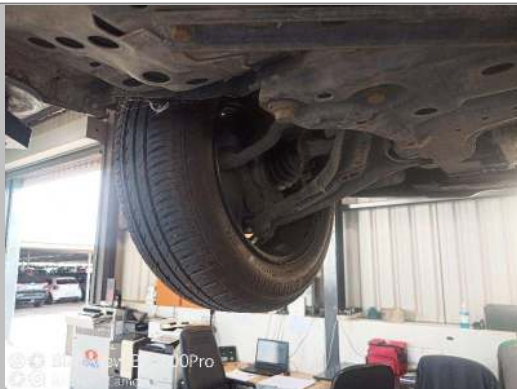
LF TYRE TREAD

Size	Load/Speed Index	Manufacture	Model	Type*	Production Date	Tread Depth (mm)
Front Left	175/65R14	82H	Continental	Contact	V	3011	4 mm
Front Right	175/70R14	84T	Cachland	Ch-268	V	1521	2 mm
Rear Left	185/65R15	92H	Dunlop	Sp sport	V	4722	2 mm
Rear Right	185/65R15	88H	Goodyear	Efficientgri	V	1722	2 mm
Spare	185/65R15	88H	Firestone	Touring	V	4721	2 mm

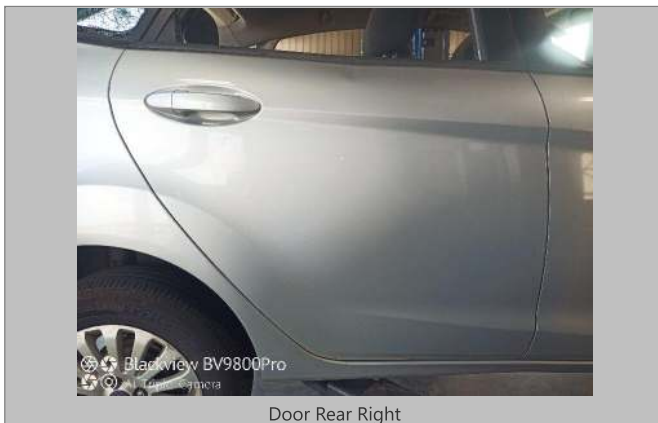
Door Rear Right

General Comments: ACCORDING TO AGE AND MILEAGE OF VEHICLE NORMAL WEAR AND TEAR ON INTERIOR, EXTERIOR, ELECTRICAL AND MECHANICAL PARTS.
 Body • Exterior: Vehicle got some scratches, stone chips and dents on some body panels and discolouring on some body panels. All the windows is damage
 Axle and Suspension: No shock test done due to shock machine not working
