CONDITION REPORT

Report No: 2016206512

MFC Auction House
M57 Pretoria Rd, Glenmarais, KEMPTON PARK
Gauteng

Vehicle Type	PASSENGER VEHICLE	Registered Owner	MFC
Manufacturer	NISSAN	Registration Number	HZ59XHGP
Model	QASHQAI	Register Number	
VIN	SJNFCAJ10Z2666252	Date Of First Licensing	
Engine Number		Last COR	
Doors	5	License Expiry Date	31/03/2024
Color	WHITE	Power / Displacement	
Year Model		Paint Finish	TWO COAT UNI
Km Reading	119,216 KM	Fuel	DIESEL
Cab / Body Type	HATCHBACK	Transmission	MANUAL

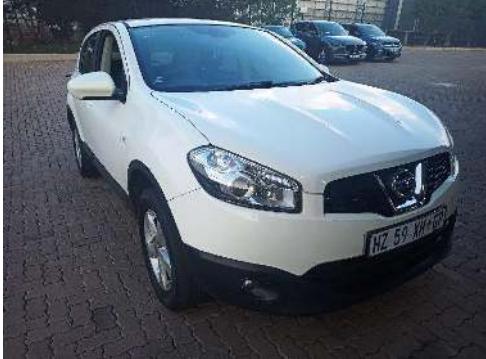
FRONT RIGHT CORNER

Body • Exterior: Minor dents and scratches and stone chips to some body panels. Signs of repair work done to some body panels. Poor alignment to some body panels.

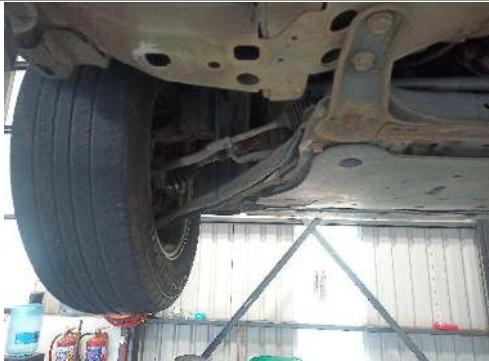
LF TYRE TREAD

Size	Load/Speed Index	Manufacture	Model	Type*	Production Date	Tread Depth (mm)
Front Left	215/65R16	98H	Powertrac	Radial	V	0117	0 mm
Front Right	215/65R16	98H	Powertrac	Radial	V	0217	0 mm
Rear Left	215/65R16	98H	Windforce	Radial	V	3918	2 mm
Rear Right	215/65R16	98H	Windforce	Radial	V	3918	2 mm

Damage	Repair Way
Seat Front Right Damaged	Repair
Front Bumper Damaged	Repair
Bonnet Damaged	Repair
Front Fender Left Damaged	Repair
Front Fender Right Damaged	Repair
Rear Fender Left Damaged	Repair
Rear Fender Right Damaged	Repair
Door Front Left Damaged	Repair
Door Rear Left Damaged	Repair
Rear bumper Damaged	Repair
Tyre Front Left Worn	Replace
Tyre Front Right Worn	Replace
