## CONDITION REPORT

Report No: 2016867754

MFC Auction House  
M57 Pretoria Rd, Glenmarais, KEMPTON PARK  
Gauteng

| Model | QASHQAI 1.2T VISIA 5-DR [2014-2018] | Register Number | |

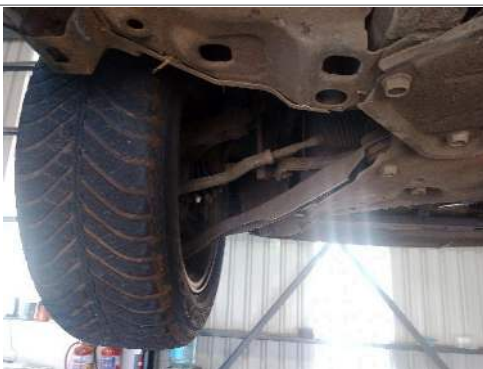
LF TYRE TREAD

| | Size | Load/Speed Index | Manufacture | Model | Type* | Production Date | Tread Depth (mm) |
|---|---|---|---|---|---|---|---|
| Front Left | 215/60R17 | 96V | Goodyear | Vector | V | 4218 | 1 mm |

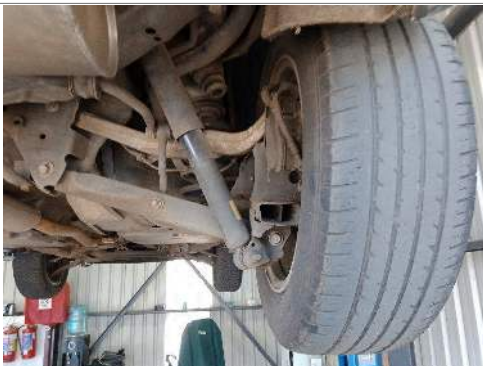
RR TYRE TREAD

| Damage | Repair Way |
|---|---|
| Rear tyres size differs | Replace |

| | Size | Load/Speed Index | Manufacture | Model | Type* | Production Date | Tread Depth (mm) |
|---|---|---|---|---|---|---|---|
| Rear Right | 215/60R17 | 96H | Goodyear | Assurance | V | 0119 | 1 mm |

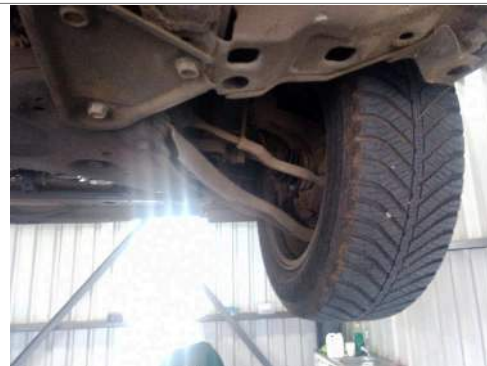
RF TYRE TREAD

| | Size | Load/Speed Index | Manufacture | Model | Type* | Production Date | Tread Depth (mm) |
|---|---|---|---|---|---|---|---|
| Front Right | 215/60R17 | 96V | Goodyear | Vector | V | 0817 | 2 mm |

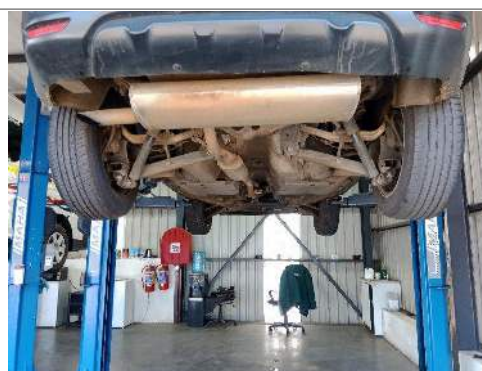
Undercarriage rear.

| Damage | Repair Way |
|---|---|
| Gearbox Oil Leak | Repair |
