CONDITION REPORT

Report No: 2016221837

MFC Auction House
M57 Pretoria Rd, Glenmarais, KEMPTON PARK
Gauteng

Vehicle Type	PASSENGER VEHICLE	Registered Owner	MFC
Manufacturer	RENAULT	Registration Number	FRJ108L
Model	CLIO	Register Number	
VIN	VF15RSV0A61441020	Date Of First Licensing	
Engine Number		Last COR	
Doors	5	License Expiry Date	31/12/2023
Color	RED	Power / Displacement	
Year Model		Paint Finish	TWO COAT UNI
Km Reading	82,057 KM	Fuel	PETROL
Cab / Body Type	HATCHBACK	Transmission	MANUAL

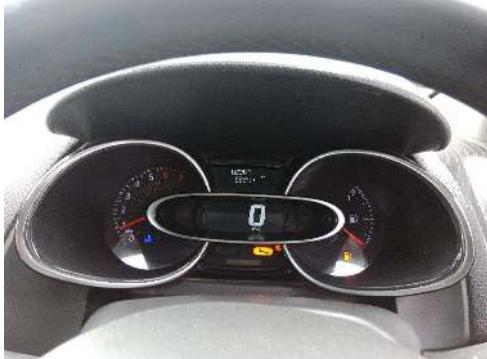
DASHBOARD (W/ ENGINE RUNNING)

Damage	Repair Way
Windscreen Chipped	Repair
Service Brake Performance Rear Axle Left / Right Difference out of legal range	Repair
Parking Brake Performance Left / Right Difference out of legal range	Repair
Mounting Rubber(s) Rear Axle Left Cracked	Replace
Tyre Rear Right Defective	Replace
Spare Tyre Damaged	Replace
Rim Front Right Dented	Repair
Chassis Dented	Repair
Sub Frame Damaged	Replace
Belly plates Damaged	Replace
Radiator Cradle Dented	Repair
Warning lights illuminated on dashboard	Repair

No	System	Code	Description	Status
1	INJECTION	DTC056016	COMPUTER SUPPLY VOLTAGE PERMANENT LOW LEVEL

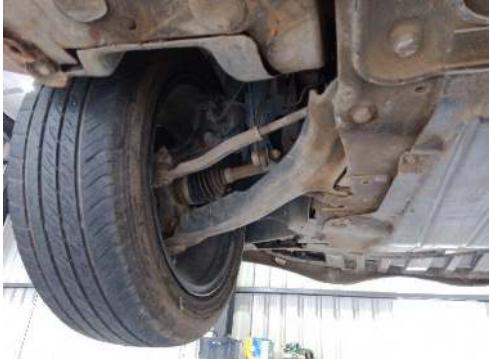
LF TYRE TREAD

Size	Load/Speed Index	Manufacture	Model	Type*	Production Date	Tread Depth (mm)
Front Left	195/55 R16	91V	Autogrip	P308	V	4520	2 mm
Front Right	195/55 R16	87V	Linglong	Green-Max	V	0621	2 mm
Rear Left	195/55 R16	91V	Autogrip	P308	V	4520	3 mm
Rear Right	185/65 R15	88T	Barum	Brillantis	V	2918	7 mm
Spare	195/55 R16	87H	Continental	ContiEco	V	2618	0 mm

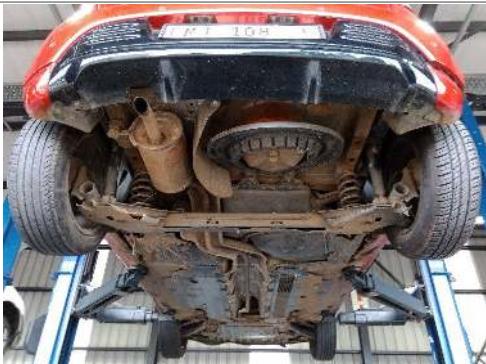
Rear chassis

General Comments: ACCORDING TO THE AGE AND MILEAGE OF THE VEHICLE, NORMAL WEAR AND TEAR MARKS ARE VISIBLE ON THE INTERIOR, EXTERIOR, ELECTRICAL AND MECHANICAL PARTS.
 Engine Compartment: Engine bay dirty. Brake fluid level ok. Corrosion on battery box.
 Electrical Components and Instruments: Radio need authentication key to operate.
 Interior: Vehicle interior dirty and some interior panels scratched.
 Body • Exterior: Dents and scratches on some body panels. Spray work on some body panels. Some body panels misaligned. Stone chips on some body panels.
 Signs of impact damage to front of vehicle.
 Brakes: Rear right wheel binding.
 Axle and Suspension: Abnormal noise coming from front and rear suspension.
 Tyres and Rims: Alloy rims scratched. Original spare wheel fitted to rear right side of vehicle. Rear left and right tyre sizes different.
 Undercarriage: Vehicle undercarriage dirty. Bottom of engine and gearbox fully covered. Exhaust rusted.

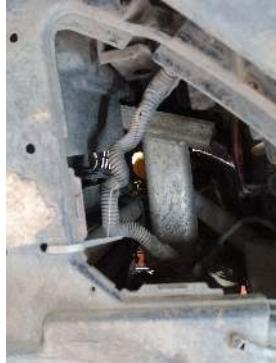
Damage	Repair Way
Engine Wiring Defective	Repair
Hoses Oil Sweat	Repair
Center Console / Cubbyhole + Lid Defective	Repair
Switch Electrical Window Winder front left Missing	Replace
Electrical Window Winder rear right Malfunction	Replace
Windscreen Wiper Damaged	Replace
Headlight Left Defective	Repair
Headlight Right Defective	Repair
Seat Front Left Dirty	Repair
Seat Front Right Damaged	Repair
Seat Rear Dirty	Repair
Hood Lining Dirty	Repair
Side Mirror Left Paintwork • Scratched	Repair
Front Bumper Damaged	Repair
Bonnet Dented	Repair
Front Fender Left Paintwork • Scratched	Repair
Rear Fender Left Damaged	Repair
Rear Fender Right Damaged	Repair
Door Front Left Damaged	Repair
Door Front Right Dented	Repair
Door Rear Left Damaged	Repair
Door Rear Right Paintwork • Scratched	Repair
Boot Lid / Hatch door Paintwork • Scratched	Repair
Rear bumper Paintwork • Scratched	Repair
Sill Panel Left Paintwork • Scratched	Repair
Sill Panel Right Paintwork • Scratched	Repair
