CONDITION REPORT

Report No:
2016911273
DATE
12/06/2025

| Manufacturer | RENAULT | Registration Number | JN82MYGP |
| Model | SANDERO | Register Number | |

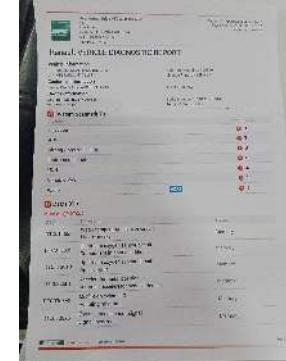
Diagnostic.

During the diagnostic no active error messages were detected. (See also attached Diagnostic Report. For more information regarding the Fault Codes (DTC) and the recommended rectifications please contact the workshops of the vehicle manufacture).

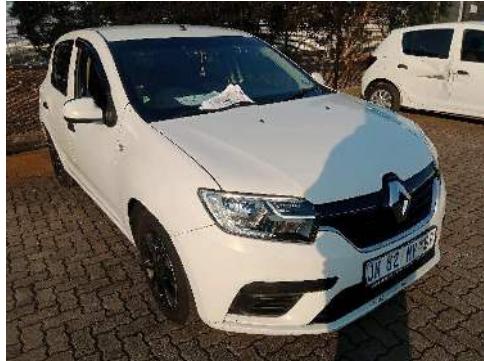
FRONT RIGHT CORNER

| Damage | Repair Way |
|--|---|
| Front Bumper Damaged | Repair |
| Front Fender Right Damaged | Repair |

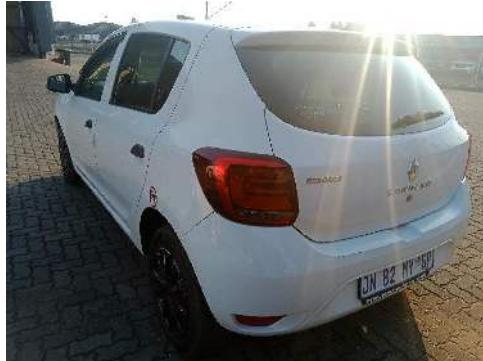
REAR LEFT CORNER

| Damage | Repair Way |
|--|---|
| Rear Fender Left Damaged | Repair |
| Rear bumper Damaged | Repair |

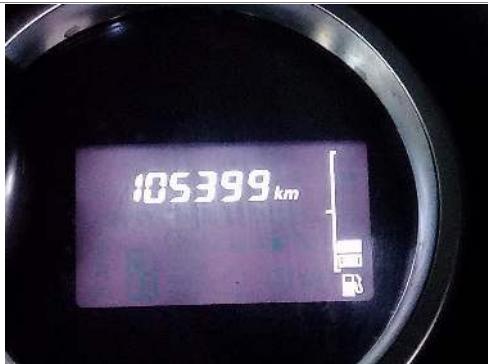
ODOMETER

| Km Reading | 105,399 KM | Fuel | PETROL |

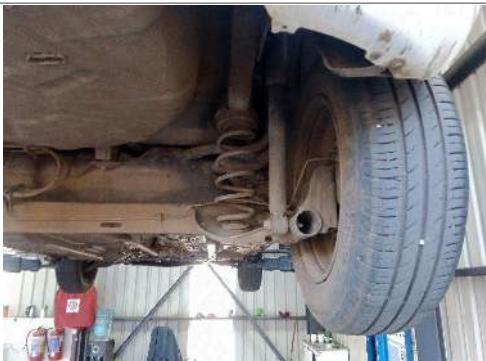
RR TYRE TREAD

| | Size | Load/Speed Index | Manufacture | Model | Type* | Production Date | Tread Depth (mm) |
|---|---|---|---|---|---|---|---|
| Rear Right | 185/65R15 | 88H | Kumho | Radial | V | 3121 | 1 mm |

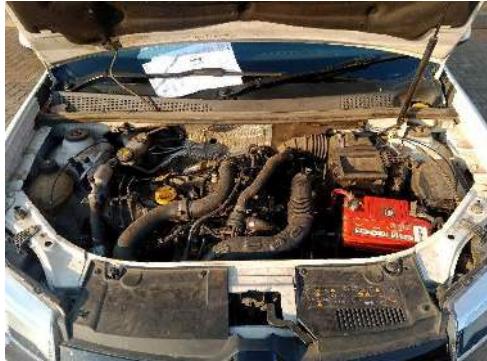
ENGINE 1

| Damage | Repair Way |
|--|---|
| Engine Oil Leak | Repair |

General Comments: ACCORDING TO THE AGE AND MILEAGE OF THE VEHICLE, NORMAL WEAR AND TEAR MARKS ARE VISIBLE ON THE INTERIOR, EXTERIOR, ELECTRICAL AND MECHANICAL PARTS. Engine Compartment: battery loose.
Body • Exterior: Minor dents and scratches and stone chips to some body panels. Signs of repair work done to somebody panels.

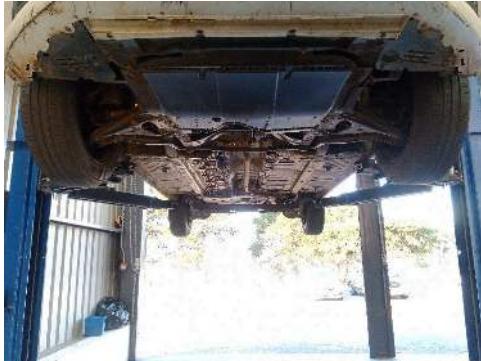
Undercarriage front.

| Damage | Repair Way |
|--|---|
| Gearbox Oil Leak | Repair |
