MFC Auction House  
M57 Pretoria Rd, Glenmarais, KEMPTON PARK  
Gauteng

## Assignment

## Vehicle Data

## VEHICLE INSPECTION

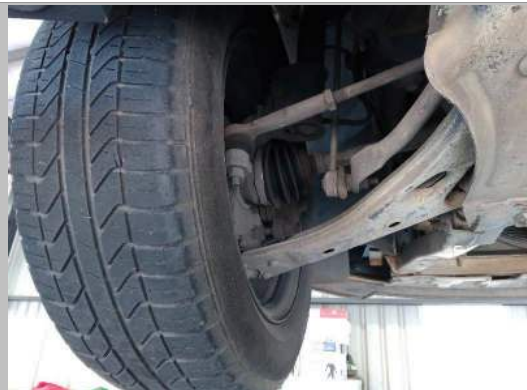
LF TYRE TREAD

Size	Load/Speed Index	Manufacture	Model	Type*	Production Date	Tread Depth (mm)
Front Left	185/65 R15	92H	Sumitomo	HTR H5	V	1921	2 mm
Front Right	185/65 R15	92H	Sumitomo	HTR T5	V	1921	3 mm
Rear Left	185/65 R15	88H	Continental	ContiEco	V	1017	0 mm
Rear Right	185/65 R15	92H	Dunlop	Sp-Sport	V	3717	0 mm

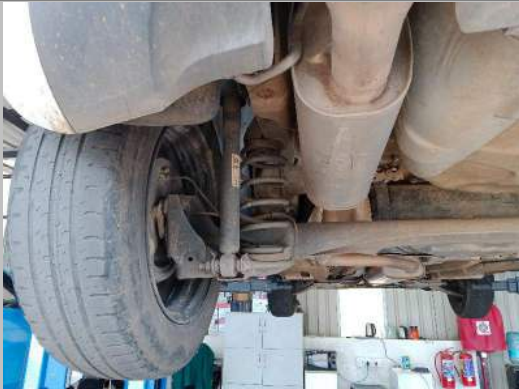
LR TYRE TREAD

Damage	Repair Way
Tyre Rear Left Worn	Replace
Tyre Rear Right Damaged	Replace
Sub Frame Dented	Repair
Engine to silencer pipe Damaged	Repair
Gearbox Oil Leak	Repair
Jack Missing	Replace
Wheel Spanner Missing	Replace
Triangle Missing	Replace
Engine	Cylinder head cover cracked.
Body and Exterior	Dents and scratches on some body panels
Interior	Vehicle interior dirty and some panels scratched
Tyres and rims	Front and rear hubcaps scratched.
Body and Exterior	Stone chips and spray work on some body panels
Body and Exterior	Residual traces of repair on some body panels
Tyres and rims	Front and rear tyre sizes different
Tyres and rims	Spare wheel missing
