## CONDITION REPORT

Report No: 2016402973

DATE  
03/06/2024

MFC Auction House  
M57 Pretoria Rd, Glenmarais, KEMPTON PARK  
Gauteng

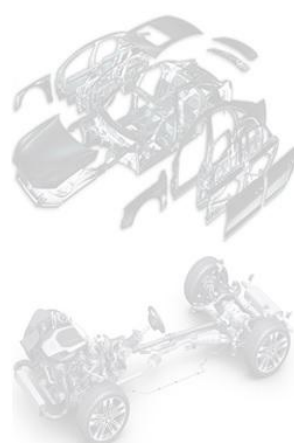
## VEHICLE INSPECTION

| Damage | Repair Way |
|---|---|
| Engine Oil Leak | Repair |
| Front Bumper Damaged | Repair |
| Front Fender Left Damaged | Repair |
| Door Front Left Damaged | Repair |
| Door Front Right Damaged | Repair |
| Door Rear Left Damaged | Repair |
| Door Rear Right Damaged | Repair |
| Boot Lid / Hatch door Damaged | Repair |
| Rear bumper Damaged | Repair |

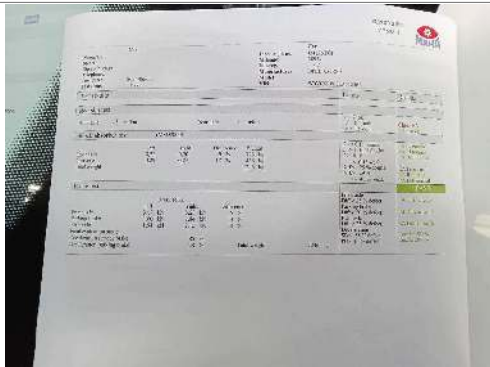
Brake and shock test

| | Left | Right | | |
|---|---|---|---|---|
| Front | 3.07 | 3.23 | - | |
| Rear | 1.94 | 2.15 | - | |
| Emergency / Parking | 1.6 | 1.84 | - | |

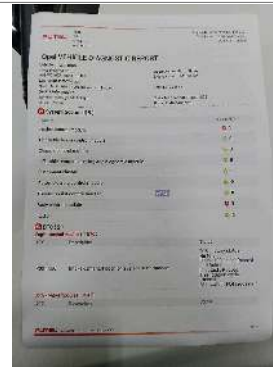
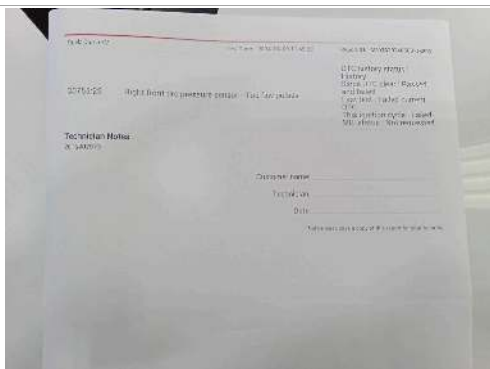
Diagnostics.

During the diagnostic no active error messages were detected. (See also attached Diagnostic Report. For more information regarding the Fault Codes (DTC) and the recommended rectifications please contact the workshops of the vehicle manufacture).

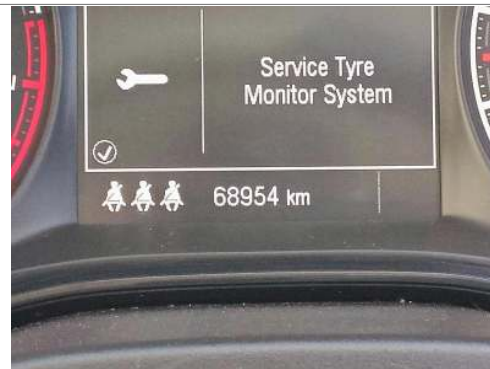
ODOMETER

| Km Reading | 68,954 KM | Fuel | PETROL |

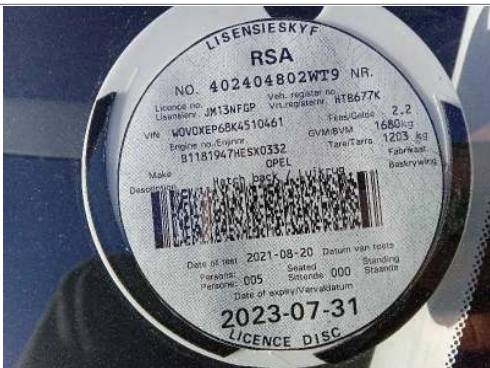
LICENSE DISC

| Doors | 5 | License Expiry Date | 31/07/2024 |
