## CONDITION REPORT

Report No: 2016204298

MFC Auction House  
M57 Pretoria Rd, Glenmarais, KEMPTON PARK  
Gauteng

| Manufacturer | AUDI | Registration Number | CG54GDGP |

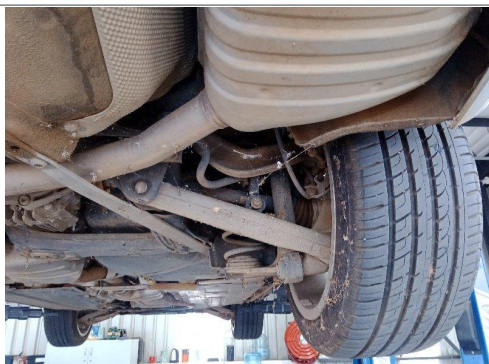
RR TYRE TREAD

| Damage | Repair Way |
|---|---|
| Tyre Rear Left Damaged | Replace |

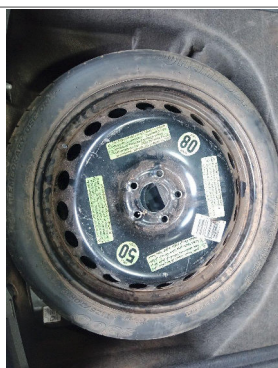
Brakes: Abnormal noise coming from of vehicle when applying brakes.  
 Axle and Suspension: Abnormal noise coming from front and rear suspension.  
 Tyres and Rims: Alloy rims scratched. Spare wheel lock down pin and bracket loose.  
 Undercarriage: Vehicle undercarriage dirty. Right side subframe bolt not tightened. Signs of surface rust on undercarriage. Excessive oil leak on bottom of engine.  
 Road Test: Gearbox faulty

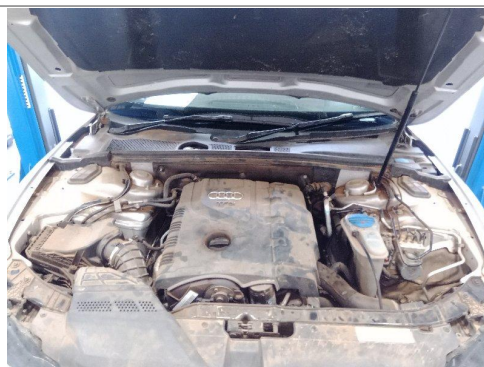
ENGINE 1

| Damage | Repair Way |
|---|---|
| Engine Oil Leak | Repair |

General Comments: ACCORDING TO THE AGE AND MILEAGE OF THE VEHICLE, NORMAL WEAR AND TEAR MARKS ARE VISIBLE ON THE INTERIOR, EXTERIOR, ELECTRICAL AND MECHANICAL PARTS.  
 Engine Compartment: Engine bay dirty. Brake fluid level ok. Oil level could not be checked due to electronics malfunctioning. Oil leak on engine splash plate. Bottom of engine and gearbox covered cannot pin direction of oil leak. Engine fan is constantly On. Signs of water leak on front right side of engine.  
 Electrical Components and Instruments: Electronic parking brake faulty. Vehicle electronics malfunctioning. Front left and right headlight washers not working.  
 Interior: Vehicle interior dirty and some interior panels scratched.  
 Body • Exterior: Dents and scratches on some body panels. Spray work on some body panels. Some body panels misaligned. Stone chips on some body panels. Residual traces of repair on some body panels.

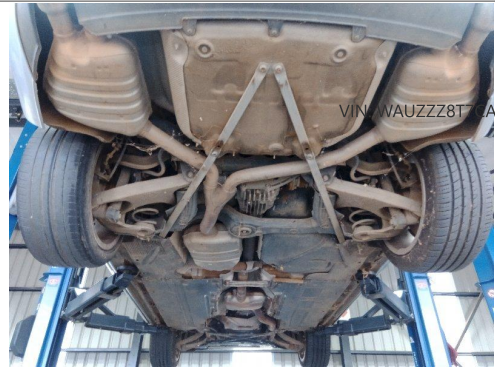
Rear chassis

| Damage | Repair Way |
|---|---|
| Cross Member Rear Left Dented | Repair |

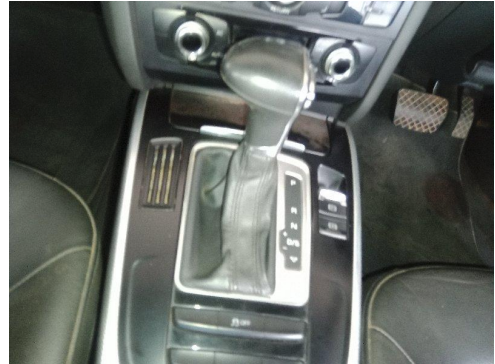
Automatic Transmission

Cross Member Rear Right Dented  
 Belly plates Damaged  
 Gearbox Oil Leak  
 Differential Oil Sweat  
 CV Joint(s) Rear Left (inner/outer) Defective  
 CV Joint(s) Rear Right (inner/outer) Defective  
 Engine Performance Idling / Hunting  
 Jack Missing  
 Wheel Spanner Missing  
 Warning lights illuminated on dashboard
