## CONDITION REPORT

Report No: 2016360753

| Manufacturer | AUDI | Registration Number | HW73GRGP |
| Model | A3 TFSI | Register Number | |

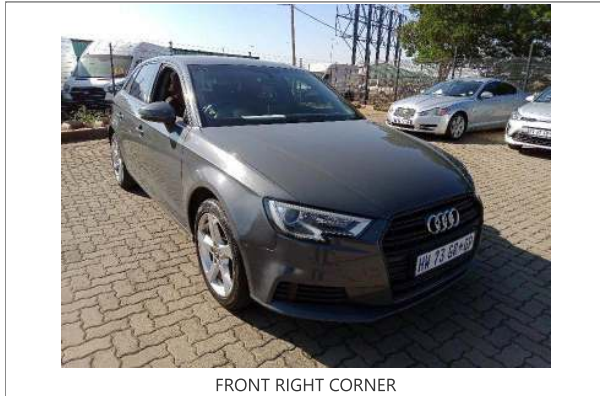
FRONT RIGHT CORNER

| Damage | Repair Way |
|--|---|
| Front Fender Right Residual Traces of Repair | Repair |
| Rear Fender Right Dented | Repair |

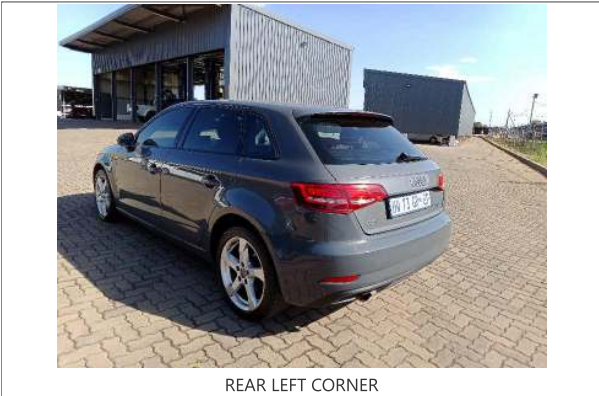
REAR LEFT CORNER

| Damage | Repair Way |
|--|---|
| Rear Fender Left Residual Traces of Repair | Repair |
