MFC Auction House  
M57 Pretoria Rd, Glenmarais, KEMPTON PARK  
Gauteng

| Manufacturer | AUDI | Registration Number | FB8838L |

## CONDITION REPORT

Report No: 2016213189

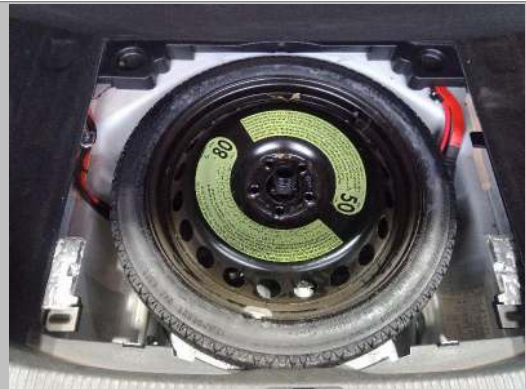
Spare wheel

| | Size | Load/Speed Index | Manufacture | Model | Type* | Production Date | Tread Depth (mm) |
|---|---|---|---|---|---|---|---|
| Spare | T125/70 R19 | 100M | Continental | Temporary | V | 4121 | 4 mm |

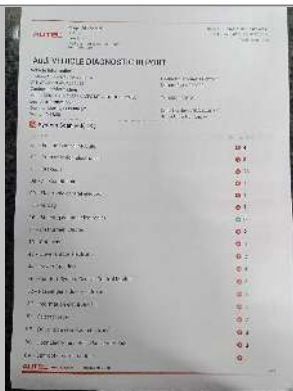
Diagnostic report page 1

| No | System | Code | Description | Status |
|---|---|---|---|---|
| 1 | 01-ENGINE CONTROL MODULE<br>1 | P308800 | STARTER RELAY ELECTRICAL FAULT IN CIRCUIT | |

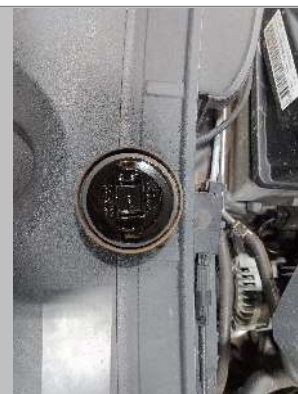
Oil cap

| | Damage | Repair Way |
|---|---|---|
| | Oil level Insufficient | Replace |

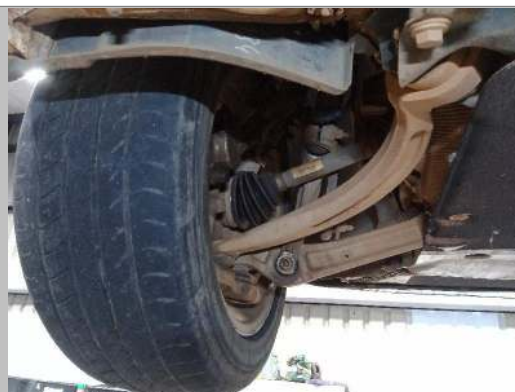
LF TYRE TREAD

| | Damage | Repair Way |
|---|---|---|
| | Tyre Front Left Defective | Replace |

| | Size | Load/Speed Index | Manufacture | Model | Type* | Production Date | Tread Depth (mm) |
|---|---|---|---|---|---|---|---|
| Front Left | 225/50 R17 | 98V | Duran | M636 | V | 4119 | 0 mm |

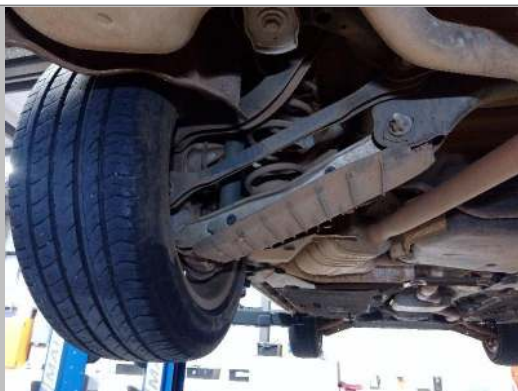
LR TYRE TREAD

| | Size | Load/Speed Index | Manufacture | Model | Type* | Production Date | Tread Depth (mm) |
|---|---|---|---|---|---|---|---|
| Rear Left | 225/50 R17 | 98V | Duran | M636 | V | 2819 | 3 mm |

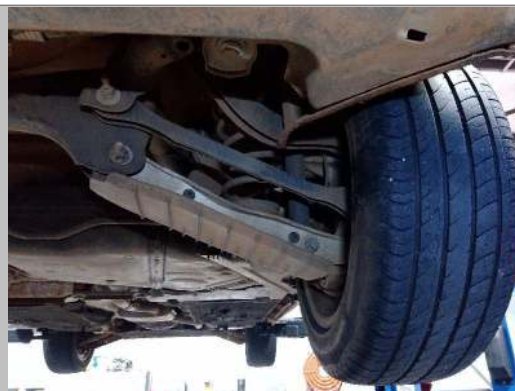
RR TYRE TREAD

| | Size | Load/Speed Index | Manufacture | Model | Type* | Production Date | Tread Depth (mm) |
|---|---|---|---|---|---|---|---|
| Rear Right | 225/50 R17 | 98V | Duran | M636 | V | 4119 | 3 mm |

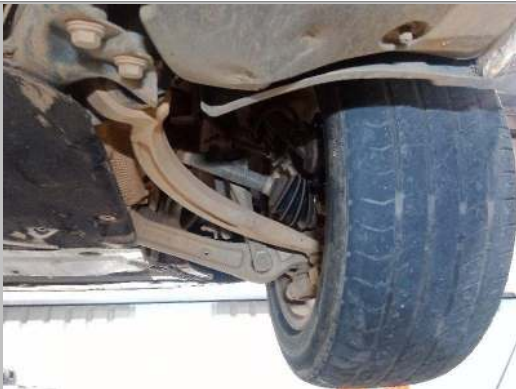
RF TYRE TREAD

| Damage | Repair Way |
|---|---|
| Tyre Front Right Worn | Replace |

| | Size | Load/Speed Index | Manufacture | Model | Type* | Production Date | Tread Depth (mm) |
|---|---|---|---|---|---|---|---|
| Front Right | 225/50 R17 | 98V | Duran | M636 | V | 4119 | 0 mm |
