DEKRA MFC  
M57 Pretoria Rd - 1619  
KEMPTON PARK - GT  
08610 33572

| Manufacturer | BMW | Registration Number | DD54JNGP |

## CONDITION REPORT

Report No: 2016213160

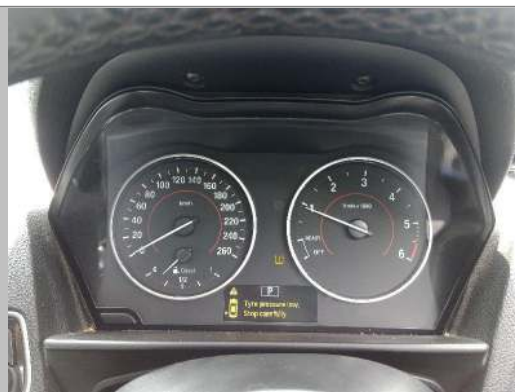
DASHBOARD (W/ ENGINE RUNNING)

| Damage | Repair Way |
|---|---|
| Tyre pressure warning light illuminated on dashboa | Repair |

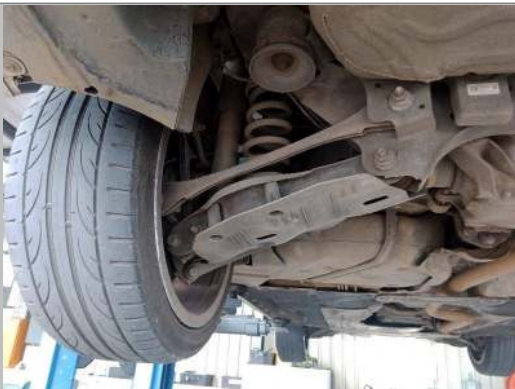
RR TYRE TREAD

| | Size | Load/Speed Index | Manufacture | Model | Type* | Production Date | Tread Depth (mm) |
|---|---|---|---|---|---|---|---|
| Rear Right | 225/40 R18 | 92W | Fronway | Eurus | V | 1723 | 5 mm |

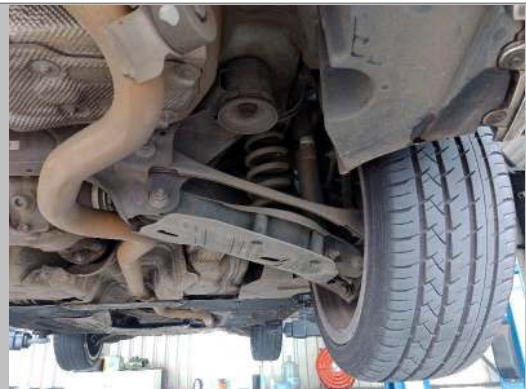
LR TYRE TREAD

| Damage | Repair Way |
|---|---|
| Tyre Rear Left Torn / Cut | Replace |

| | Size | Load/Speed Index | Manufacture | Model | Type* | Production Date | Tread Depth (mm) |
|---|---|---|---|---|---|---|---|
| Rear Left | 225/40Z R18 | 92Y | Hankook | Ventus | V | 3121 | 3 mm |

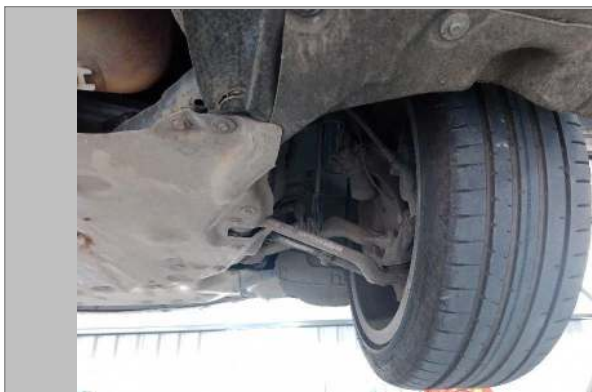
RF TYRE TREAD

| Damage | Repair Way |
|---|---|
| Tyre Front Right Torn / Cut | Replace |

| | Size | Load/Speed Index | Manufacture | Model | Type* | Production Date | Tread Depth (mm) |
|---|---|---|---|---|---|---|---|
| Front Right | 225/40Z R18 | 92Y | Dunlop | Sportmax | V | 0419 | 4 mm |
