## CONDITION REPORT

Report No:  
2016893862  
DATE  
28/05/2025

| Manufacturer | BMW | Registration Number | HH60VXGP |
| Model | 120I HATCH 5-DR STEPTRONIC [2016-2019] | Register Number | |

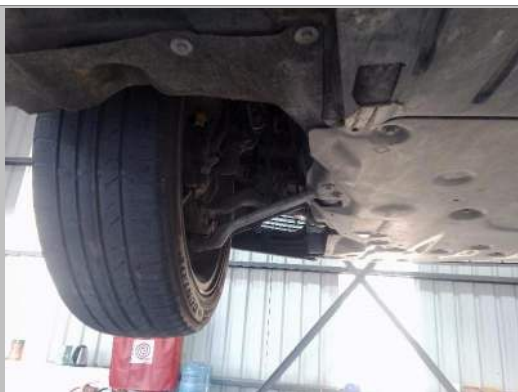
LF TYRE TREAD

| | Size | Load/Speed Index | Manufacture | Model | Type* | Production Date | Tread Depth (mm) |
|---|---|---|---|---|---|---|---|
| Front Left | 205/50R17 | 93W | Dunlop | Sp | V | 1220 | 2 mm |

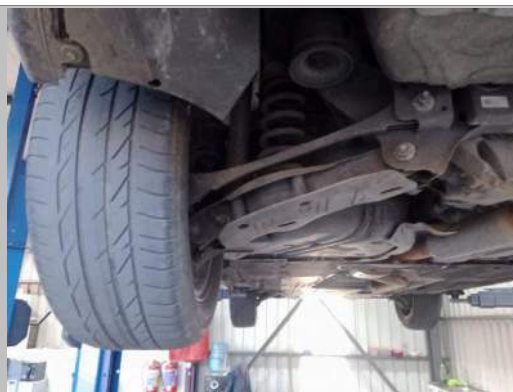
LR TYRE TREAD

| Damage | Repair Way |
|---|---|
| Tyre Rear Left Worn | Replace |

| | Size | Load/Speed Index | Manufacture | Model | Type* | Production Date | Tread Depth (mm) |
|---|---|---|---|---|---|---|---|
| Rear Left | 225/50R17 | 94W | Bridgestone | Radial | V | 1820 | 0 mm |

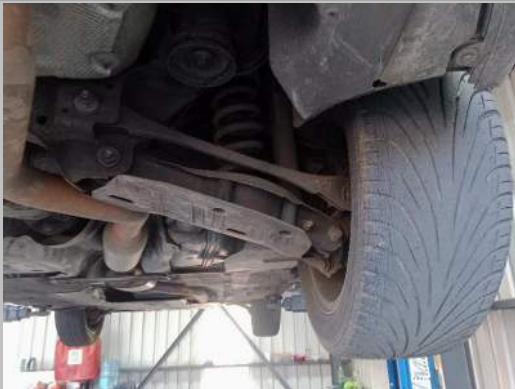
RR TYRE TREAD

| Damage | Repair Way |
|---|---|
| Tyre Rear Right Worn | Replace |

| | Size | Load/Speed Index | Manufacture | Model | Type* | Production Date | Tread Depth (mm) |
|---|---|---|---|---|---|---|---|
| Rear Right | 225/45R17 | 94W | Nexen | Radial | V | 1013 | 0 mm |

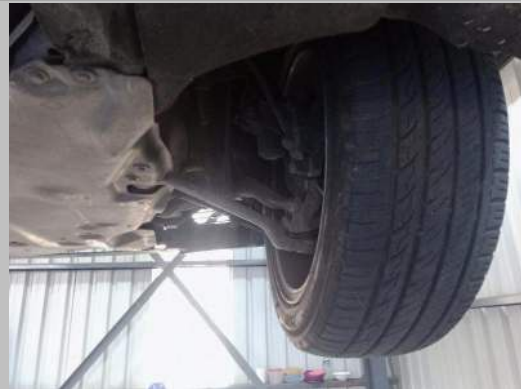
RF TYRE TREAD

| Damage | Repair Way |
|---|---|
| Rear and Front tyres size differs | Repair |

| | Size | Load/Speed Index | Manufacture | Model | Type* | Production Date | Tread Depth (mm) |
|---|---|---|---|---|---|---|---|
| Front Right | 225/45R17 | 94W | Rapid | Radial | V | 3521 | 2 mm |

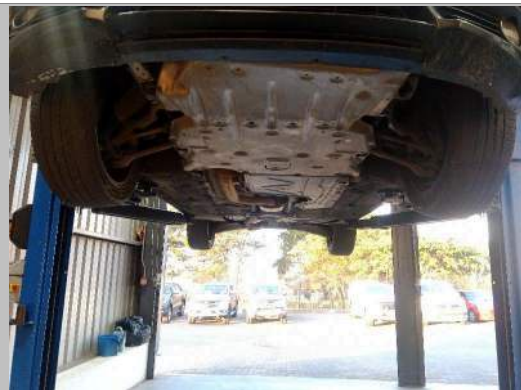
Undercarriage front.

| Damage | Repair Way |
|---|---|
| Belly plates Damaged | Replace |
| Radiator Cradle Damaged | Replace |
