## CONDITION REPORT

Report No:  
2016967753  
DATE  
04/08/2025

| Manufacturer | BMW | Registration Number | MC95KYGP |
| Model | 320I STEPTRONIC 5F32 [2019-2022] | Register Number | |

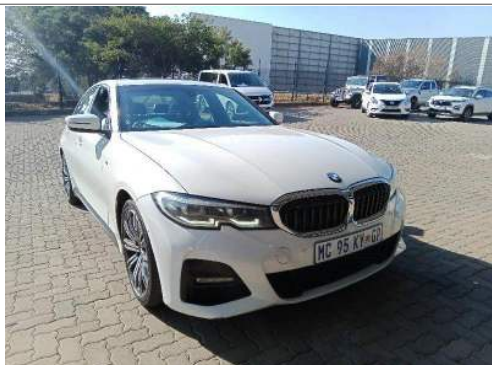
FRONT RIGHT CORNER

| Front Fender Right Paintwork • Chipmarks | Repair |
| Door Front Right Dented | Repair |

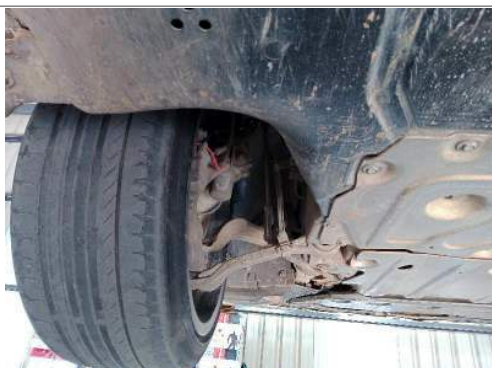
LF TYRE TREAD

| Tyre Front Left Worn | Replace |

| | Size | Load/Speed Index | Manufacture | Model | Type* | Production Date | Tread Depth (mm) |
|---|---|---|---|---|---|---|---|
| Front Left | 225/40 R18 | 92Y | Continental | Contisport | V | 1019 | 0 mm |

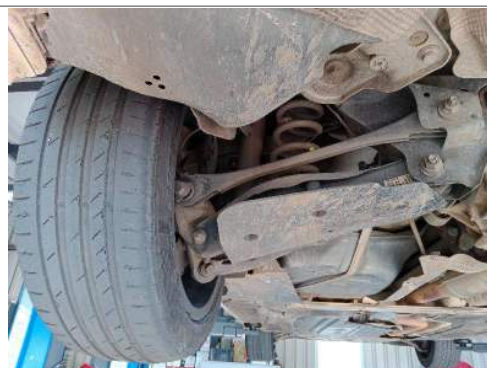
LR TYRE TREAD

| Tyre Rear Left Damaged | Replace |

| | Size | Load/Speed Index | Manufacture | Model | Type* | Production Date | Tread Depth (mm) |
|---|---|---|---|---|---|---|---|
| Rear Left | 225/45RF18 | 91Y | Kumho | Ecsta | V | 4319 | 0 mm |

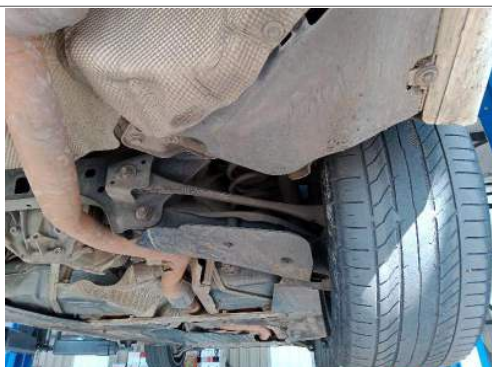
RR TYRE TREAD

| Tyre Rear Right Damaged | Replace |

| | Size | Load/Speed Index | Manufacture | Model | Type* | Production Date | Tread Depth (mm) |
|---|---|---|---|---|---|---|---|
| Rear Right | 255/40 R18 | 95Y | Continental | Contisport | V | 2921 | 0 mm |

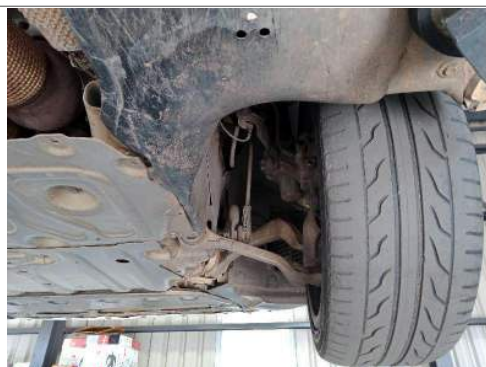
RF TYRE TREAD

| Tyre Front Right Damaged | Replace |

| | Size | Load/Speed Index | Manufacture | Model | Type* | Production Date | Tread Depth (mm) |
|---|---|---|---|---|---|---|---|
| Front Right | 225/40Z R18 | 92Y | Hankook | Ventus | V | 3221 | 0 mm |
