CONDITION REPORT

Report No: 2016220563

| Manufacturer | BMW | Registration Number | FSK108L |
| Model | 330D | Register Number | |

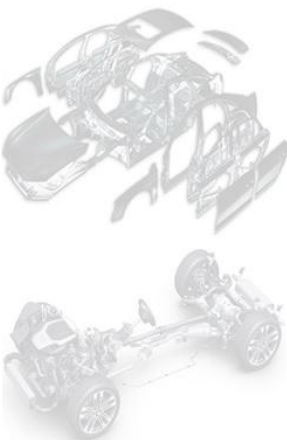
| Damage | Repair Way |
|---|---|
| Front Bumper Damaged | Repair |
| Bonnet Damaged | Repair |
| Front Fender Right Damaged | Repair |
| Door Rear Left Damaged | Repair |
| Rear bumper Damaged | Repair |
