| Manufacturer | BMW | Registration Number | CY238235 |
| Model | 335I | Register Number | |

## CONDITION REPORT

Report No: 2016348187

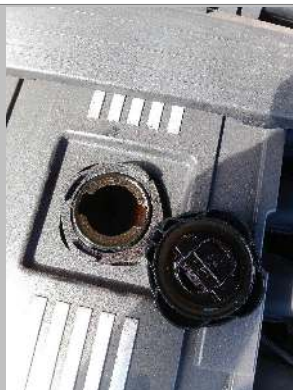
Oil cap.

| Damage | Repair Way |
|---|---|
| Engine Oil Leak | Repair |

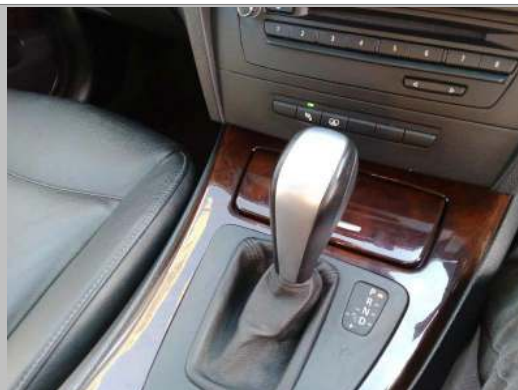
Automatic.

| Damage | Repair Way |
|---|---|
| Gearbox Oil Leak | Repair |

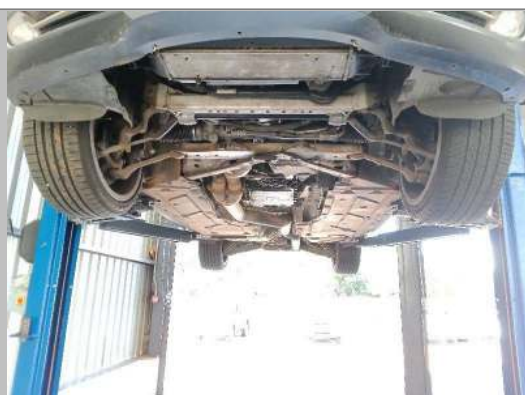
Undercarriage front.

| Damage | Repair Way |
|---|---|
| Engine to silencer pipe Welded | Repair |
| Silencer Defective | Repair |
| Catalytic converter Missing | Replace |
| Undercarriage. | Non-standard exhaust fitted to vehicle |

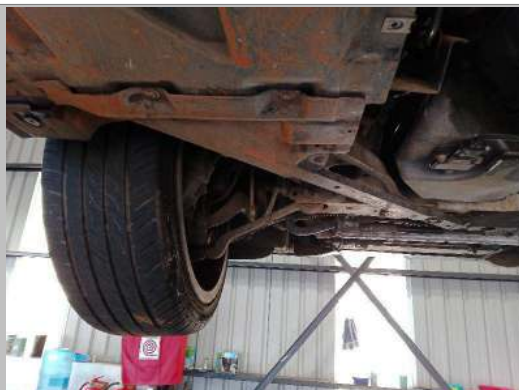
LF TYRE TREAD

| | Size | Load/Speed Index | Manufacture | Model | Type* | Production Date | Tread Depth (mm) |
|---|---|---|---|---|---|---|---|
| Front Left | 225/40R18 | 92W | Autogrip | Radial | V | 3820 | 3 mm |

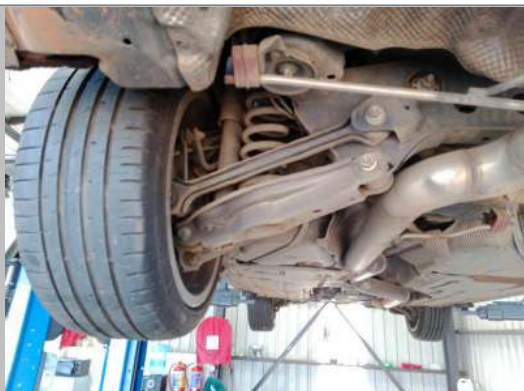
LR TYRE TREAD

| | Size | Load/Speed Index | Manufacture | Model | Type* | Production Date | Tread Depth (mm) |
|---|---|---|---|---|---|---|---|
| Rear Left | 255/35R18 | 90Y | Goodyear | Eagle | V | 1020 | 3 mm |

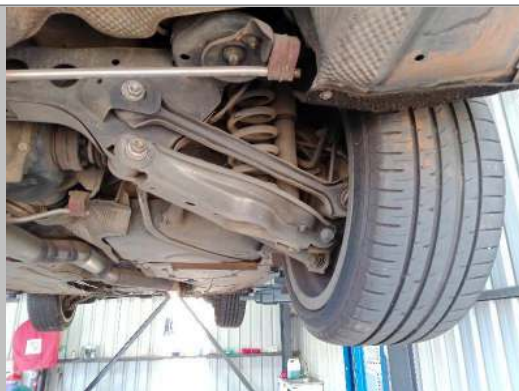
RR TYRE TREAD

| | Size | Load/Speed Index | Manufacture | Model | Type* | Production Date | Tread Depth (mm) |
|---|---|---|---|---|---|---|---|
| Rear Right | 255/35R18 | 90Y | Goodyear | Eagle | V | 1121 | 3 mm |

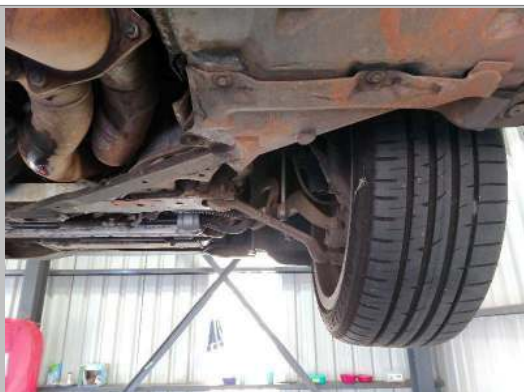
RF TYRE TREAD

| | Size | Load/Speed Index | Manufacture | Model | Type* | Production Date | Tread Depth (mm) |
|---|---|---|---|---|---|---|---|
| Front Right | 225/40R18 | 88Y | Goodyear | Eagle | V | 3721 | 3 mm |
