## CONDITION REPORT

Report No: 2016608489

MFC Auction House  
M57 Pretoria Rd, Glenmarais, KEMPTON PARK  
Gauteng

| Model | X5 XDRIVE40D DSL AT [2010-2014] | Register Number | |

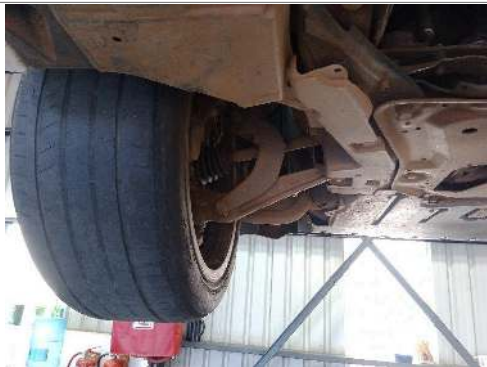
LF TYRE TREAD

| | Size | Load/Speed Index | Manufacture | Model | Type* | Production Date | Tread Depth (mm) |
|---|---|---|---|---|---|---|---|
| Front Left | 275/40R20 | 106W | Bridgestone | Radial | V | 1421 | 0 mm |

| Damage | Repair Way |
|---|---|
| Tyre Front Left Worn | Replace |

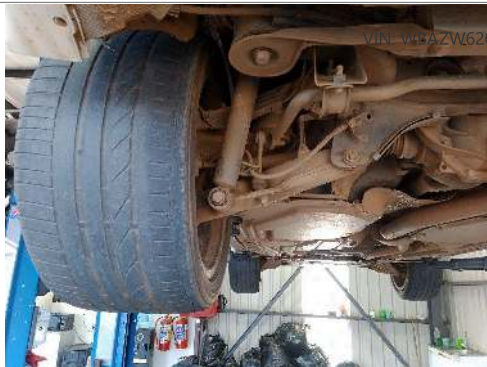
LR TYRE TREAD

| | Size | Load/Speed Index | Manufacture | Model | Type* | Production Date | Tread Depth (mm) |
|---|---|---|---|---|---|---|---|
| Rear Left | 315/35R20 | 110W | Bridgestone | Radial | V | 4716 | 0 mm |

| Damage | Repair Way |
|---|---|
| Tyre Rear Left Worn | Replace |

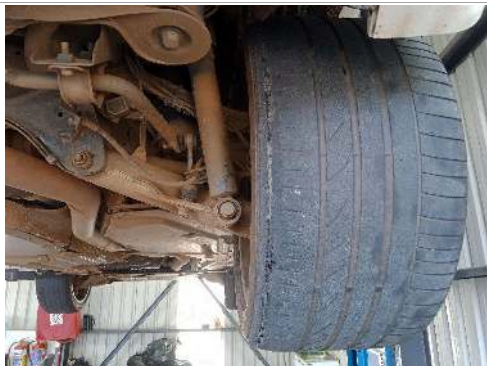
RR TYRE TREAD

| | Size | Load/Speed Index | Manufacture | Model | Type* | Production Date | Tread Depth (mm) |
|---|---|---|---|---|---|---|---|
| Rear Right | 315/35R20 | 110W | Bridgestone | Radial | V | 4716 | 0 mm |

| Damage | Repair Way |
|---|---|
| Tyre Rear Right Worn | Replace |

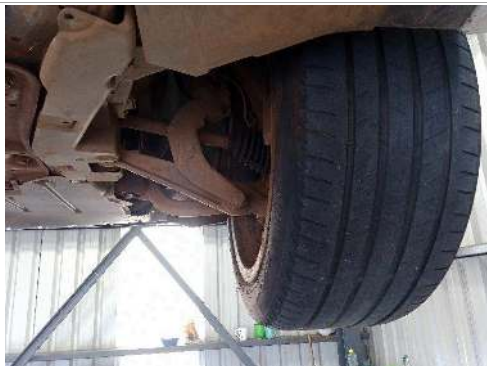
RF TYRE TREAD

| | Size | Load/Speed Index | Manufacture | Model | Type* | Production Date | Tread Depth (mm) |
|---|---|---|---|---|---|---|---|
| Front Right | 275/40R20 | 106W | Bridgestone | Radial | V | 0821 | 2 mm |

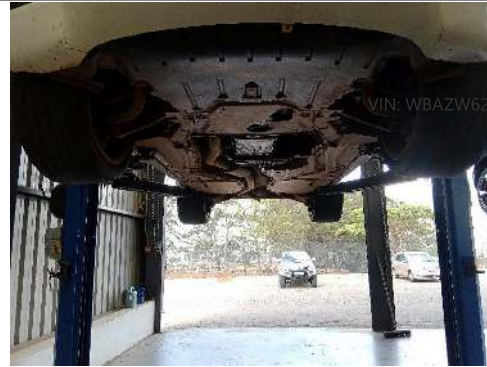
undercarriage front.

Road Test: front prop shop missing from x drive system. vehicle suspension not working correctly vehicle unsafe to drive.
