MFC Auction House  
M57 Pretoria Rd, Glenmarais, KEMPTON PARK  
Gauteng

| Manufacturer | MERCEDES-BENZ | Registration Number | CY56973 |

## CONDITION REPORT

Report No: 2016219037

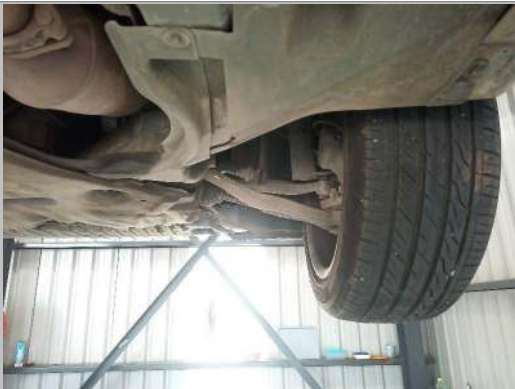
RF TYRE TREAD

| | Size | Load/Speed Index | Manufacture | Model | Type* | Production Date | Tread Depth (mm) |
|---|---|---|---|---|---|---|---|
| Front Right | 225/45R17 | 94W | Landsail | Radial | V | 0623 | 2 mm |

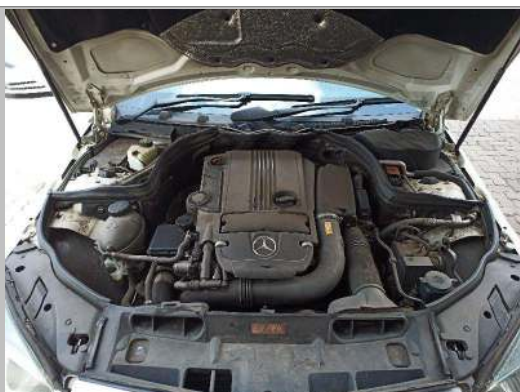
ENGINE 1

| | Damage | Repair Way |
|---|---|---|
| | Engine Oil Leak | Repair |
