CONDITION REPORT

Report No: 2016200569

MFC Auction House
M57 Pretoria Rd, Glenmarais, KEMPTON PARK
Gauteng

Vehicle Type	PASSENGER VEHICLE	Registered Owner	MFC
Manufacturer	MERCEDES-BENZ	Registration Number	JW08DZGP
Model	C180	Register Number	
VIN	WDD2050402R293345	Date Of First Licensing	
Engine Number		Last COR	
Doors	4	License Expiry Date	31/12/2023
Color	WHITE	Power / Displacement	
Year Model		Paint Finish	TWO COAT UNI
Km Reading	129,378 KM	Fuel	PETROL
Cab / Body Type	SEDAN	Transmission	AUTOMATIC

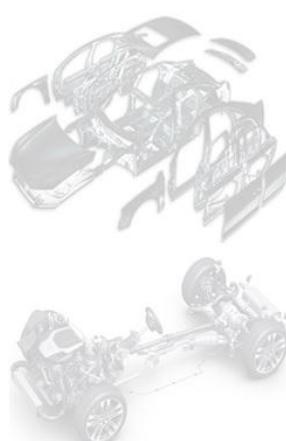
VEHICLE INSPECTION

Damage	Repair Way
Seat Front Right Damaged	Repair
Front Bumper Damaged	Repair
Bonnet Damaged	Repair
Front Fender Left Damaged	Repair
Front Fender Right Damaged	Repair
Rear Fender Left Damaged	Repair
Rear Fender Right Damaged	Repair
Door Front Left Damaged	Repair
Door Front Right Damaged	Repair
Door Rear Left Damaged	Repair
Door Rear Right Damaged	Repair
Rear bumper Damaged	Repair
