## CONDITION REPORT

Report No: 2016211827

MFC Auction House  
M57 Pretoria Rd, Glenmarais, KEMPTON PARK  
Gauteng

| Manufacturer | FORD | Registration Number | HN15RGGP |

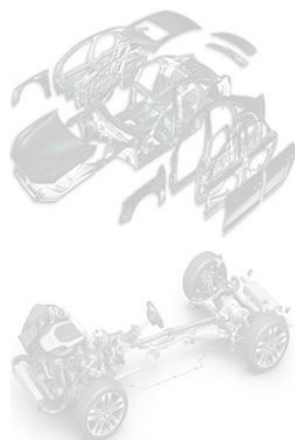
| Damage | Repair Way |
|---|---|
| Front Bumper Damaged | Repair |
| Bonnet Damaged | Repair |
| Rear Fender Left Damaged | Repair |
| Door Rear Left Damaged | Repair |
| Door Rear Right Damaged | Repair |
| Rear bumper Damaged | Repair |

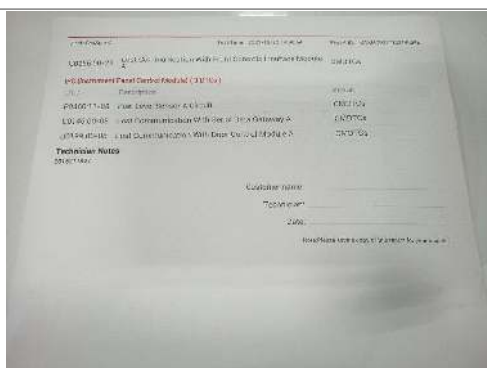
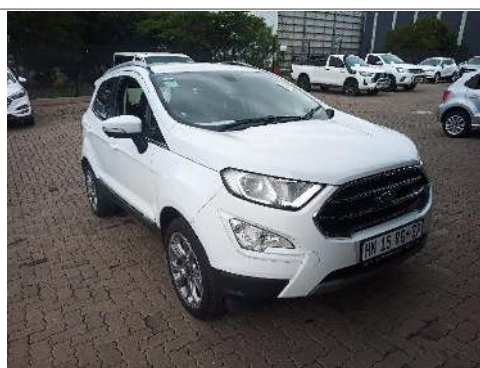
Diagnostic report

During the diagnostic no active error messages were detected. (See also attached Diagnostic Report. For more information regarding the Fault Codes (DTC) and the recommended rectifications please contact the workshops of the vehicle manufacture).

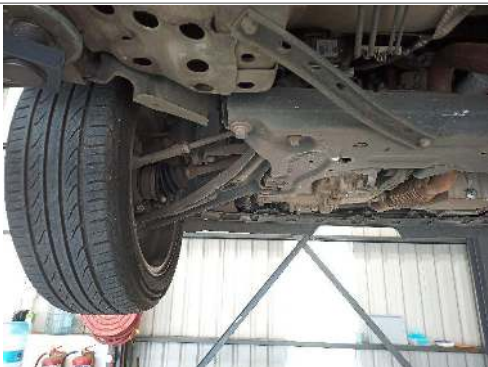
LF TYRE TREAD

| | Size | Load/Speed Index | Manufacture | Model | Type* | Production Date | Tread Depth (mm) |
|---|---|---|---|---|---|---|---|
| Front Left | 205/50R17 | 93W | Landsail | Radial | V | 3321 | 3 mm |

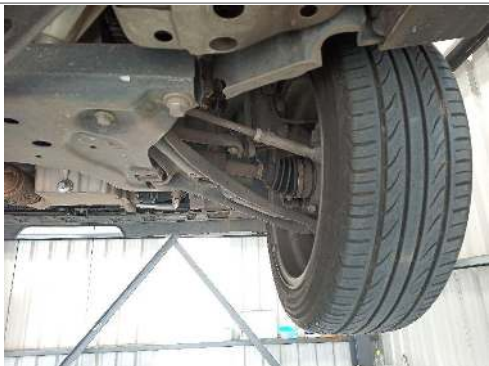
RF TYRE TREAD

| | Size | Load/Speed Index | Manufacture | Model | Type* | Production Date | Tread Depth (mm) |
|---|---|---|---|---|---|---|---|
| Front Right | 205/50R17 | 93W | Landsail | Radial | V | 0921 | 3 mm |
