CONDITION REPORT

Report No: 2016207074

MFC Auction House
M57 Pretoria Rd, Glenmarais, KEMPTON PARK
Gauteng

| Manufacturer | FORD | Registration Number | JD76CTGP |

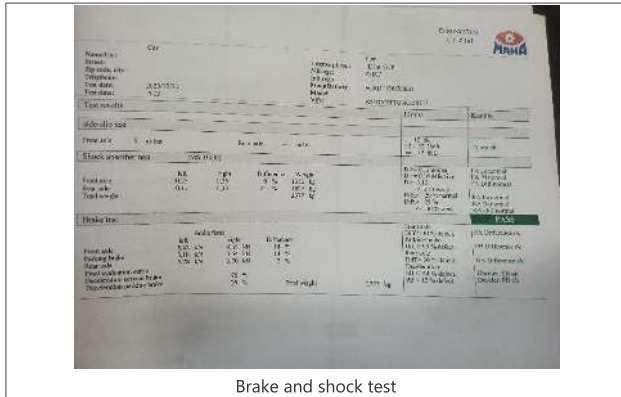
Brake and shock test

Brake Test Results

| | Left | Right | Axle Weight [KG] | Deceleration [m/s ²] |
|---|---|---|---|---|
| Front | 5.42 | 4.68 | - | |
| Rear | 3.78 | 3.7 | - | |
| Emergency / Parking | 3.18 | 3.64 | - | |

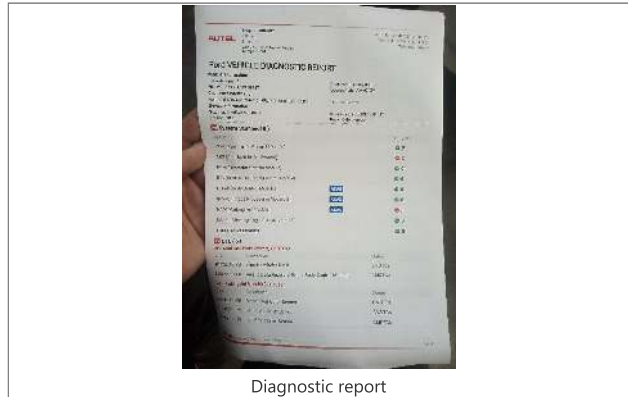
Diagnostic report

During the diagnostic no active error messages were detected. (See also attached Diagnostic Report. For more information regarding the Fault Codes (DTC) and the recommended rectifications please contact the workshops of the vehicle manufacture).

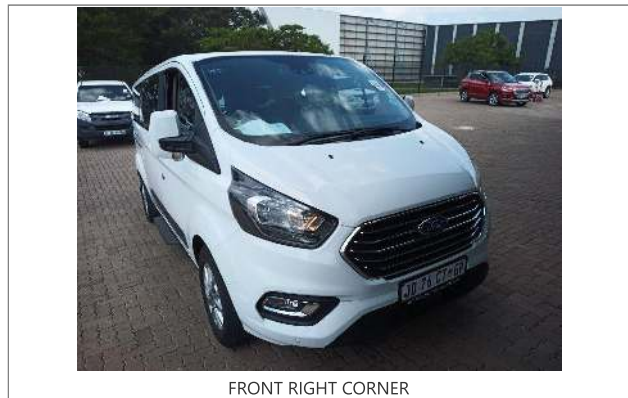
FRONT RIGHT CORNER

Body • Exterior: Minor dents and scratches and stone chips to some body panels. Signs of repair work done to some body panels. Poor alignment to some body panels.
