CONDITION REPORT

Report No: 2016252626

MFC Auction House
M57 Pretoria Rd, Glenmarais, KEMPTON PARK
Gauteng

Vehicle Type	PASSENGER VEHICLE	Registered Owner	MFC AUCTION HOUSE
Manufacturer	FORD	Registration Number	FJ36GSGP
Model	FIESTA	Register Number	
VIN	WF0DXXGAKDGR54328	Date Of First Licensing	
Engine Number		Last COR	
Doors	5	License Expiry Date	31/12/2023
Color	GREY	Power / Displacement	
Year Model		Paint Finish	M - METALLIC
Km Reading	135,284 KM	Fuel	PETROL
Cab / Body Type	HATCHBACK	Transmission	MANUAL

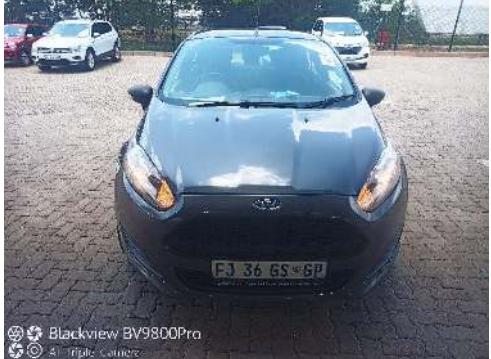
90 DEGREE FRONT

Damage	Repair Way
Under bonnet insulation cover Damaged	Replace
Front Bumper Paintwork • Scratched	Repair
Front Fender Left Dented	Repair
Front Fender Right Paintwork • Scratched	Repair
Rear Fender Right Dented	Repair
Door Front Left Dented	Repair
Door Front Right Dented	Repair
Door Rear Left Paintwork • Discoloured	Repair
Rear bumper Paintwork • Scratched	Repair
CV Joint(s) Boot(s) Front Right (inner/outer) Defective	Repair

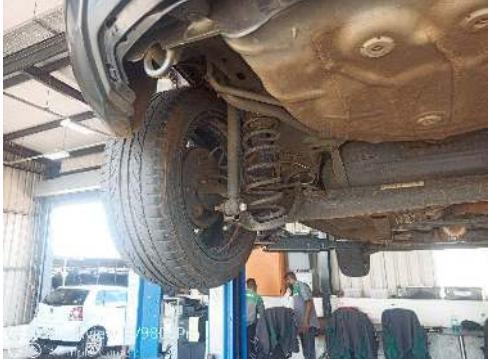
LR TYRE TREAD

Size	Load/Speed Index	Manufacture	Model	Type*	Production Date	Tread Depth (mm)
Front Left	195/50R15	82V	Hankook	Ventus	V	0620	2 mm
Front Right	195/50R15	82V	Hankook	Ventus	V	0520	3 mm
Rear Left	195/50R15	82V	Hankook	Ventus	V	0520	3 mm
Rear Right	175/65R14	82T	Continental	Contact	V	0316	4 mm
Spare	195/50R15	82H	Hankook	Ventus	V	///	4 mm
