CONDITION REPORT

Report No: 2016230376

MFC Auction House
M57 Pretoria Rd, Glenmarais, KEMPTON PARK
Gauteng

Vehicle Type	LIGHT LOAD VEHICLE	Registered Owner	MFC AUCTION HOUSE
Manufacturer	VOLKSWAGEN	Registration Number	KT27WXGP
Model	AMAROK	Register Number	
VIN	WV1ZZZ2HZDH011794	Date Of First Licensing	
Engine Number		Last COR	
Doors	4	License Expiry Date	16/01/2024
Color	WHITE	Power / Displacement	
Year Model		Paint Finish	TWO COAT UNI
Km Reading	271,691 KM	Fuel	DIESEL
Cab / Body Type	DOUBLE CAB	Transmission	MANUAL

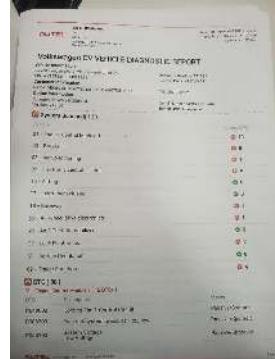
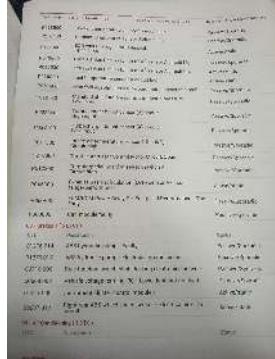
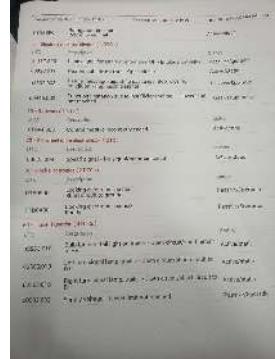
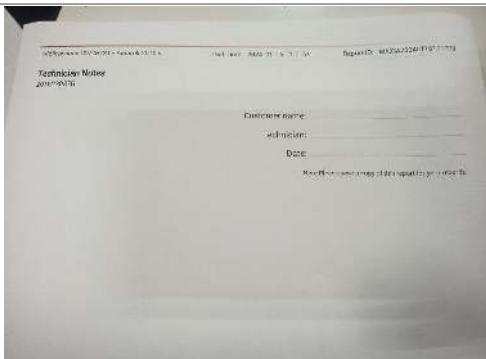
Diagnostic report

During the diagnostic no active error messages were detected. (See also attached Diagnostic Report. For more information regarding the Fault Codes (DTC) and the recommended rectifications please contact the workshops of the vehicle manufacture).

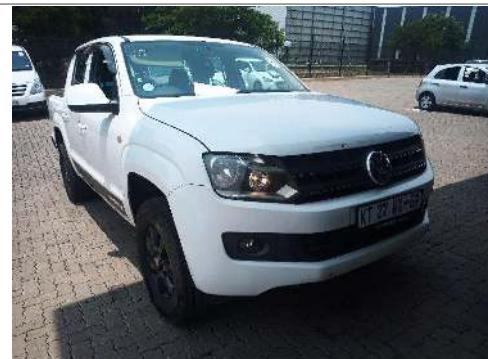
FRONT RIGHT CORNER

Body • Exterior: Minor dents and scratches and stone chips to some body panels. Signs of

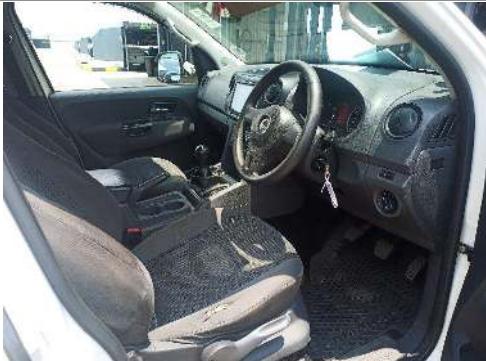
INTERIOR (FRONT DRIVER DOOR)

Lights: Interior panic handles damaged.
