## CONDITION REPORT

Report No: 2016403039

| Manufacturer | VOLKSWAGEN | Registration Number | KHX312NW |
| Model | GOLF TSI | Register Number | |

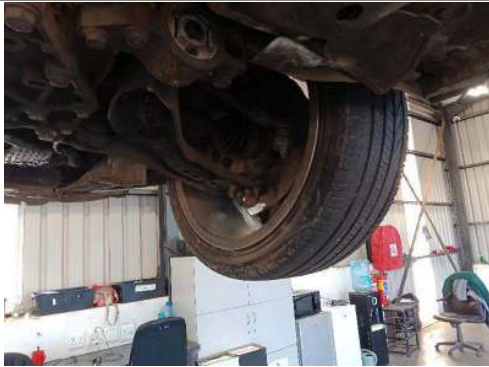
RF TYRE TREAD

| Damage | Repair Way |
|---|---|
| Tyre Front Right Damaged | Replace |

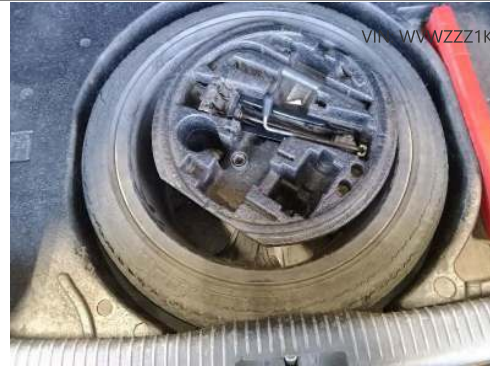
Spare wheel fitted

| Damage | Repair Way |
|---|---|
| Spare Tyre Damaged | Replace |

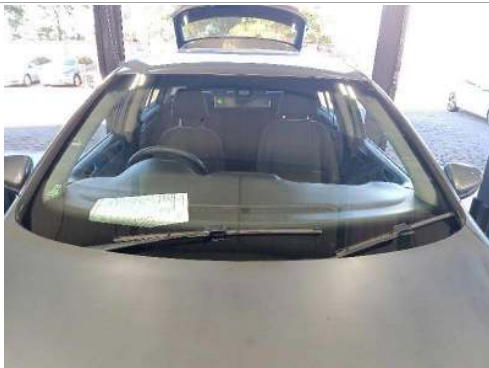
LICENSE DISC

Radiator Cradle Damaged  
Engine Performance Idling / Hunting  
Engine Noise Excessive  
Engine Smoke Excessive  
Battery loose  
Engine management lights illuminated  
Aircon not working  
Both front fog lights malfunction  
No license disc

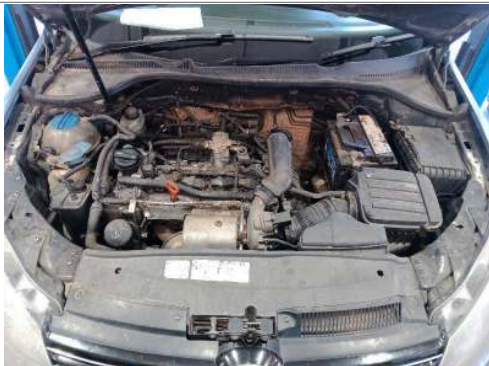
ENGINE 1

| Damage | Repair Way |
|---|---|
| Engine Oil Leak | Repair |
