CONDITION REPORT

Report No: 2016218352

Vehicle Type	PASSENGER VEHICLE	Registered Owner	MFC
Manufacturer	VOLKSWAGEN	Registration Number	KBH184MP
Model	POLO GTI	Register Number	
VIN	WVWZZZ6RZDY087210	Date Of First Licensing	
Engine Number		Last COR	
Doors	5	License Expiry Date	31/10/2023
Color	WHITE	Power / Displacement	
Year Model		Paint Finish	TWO COAT UNI
Km Reading	146,855 KM	Fuel	PETROL
Cab / Body Type	HATCHBACK	Transmission	AUTOMATIC

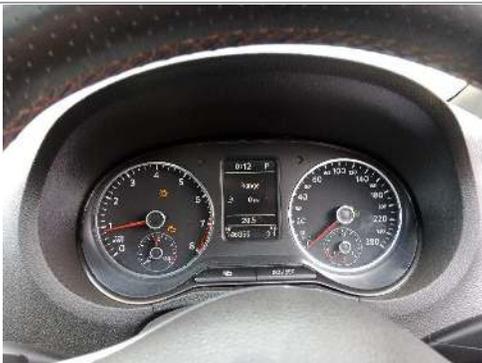
DASHBOARD (W/ ENGINE RUNNING)

Damage	Repair Way
Windscreen Cracked	Replace
Stabilizer Mounting Front Left Damaged	Replace
Control Arm Bush(es) Front Axle Left Cracked	Replace
Control Arm Bush(es) Front Axle Right Cracked	Replace
Tyre Front Left Damaged	Replace
Tyre Rear Right Worn	Replace
Spare Tyre Damaged	Replace
Rim Front Left Dented	Repair
Rim Front Right Dented	Repair
Rim Rear Right Dented	Repair
Rim Spare Wheel Cracked	Repair
Main Beam Right Dented	Repair
Engine to silencer pipe Defective	Replace
Catalytic converter Missing	Replace
Belly plates Damaged	Replace
Gearbox Oil Leak	Repair
CV Joint(s) Front Left (inner/outer) Defective	Repair
CV Joint(s) Boot(s) Front Left (inner/outer) Damaged	Replace
Radiator Cradle Damaged	Replace
Warning lights illuminated on dashboard	Repair

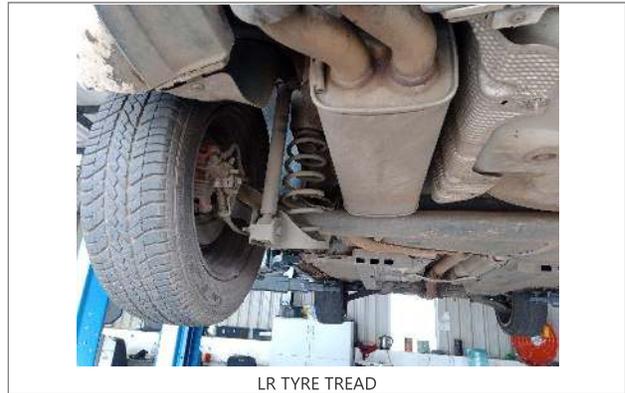
LR TYRE TREAD

Tyres and Rims: Alloy rims scratched. Rear left and right tyre sizes different.

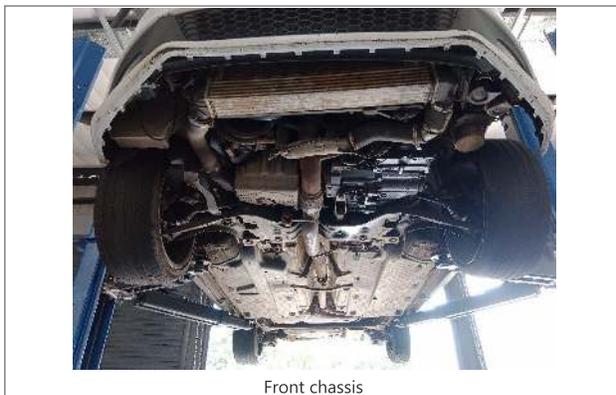
Front chassis

Undercarriage: Vehicle undercarriage dirty. Engine splash plate missing. Non standard exhaust fitted to vehicle. Bolt missing on front left inner CV joint.

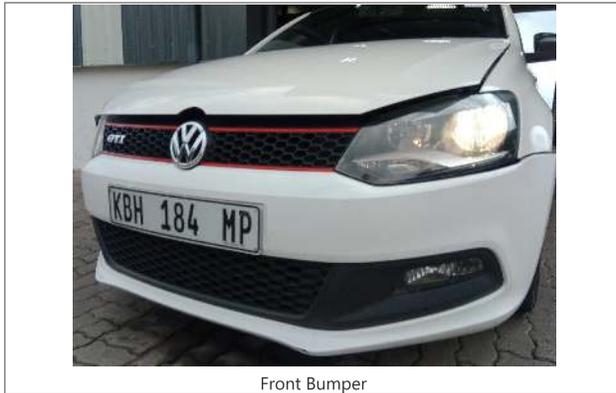
Front Bumper

Residual traces of repair on some body panels. Front left and right inner fender liners damaged. Signs of impact damage to front of vehicle. Rear number plate missing.

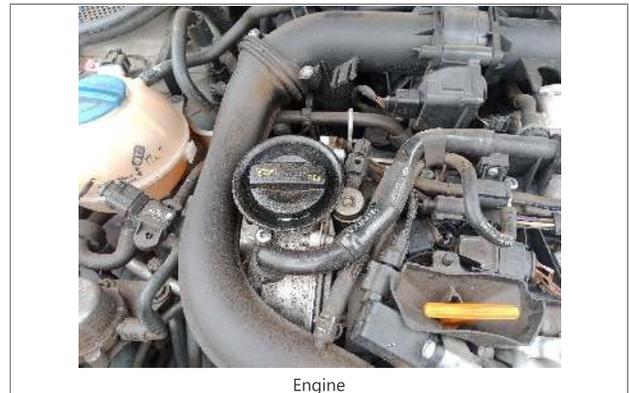
Damage	Repair Way
Engine Oil Leak	Repair
Engine Wiring Defective	Repair
Under bonnet insulation cover Damaged	Replace
Center Console / Cubbyhole + Lid Broken	Repair
Tail Light Left Cracked	Replace
Headlight Left Cracked	Replace
Headlight Right Damaged	Replace
Seat Front Right Torn / Cut	Repair
Door Handle Rear Right Defective	Repair
Door Sealing Rubber Front Right Damaged	Replace
Parcel Tray Missing	Replace
Side Mirror Left Paintwork • Scratched	Repair
Side Mirror Right Paintwork • Scratched	Repair
Front Bumper Damaged	Repair
Bonnet Paintwork • Chipmarks	Repair
Front Fender Left Dented	Repair
Front Fender Right Dented	Repair
Rear Fender Left Residual Traces of Repair	Repair
Rear Fender Right Paintwork • Scratched	Repair
Door Front Left Paintwork • Scratched	Repair
Door Front Right Paintwork • Scratched	Repair
Door Rear Left Dented	Repair
Door Rear Right Paintwork • Scratched	Repair
Boot Lid / Hatch door Dented	Repair

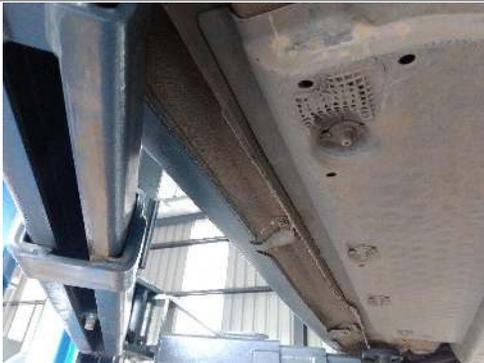
Rear bumper Paintwork • Scratched	Repair
Sill Panel Right Paintwork • Scratched	Repair
Rocker Panel Left Damaged	Repair
Rocker Panel Right Damaged	Repair
Roof Dented	Repair
