CONDITION REPORT

Report No:
2016931041
DATE
01/07/2025

MFC Auction House
M57 Pretoria Rd, Glenmarais, KEMPTON PARK
Gauteng

Vehicle Type	PASSENGER VEHICLE	Registered Owner	MFC
Manufacturer	VOLKSWAGEN	Registration Number	LGG289MP
Model	POLO GP 1.8 TSI GTI 141KW 5-DR DSG [2016-2018]	Register Number	
VIN	WVWZZZ6RZHY071232	Date Of First Licensing	
Engine Number		Last COR	
Doors	5	License Expiry Date	31/01/2026
Color	RED	Power / Displacement	
Year Model	2016	Paint Finish	C - COMMON
Km Reading	203,062 KM	Fuel	PETROL
Cab / Body Type	HATCHBACK	Transmission	AUTOMATIC

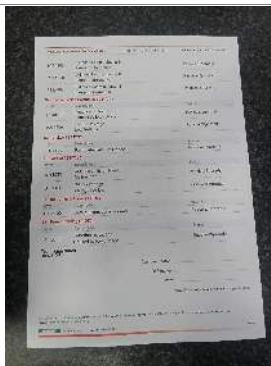
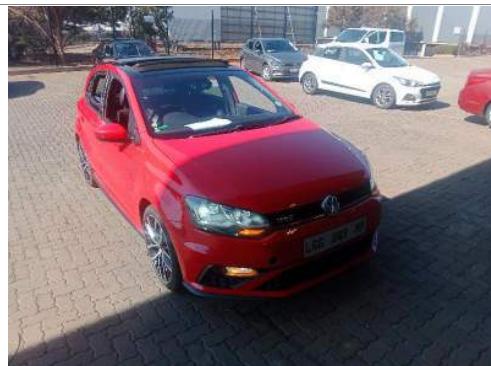
Diagnostic report

No	System	Code	Description	Status
1	PASSIVE/SPORADIC	U101100	SUPPLY VOLTAGE VOLTAGE TOO LOW

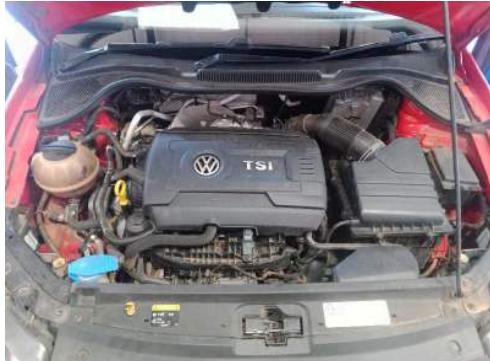
ENGINE 1

Damage	Repair Way
Engine Oil Leak	Repair
Center Console / Cubbyhole + Lid Damaged	Repair
Front Bumper Paintwork • Scratched	Repair
Bonnet Paintwork • Chipmarks	Repair
Front Fender Left Paintwork • Scratched	Repair
Front Fender Right Paintwork • Scratched	Repair
Rear Fender Left Paintwork • Scratched	Repair
Rear Fender Right Paintwork • Scratched	Repair
Door Front Left Paintwork • Scratched	Repair
Door Front Right Paintwork • Scratched	Repair
Door Rear Left Paintwork • Scratched	Repair
Door Rear Right Paintwork • Chipmarks	Repair
Boot Lid / Hatch door Paintwork • Scratched	Repair
Parking Brake Performance Left / Right Difference out of legal range	Repair
