CONDITION REPORT

Report No: 2016204986

MFC Auction House
M57 Pretoria Rd, Glenmarais, KEMPTON PARK
Gauteng

| Manufacturer | VOLKSWAGEN | Registration Number | HK41BWGP |

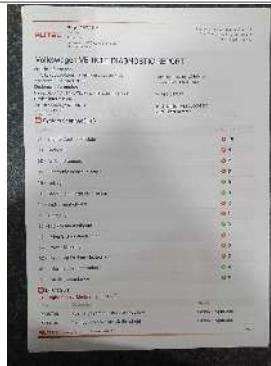
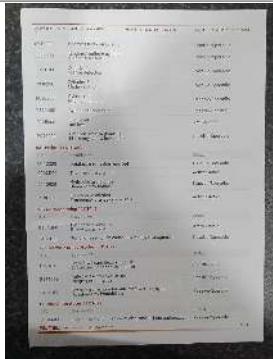
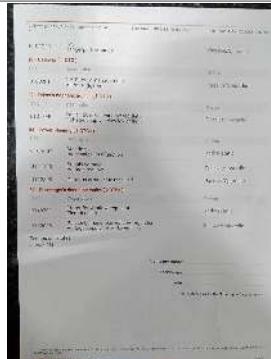
Diagnostic test

During the diagnostic no active error messages were detected. (See also attached Diagnostic Report. For more information regarding the Fault Codes (DTC) and the recommended rectifications please contact the workshops of the vehicle manufacture).

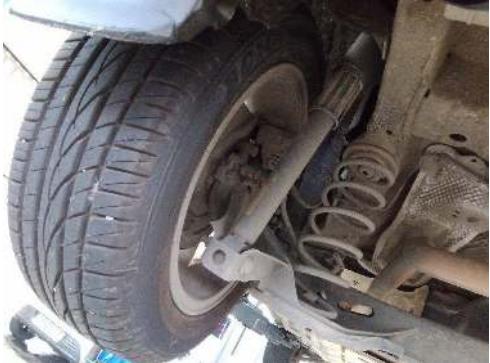
LR TYRE TREAD

| | Size | Load/Speed Index | Manufacture | Model | Type* | Production Date | Tread Depth (mm) |
|---|---|---|---|---|---|---|---|
| Rear Left | 205/55R16 | 91V | Sumitomo | BC100 | V | 1223 | 7 mm |

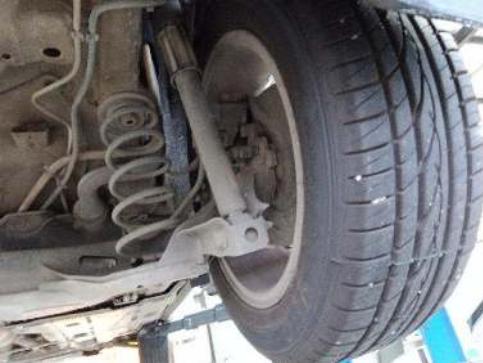
RR TYRE TREAD

| | Size | Load/Speed Index | Manufacture | Model | Type* | Production Date | Tread Depth (mm) |
|---|---|---|---|---|---|---|---|
| Rear Right | 205/55R16 | 91V | Sumitomo | BC100 | | 3722 | 7 mm |

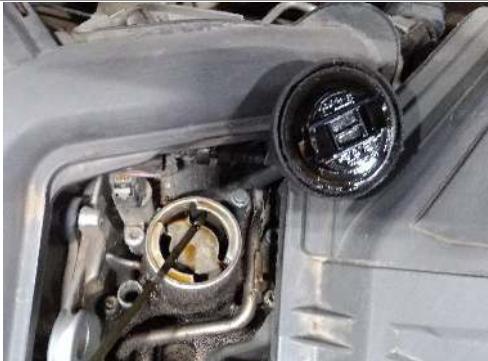
Oil cap and dipstick

| Damage | Repair Way |
|--|---|
| Engine Oil Leak | Repair |
