## CONDITION REPORT

Report No: 2016445842

MFC Auction House  
M57 Pretoria Rd, Glenmarais, KEMPTON PARK  
Gauteng

| Manufacturer | VOLKSWAGEN | Registration Number | ZLH924GP |

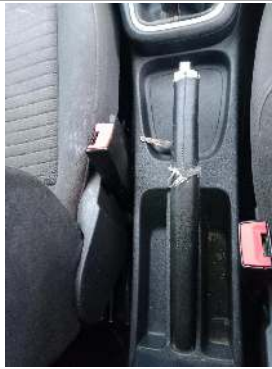
| Damage | Repair Way |
|---|---|
| Interior | Handbrake lever dust cover damaged |

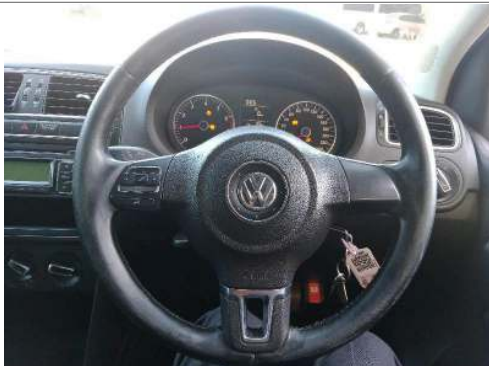
| Damage | Repair Way |
|---|---|
| Steering Wheel Trim Defective | Repair |

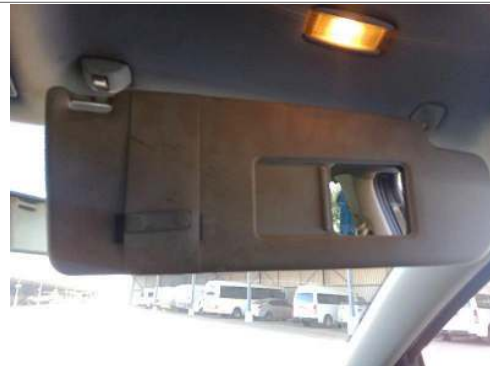
| Damage | Repair Way |
|---|---|
| Sun Visor Right Damaged | Replace |

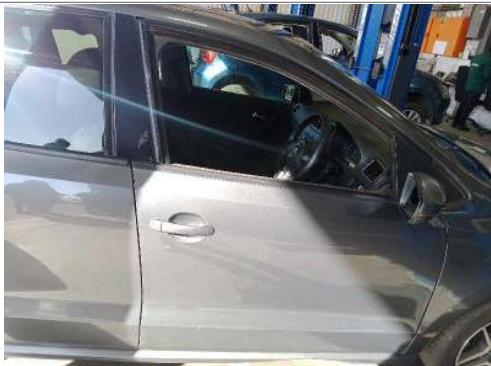
| Damage | Repair Way |
|---|---|
| Door Front Right Damaged | Repair |

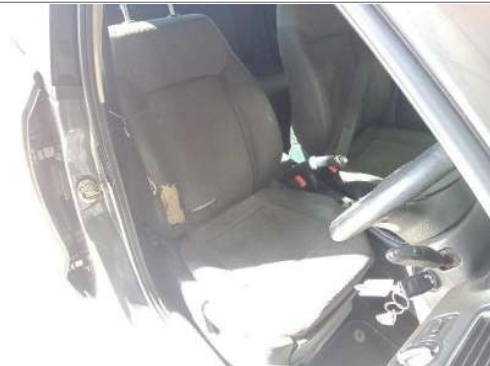
| Damage | Repair Way |
|---|---|
| Seat Front Right Damaged | Repair |

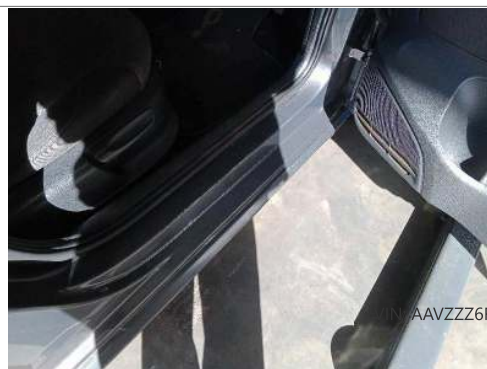
| Damage | Repair Way |
|---|---|
| Sill Panel Right Paintwork • Scratched | Repair |

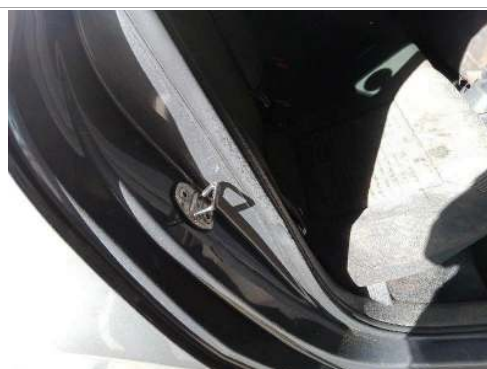
| Damage | Repair Way |
|---|---|
| Door Sealing Rubber Rear Right Torn / Cut | Replace |

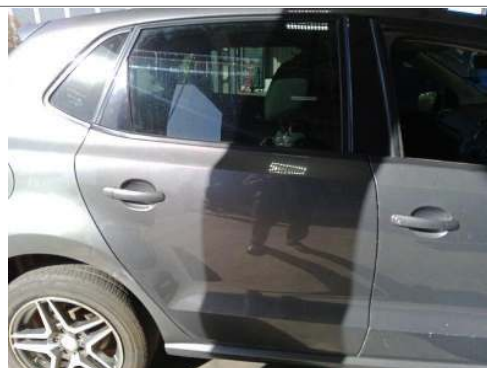
| Damage | Repair Way |
|---|---|
| Door Rear Right Paintwork • Scratched | Repair |

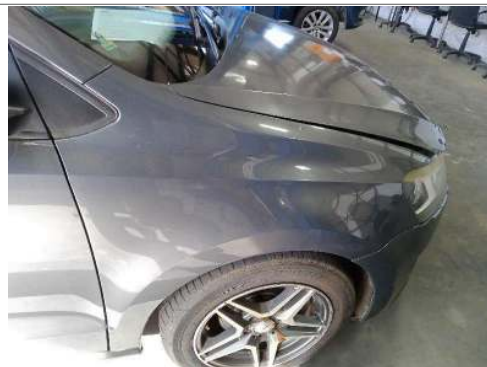
| Damage | Repair Way |
|---|---|
| Front Fender Right Paintwork • Scratched | Repair |

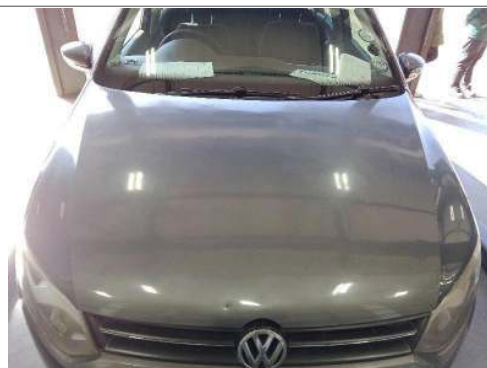
| Damage | Repair Way |
|---|---|
| Bonnet Damaged | Repair |

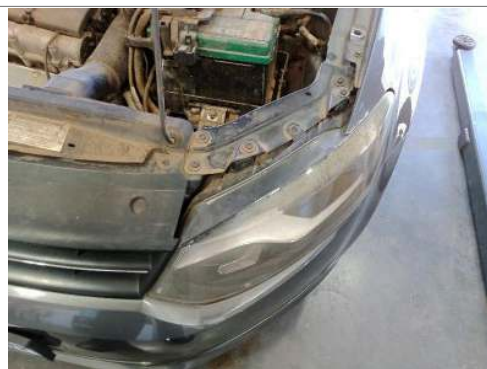
| Damage | Repair Way |
|---|---|
| Headlight Left Damaged | Replace |

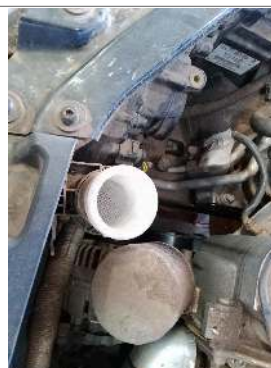
| Damage | Repair Way |
|---|---|
| Caps Missing | Replace |

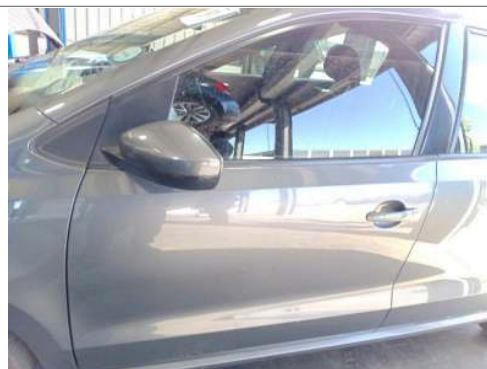
| Damage | Repair Way |
|---|---|
| Door Front Left Damaged | Repair |

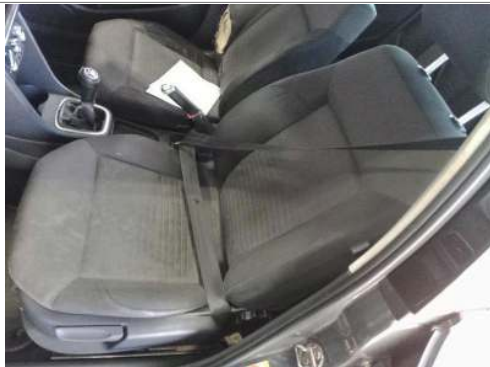
| Damage | Repair Way |
|---|---|
| Seat Front Left Defective | Repair |

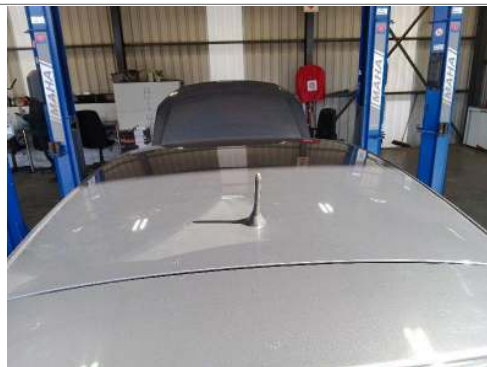
| Damage | Repair Way |
|---|---|
| Roof Dented | Repair |

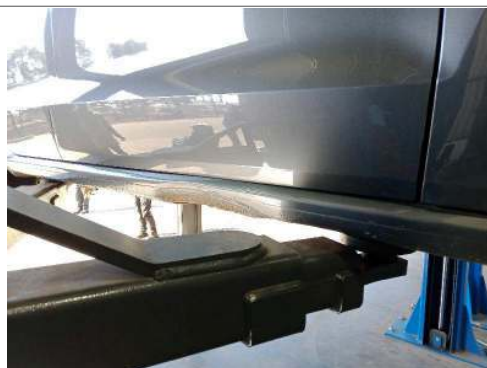
| Damage | Repair Way |
|---|---|
| Rocker Panel Right Damaged | Repair |

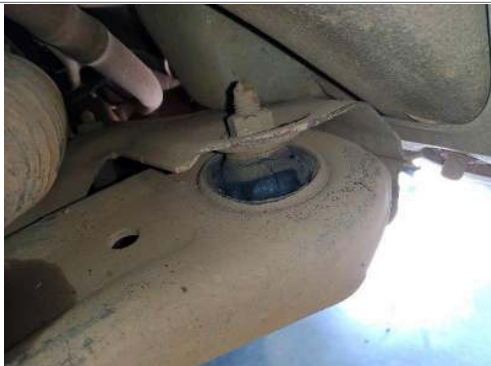
| Damage | Repair Way |
|---|---|
| Control Arm Bush(es) Front Axle Left Damaged | Replace |

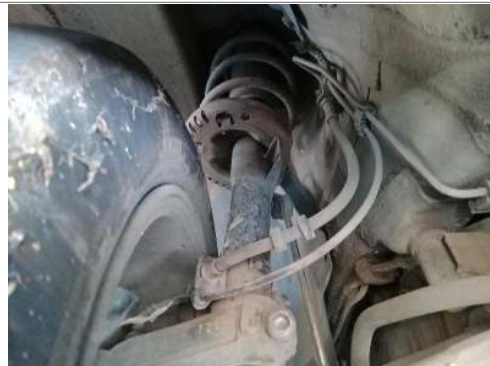
| Damage | Repair Way |
|---|---|
| Shock Absorber Front Left Defective | Replace |

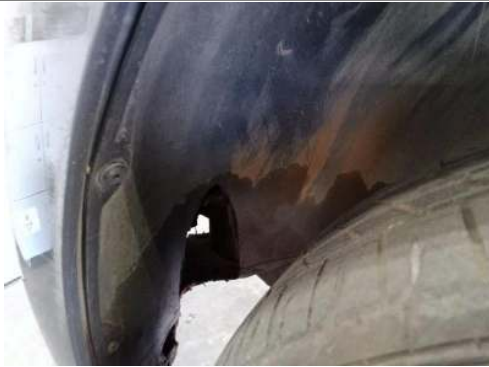
| Damage | Repair Way |
|---|---|
| Front Fender Left / Inner Tray Damaged | Repair |

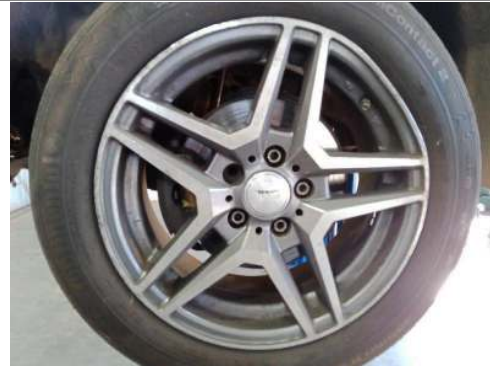
| Damage | Repair Way |
|---|---|
| Rim Front Left Dented | Repair |

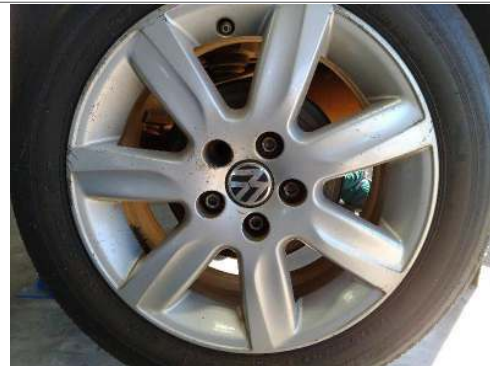
| Damage | Repair Way |
|---|---|
| Bolt(s) / Nut(s) Rear Wheel Left Missing | Replace |

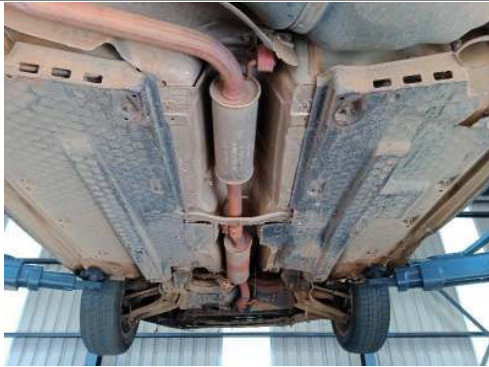
| Damage | Repair Way |
|---|---|
| Belly plates Damaged | Replace |

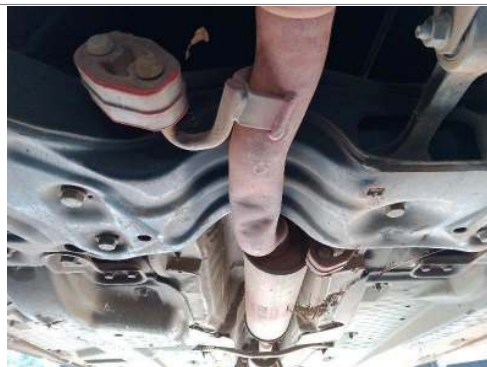
| Damage | Repair Way |
|---|---|
| Engine to silencer pipe Damaged | Repair |
