## CONDITION REPORT

Report No: 2016194485

| Manufacturer | VOLKSWAGEN | Registration Number | FXF556L |
| Model | POLO VIVO | Register Number | |

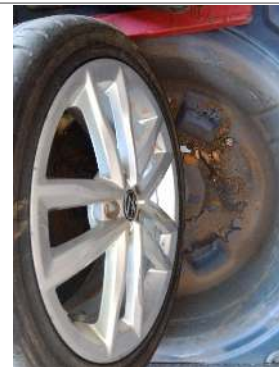
| Damage | Repair Way |
|---|---|
| Rim Spare Wheel Scratched | Repair |

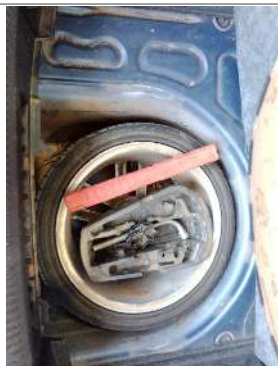
| Damage | Repair Way |
|---|---|
| Inner Boot Floor Pan and Spare Wheel Well Paintwork • Scratched | Repair |

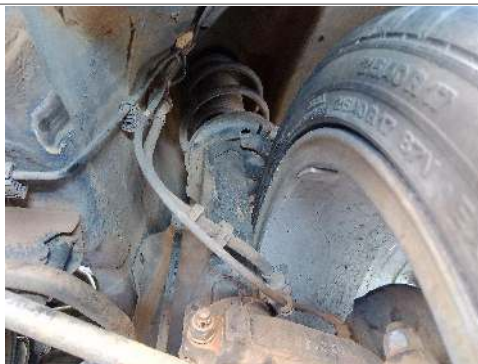
| Damage | Repair Way |
|---|---|
| Shock Absorber Front Right Defective | Replace |

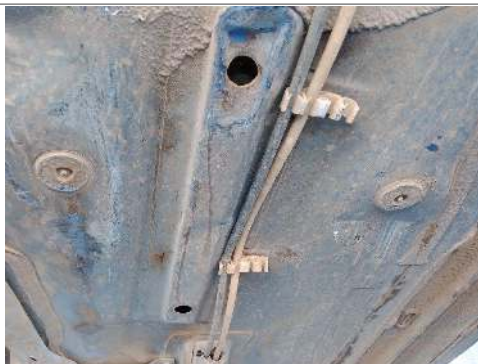
| Damage | Repair Way |
|---|---|
| Fuel Lines Defective | Repair |
