## CONDITION REPORT

Report No: 2016272800

MFC Auction House  
M57 Pretoria Rd, Glenmarais, KEMPTON PARK  
Gauteng

| Manufacturer | NISSAN | Registration Number | JR23PWGP |

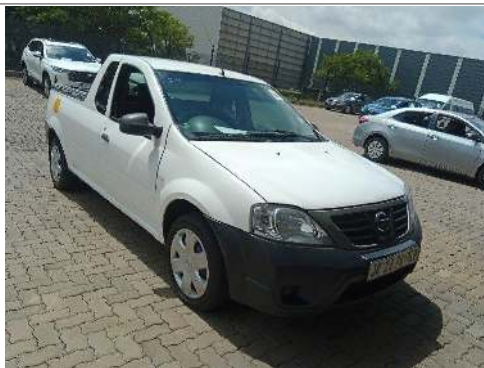
FRONT RIGHT CORNER

| Damage | Repair Way |
|---|---|
| Body and Exterior | Signs of impact damage to front of vehicle |

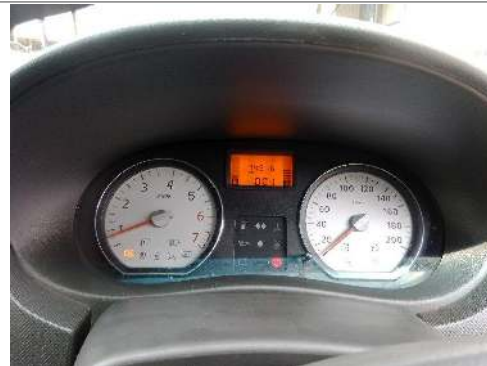
DASHBOARD (W/ ENGINE RUNNING)

| Damage | Repair Way |
|---|---|
| Warning lights illuminated on dashboard | Repair |

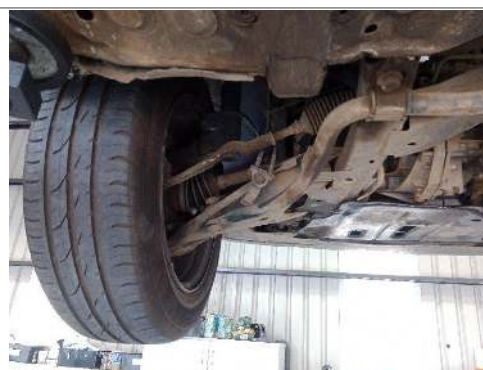
LF TYRE TREAD

| Damage | Repair Way |
|---|---|
| Tyre Front Left Defective | Replace |

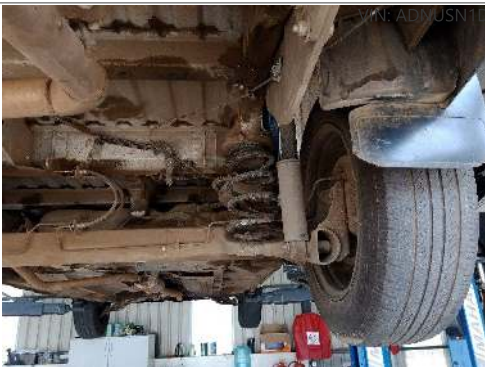
RR TYRE TREAD

| Damage | Repair Way |
|---|---|
| Tyre Rear Right Worn | Replace |

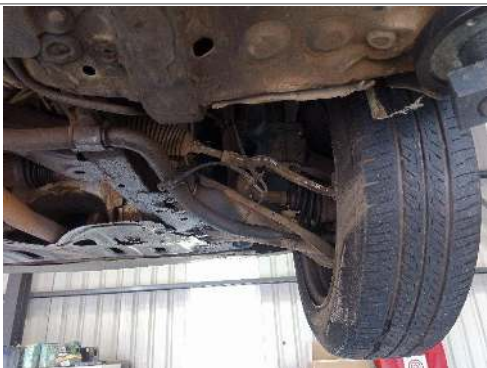
RF TYRE TREAD

| Damage | Repair Way |
|---|---|
| Tyre Front Right Torn / Cut | Replace |

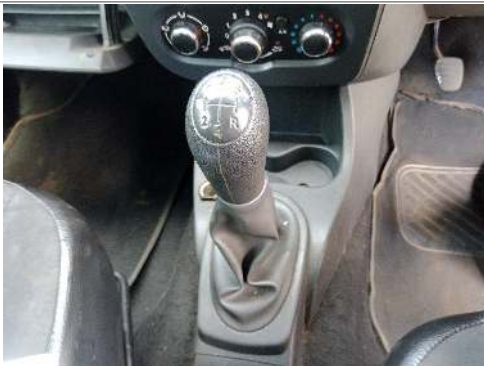
Manual Transmission

| Damage | Repair Way |
|---|---|
| Gearbox Oil Sweat | Repair |

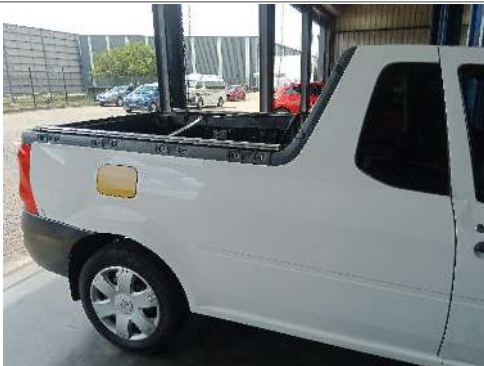
| Damage | Repair Way |
|---|---|
| Rear Fender Right Damaged | Repair |

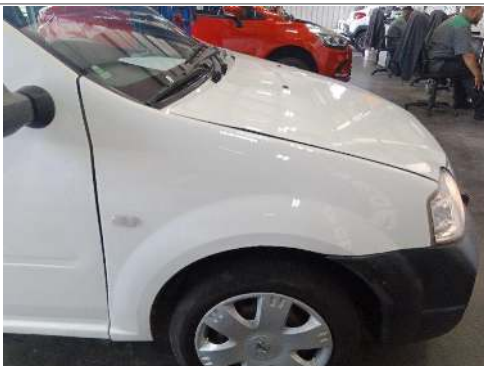
| Damage | Repair Way |
|---|---|
| Front Fender Right Paintwork • Scratched | Repair |

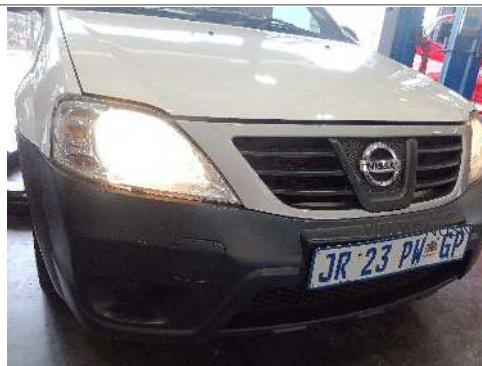
| Damage | Repair Way |
|---|---|
| Front Bumper Paintwork • Scratched | Repair |

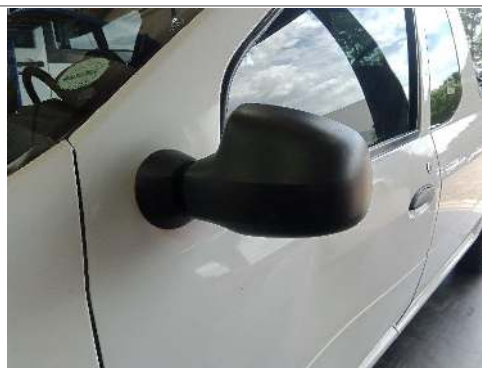
| Damage | Repair Way |
|---|---|
| Side Mirror Left Paintwork • Scratched | Repair |

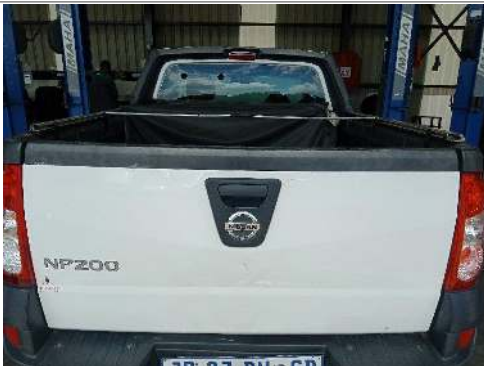
| Damage | Repair Way |
|---|---|
| Tailgate Dented | Repair |

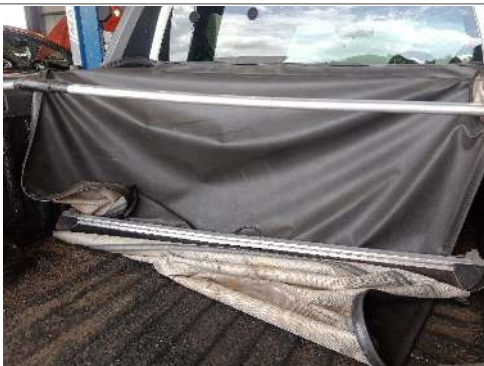
| Damage | Repair Way |
|---|---|
| Load Body Defective | Repair |

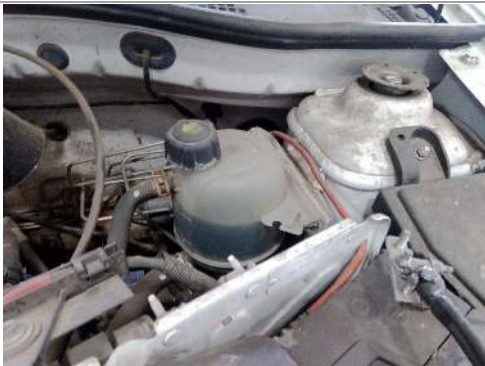
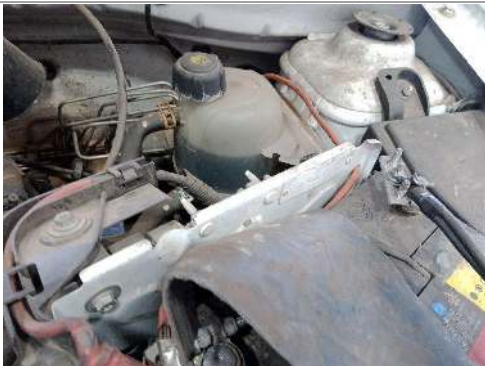
| Damage | Repair Way |
|---|---|
| Engine Wiring Defective | Repair |

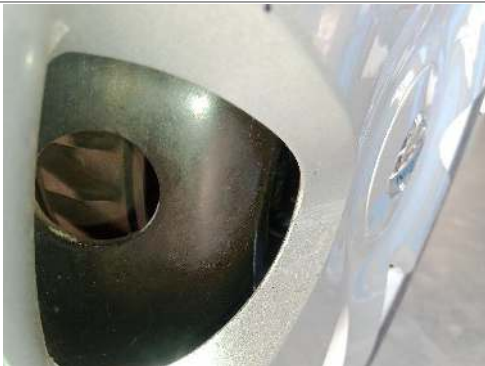
| Damage | Repair Way |
|---|---|
| Bolt(s) / Nut(s) Rear Wheel Right Missing | Replace |

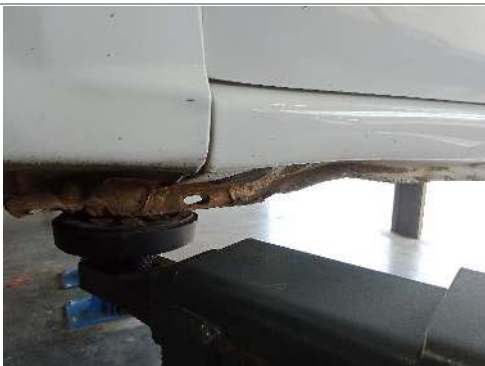
| Damage | Repair Way |
|---|---|
| Rocker Panel Left Damaged | Repair |

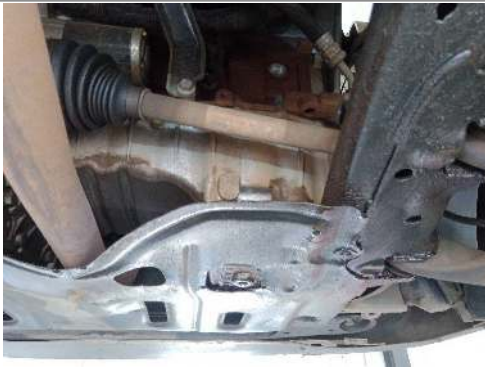
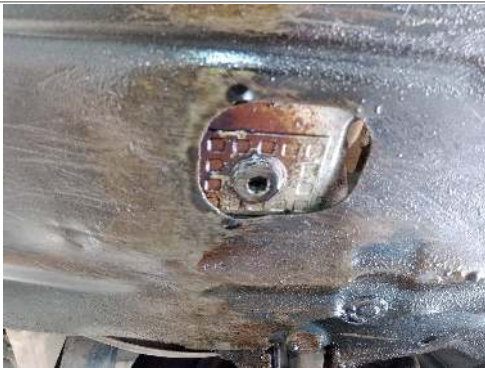
| Damage | Repair Way |
|---|---|
| Engine Oil Leak | Repair |

| Damage | Repair Way |
|---|---|
| Engine Noise Excessive | Repair |

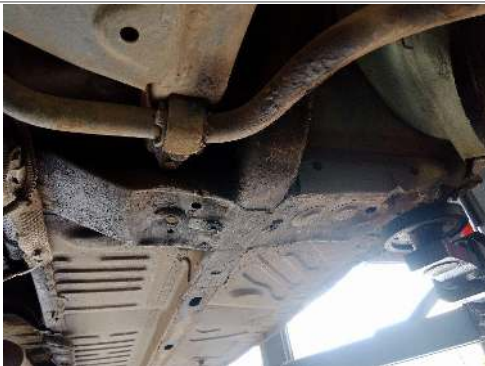
| Damage | Repair Way |
|---|---|
| Chassis Damaged | Repair |

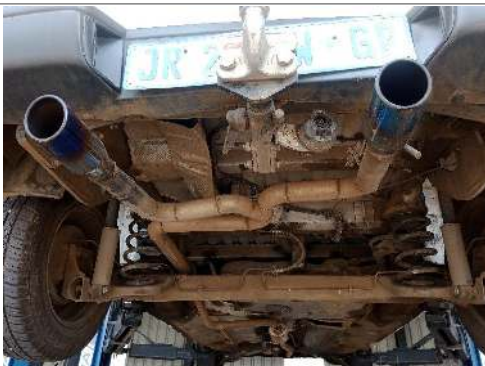
| Damage | Repair Way |
|---|---|
| Engine to silencer pipe Defective | Repair |

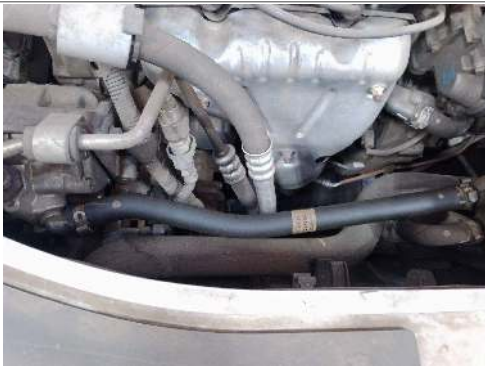
| Damage | Repair Way |
|---|---|
| Hoses Sweat | Repair |

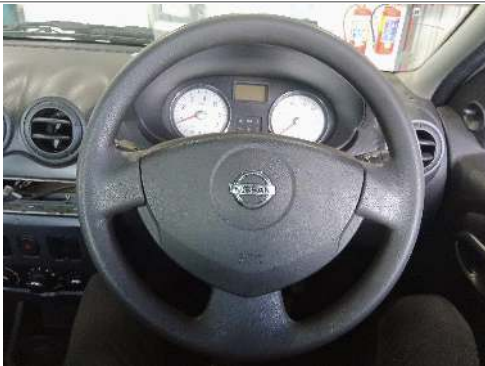
| Damage | Repair Way |
|---|---|
| Steering Wheel Trim Defective | Repair |
