MFC Auction House  
M57 Pretoria Rd, Glenmarais, KEMPTON PARK  
Gauteng

| Manufacturer | TOYOTA | Registration Number | JVW818NW |

## CONDITION REPORT

Report No: 2016664530

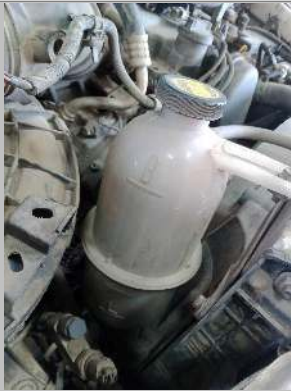
Expansion bottle

| Damage | Repair Way |
|---|---|
| Expansion Bottle Damaged | Repair |

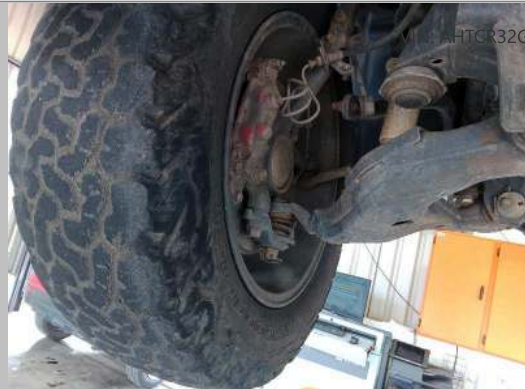
LF TYRE TREAD

| Damage | Repair Way |
|---|---|
| Tyre Front Left Excessive Wear & Tear | Replace |

| | Size | Load/Speed Index | Manufacture | Model | Type* | Production Date | Tread Depth (mm) |
|---|---|---|---|---|---|---|---|
| Front Left | 245/65R17 | 111/108s | BF Goodrich | All terrain | V | 2319 | 0 mm |

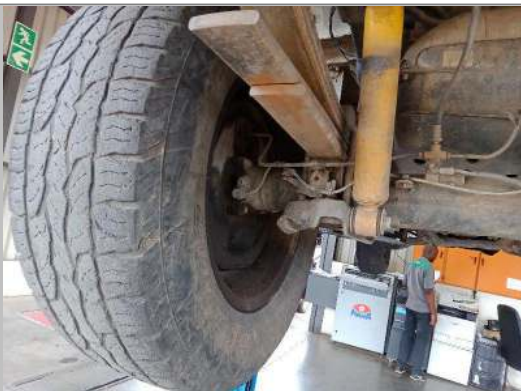
RF TYRE TREAD

| Damage | Repair Way |
|---|---|
| Tyre Front Right Smooth | Replace |

| | Size | Load/Speed Index | Manufacture | Model | Type* | Production Date | Tread Depth (mm) |
|---|---|---|---|---|---|---|---|
| Front Right | 245/70R16 | 111/109T | Goodyear | Wrangler | V | 2719 | 0 mm |

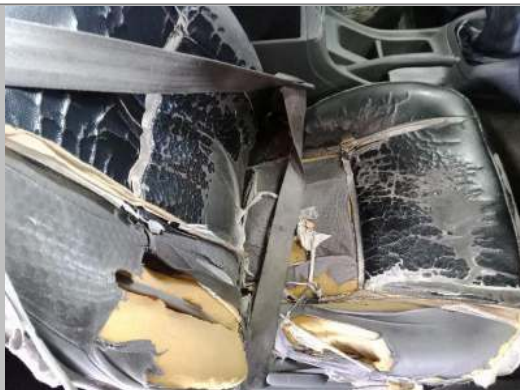
| Damage | Repair Way |
|---|---|
| Seat Front Right Torn / Cut | Repair |

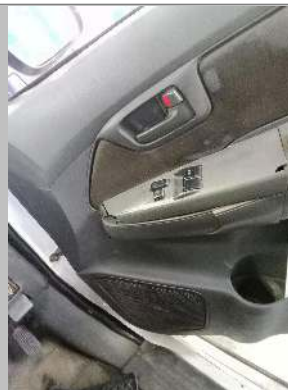
| Damage | Repair Way |
|---|---|
| Door Panel Front Right Damaged | Repair |

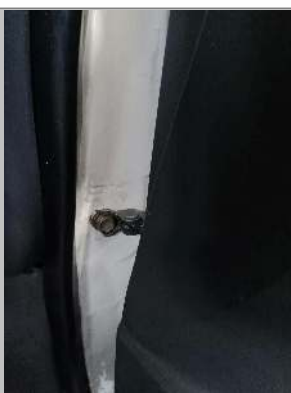
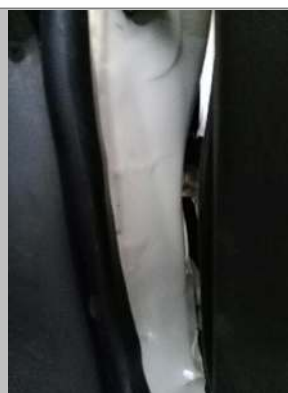
| Damage | Repair Way |
|---|---|
| A • Pillar Right Residual Traces of Repair | Repair |

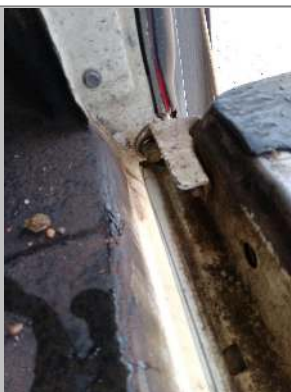
### Tailgate Hinge Right

| Damage | Repair Way |
|---|---|
| Tailgate Hinge Right Defective | Repair |

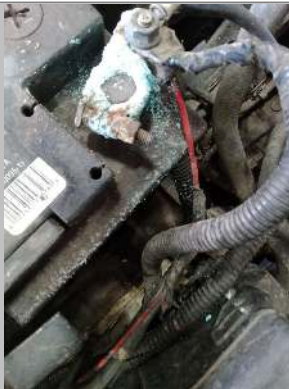
| Damage | Repair Way |
|---|---|
| Engine Wiring Defective | Repair |

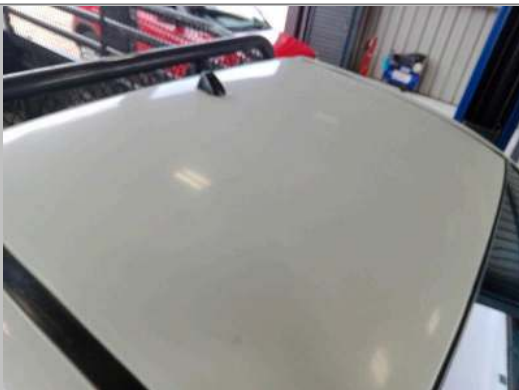
| Damage | Repair Way |
|---|---|
| Roof Residual Traces of Repair | Repair |

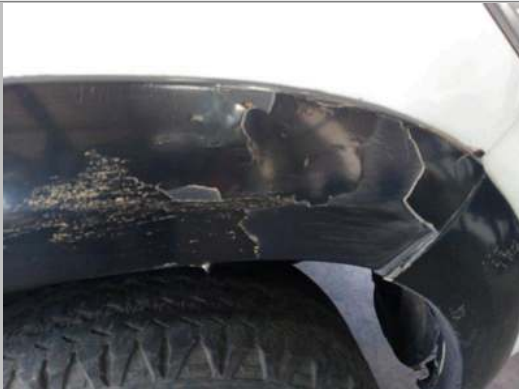
| Damage | Repair Way |
|---|---|
| Front Fender Right Residual Traces of Repair | Repair |
| Front Fender Right / Inner Tray Cracked | Replace |

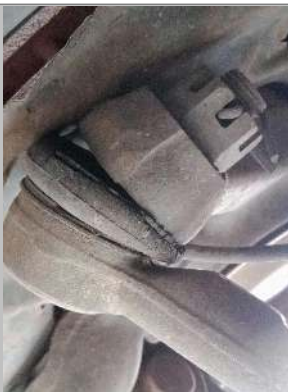
| Damage | Repair Way |
|---|---|
| Tie Rod End right Loose / Excessive Play | Replace |

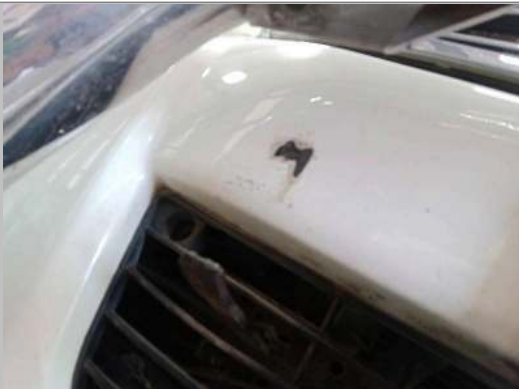
| Damage | Repair Way |
|---|---|
| Front Bumper Paintwork • Scratched | Repair |

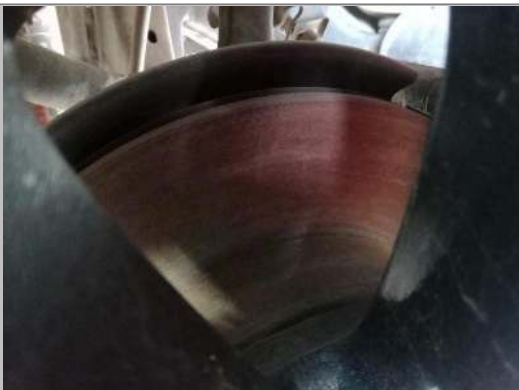
| Damage | Repair Way |
|---|---|
| Brake disc 1. Axle left Worn | Replace |

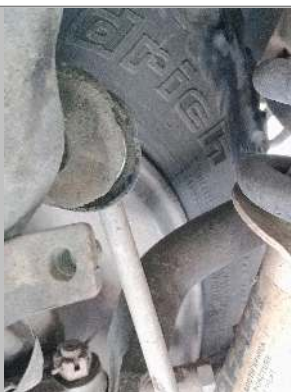
| Damage | Repair Way |
|---|---|
| Stabilizer Mounting Front Left Damaged | Replace |

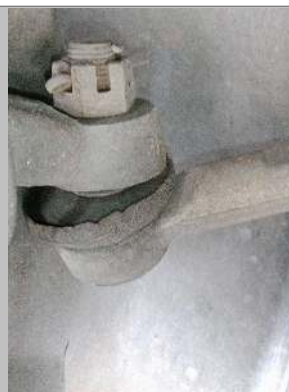
| Damage | Repair Way |
|---|---|
| Tie Rod End left Damaged | Replace |

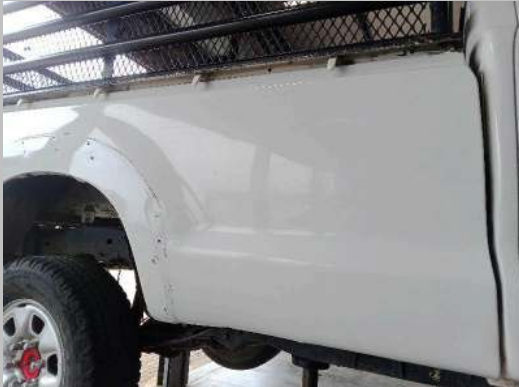
| Damage | Repair Way |
|---|---|
| Load Body Damaged | Repair |

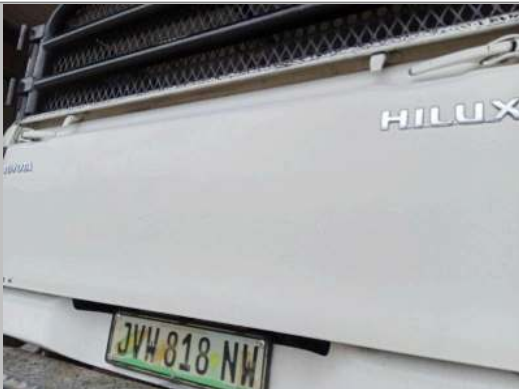
| Damage | Repair Way |
|---|---|
| Tailgate Cracked | Repair |

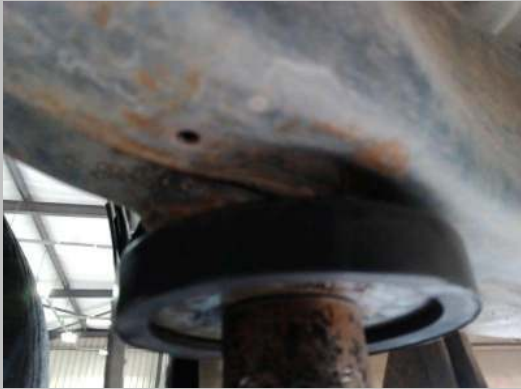
| Damage | Repair Way |
|---|---|
| Main Beam Right Dented | Repair |

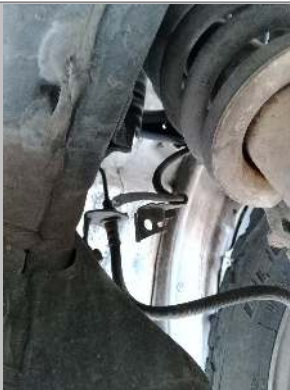
| Damage | Repair Way |
|---|---|
| Brake Piping Torn / Cut | Replace |

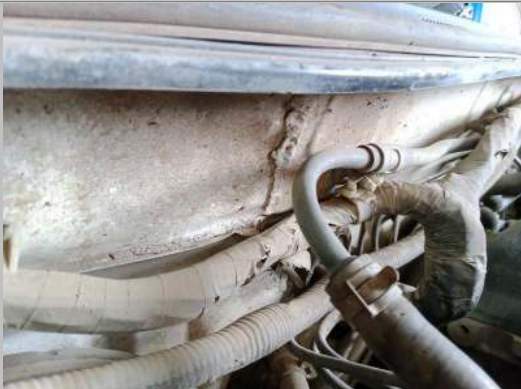
| Damage | Repair Way |
|---|---|
| Firewall Welded | Repair |

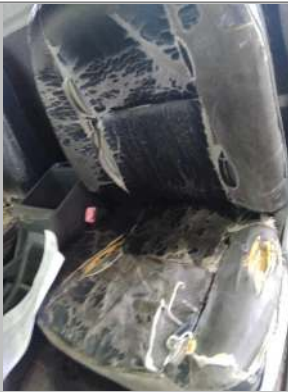
| Damage | Repair Way |
|---|---|
| Seat Front Left Torn / Cut | Repair |

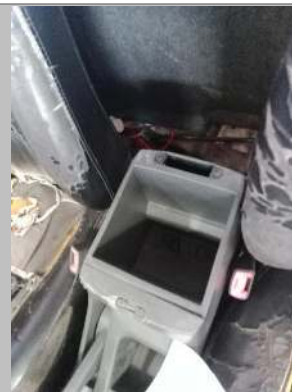
| Damage | Repair Way |
|---|---|
| Center Console / Cubbyhole + Lid Damaged | Replace |
