MFC Auction House  
M57 Pretoria Rd, Glenmarais, KEMPTON PARK  
Gauteng

| Manufacturer | HYUNDAI | Registration Number | JJ95HFGP |

## CONDITION REPORT

Report No: 2016295247

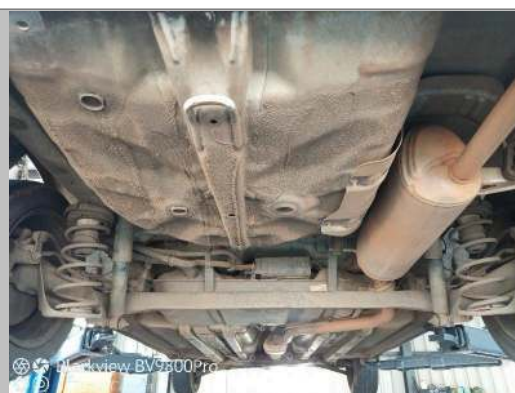
CHASSIS

| Damage | Repair Way |
|---|---|
| Chassis Dented | Repair |

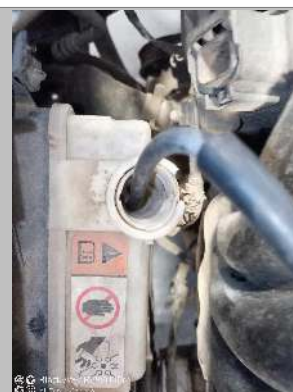
| | Damage | Repair Way |
|---|---|---|
| | Caps Missing | Replace |

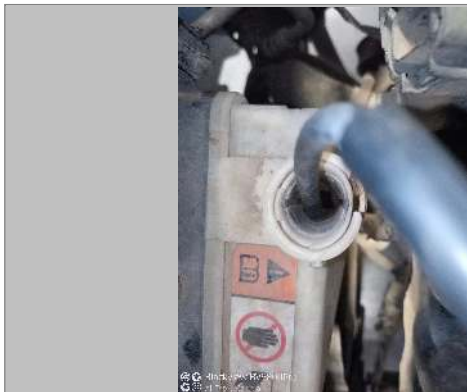
| | Damage | Repair Way |
|---|---|---|
| | Water level Insufficient | Repair |

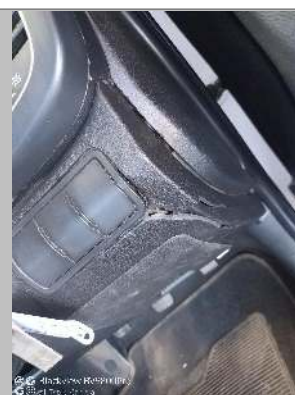
| | Damage | Repair Way |
|---|---|---|
| | Dash Padding Damaged | Repair |

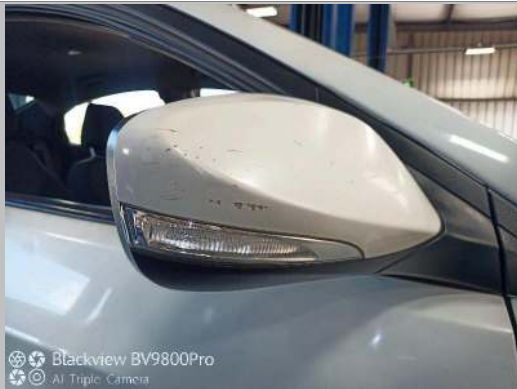
| | Damage | Repair Way |
|---|---|---|
| | Side Mirror Right Paintwork • Scratched | Repair |

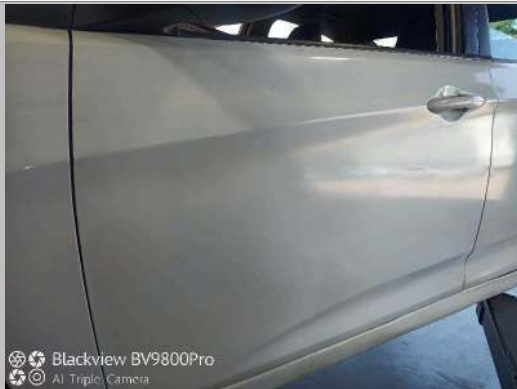
| | Damage | Repair Way |
|---|---|---|
| | Door Front Left Residual Traces of Repair | Repair |

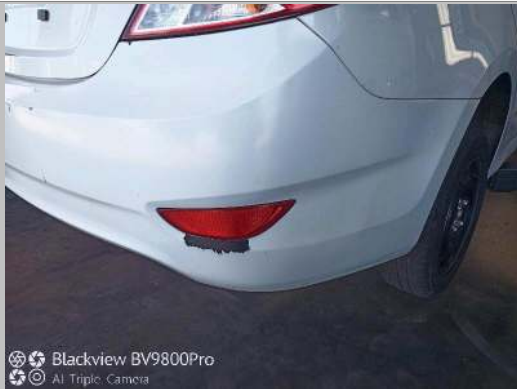
| Damage | Repair Way |
|---|---|
| Rear bumper Paintwork • Scratched | Repair |

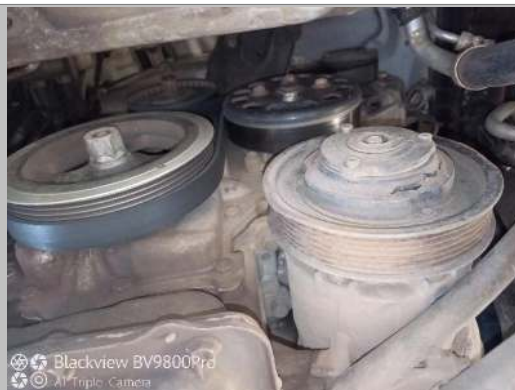
| | Damage | Repair Way |
|---|---|---|
| | Fan Belt Defective | Repair |

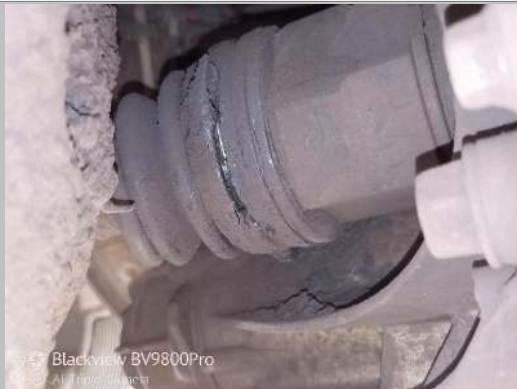
| Damage | Repair Way |
|---|---|
| CV Joint(s) Boot(s) Front Left (inner/outer) Damaged | Replace |
