CONDITION REPORT

Report No: 2016466181

MFC Auction House
M57 Pretoria Rd, Glenmarais, KEMPTON PARK
Gauteng

| Manufacturer | HYUNDAI | Registration Number | JX44SGGP |

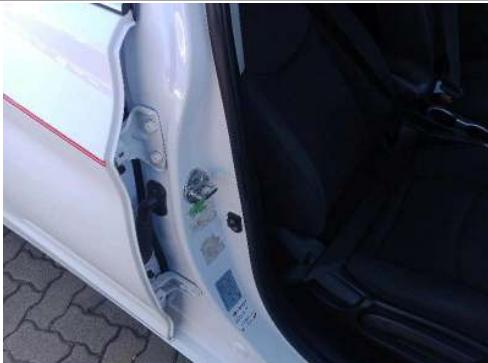
| Damage | Repair Way |
|---|---|
| Door Sealing Rubber Front Right Damaged | Replace |

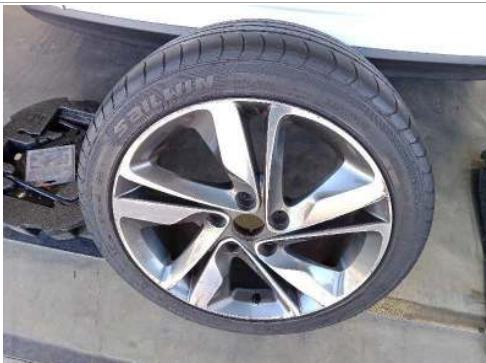
| Damage | Repair Way |
|--|--|
| Rim Spare Wheel Scratched | Repair |

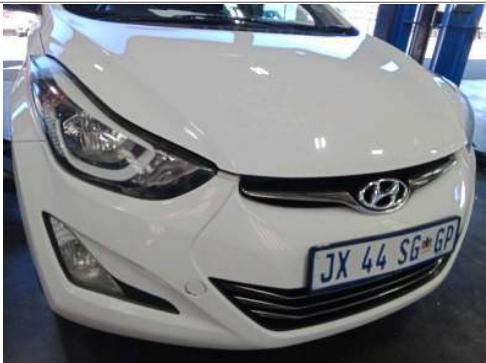
| Damage | Repair Way |
|---|---|
| Front Bumper Damaged | Repair |

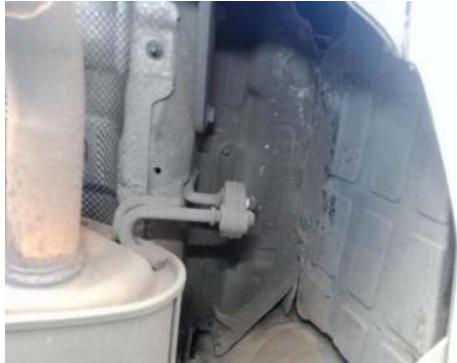
| Damage | Repair Way |
|---|---|
| Rear Fender Right / Inner Tray Dented | Repair |
