MFC Auction House  
M57 Pretoria Rd, Glenmarais, KEMPTON PARK  
Gauteng

DEKRA MFC  
M57 Pretoria Rd - 1619  
KEMPTON PARK - GT  
08610 33572

## Assignment

## VEHICLE INSPECTION

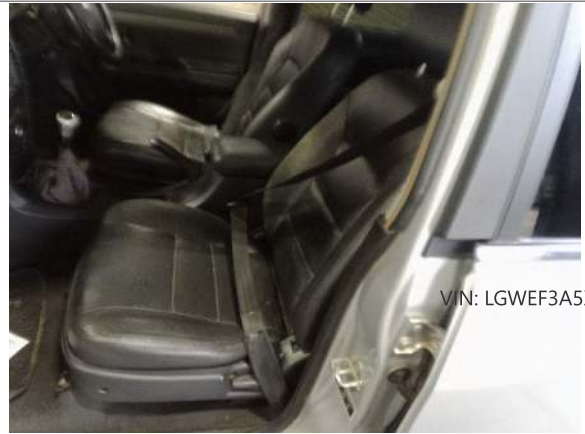
| | Damage | Repair Way |
|---|---|---|
| | Door Panel Front Left Defective | Repair |

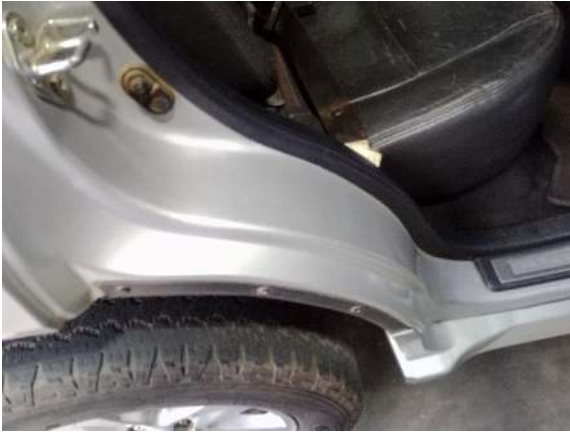
| Damage | Repair Way |
|---|---|
| C • Pillar Right Dented | Repair |

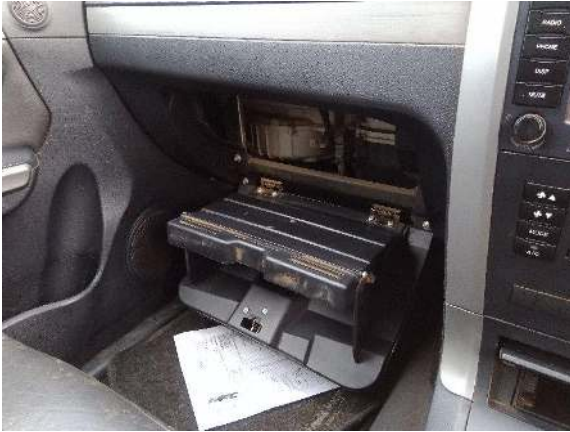
| | Damage | Repair Way |
|---|---|---|
| | Center Console / Cubbyhole + Lid Broken | Repair |

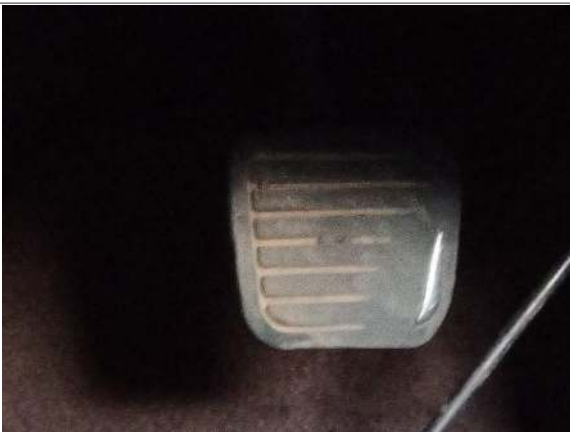
| | Damage | Repair Way |
|---|---|---|
| | Brake Pedal Rubber Torn / Cut | Replace |

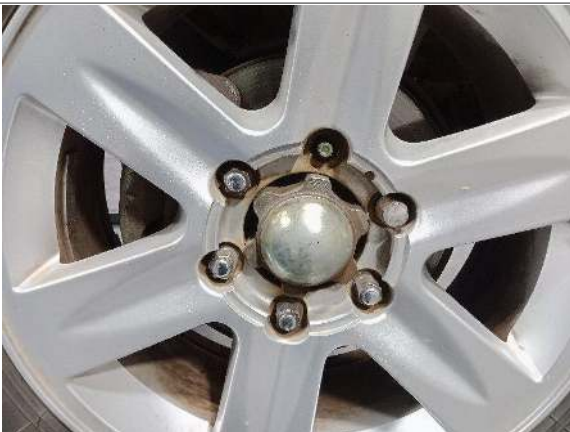
| Damage | Repair Way |
|---|---|
| Bolt(s) / Nut(s) Front Wheel Right Missing | Replace |

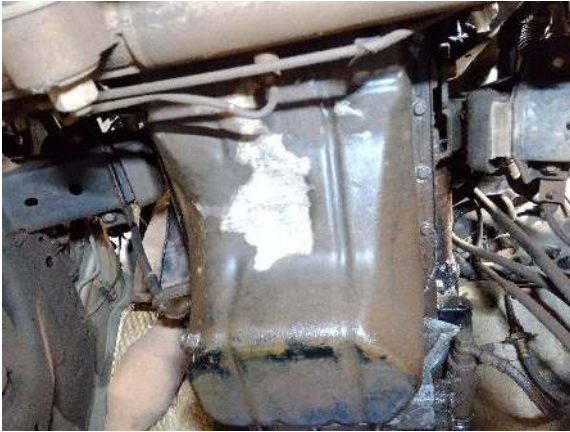
| | Damage | Repair Way |
|---|---|---|
| | Engine Oil Leak | Repair |

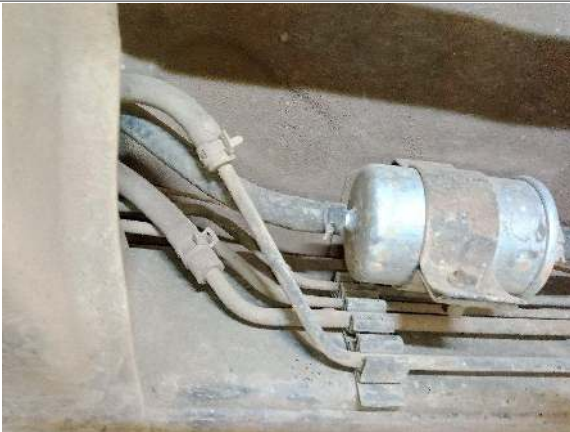
| Damage | Repair Way |
|---|---|
| Fuel Lines Defective | Repair |

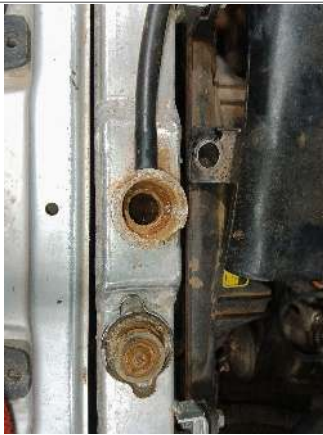
Water level

| | Damage | Repair Way |
|---|---|---|
| | Expansion Bottle Water Leak | Replace |

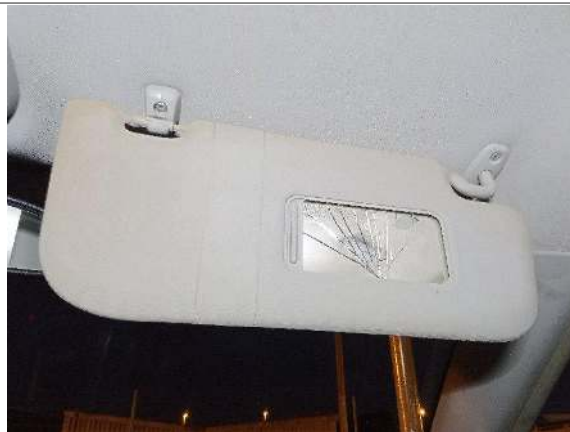
| | Damage | Repair Way |
|---|---|---|
| | Sun Visor Right Cracked | Repair |
