MFC Auction House  
M57 Pretoria Rd, Glenmarais, KEMPTON PARK  
Gauteng

DEKRA MFC  
M57 Pretoria Rd - 1619  
KEMPTON PARK - GT  
08610 33572

## Assignment

| Manufacturer | FORD | Registration Number | CL15VVGP |

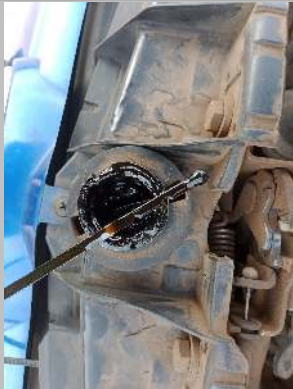
Oil cap and dipstick

Engine Compartment: Engine bay dirty. Brake fluid level ok. Signs of oil sludge on oil cap. Radiator and Aircon condenser bend. Oil sump scratched. Fan Cowley loose. Wire fitted to bonnet release latch. Expansion bottle leaking water.

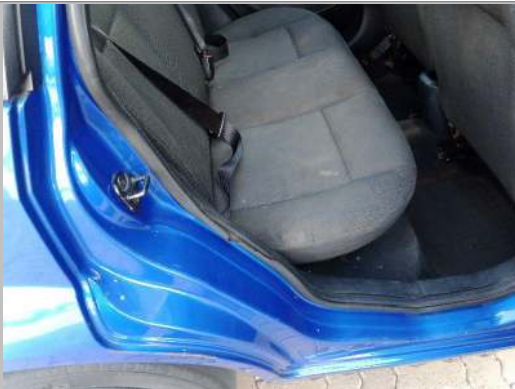
| | Damage | Repair Way |
|---|---|---|
| | Door Sealing Rubber Rear Right Damaged | Replace |

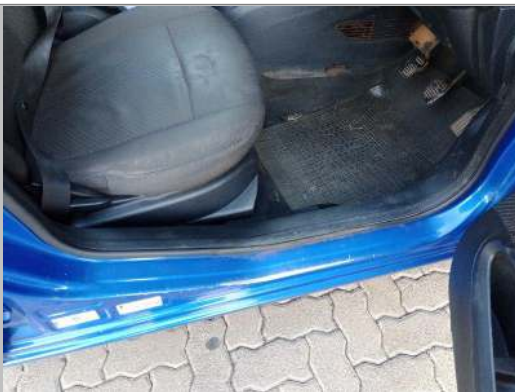
| Damage | Repair Way |
|---|---|
| Sill Panel Right Paintwork • Scratched | Repair |

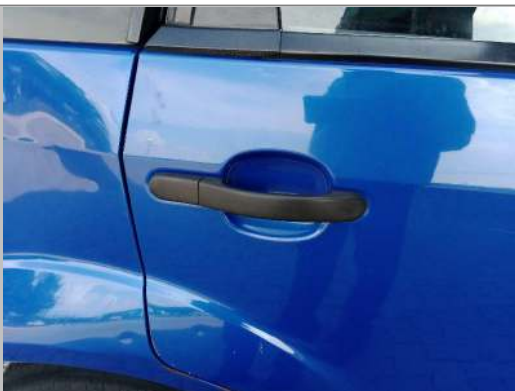
| | Damage | Repair Way |
|---|---|---|
| | Door Handle Rear Right Damaged | Replace |

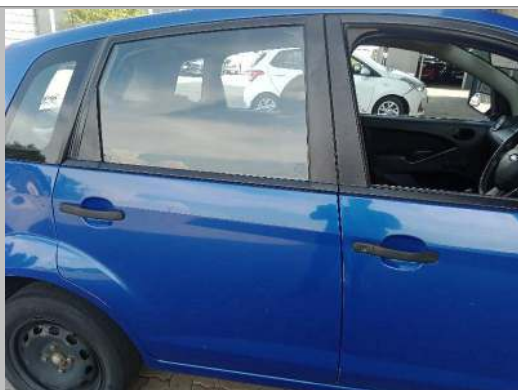
| Damage | Repair Way |
|---|---|
| Door Rear Right Dented | Repair |

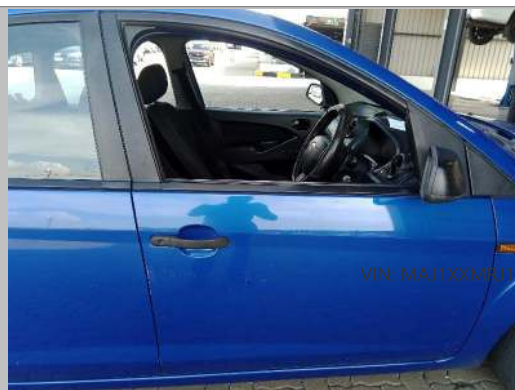
| Damage | Repair Way |
|---|---|
| Door Front Right Paintwork • Scratched | Repair |

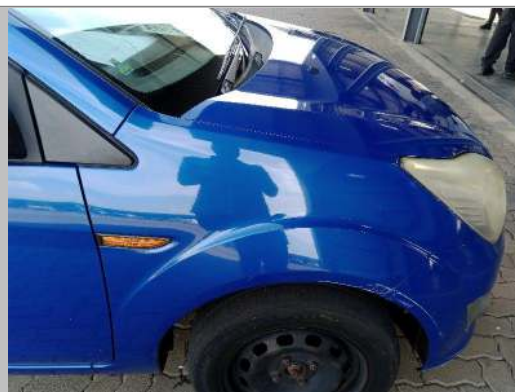
| Damage | Repair Way |
|---|---|
| Front Fender Right Paintwork • Scratched | Repair |

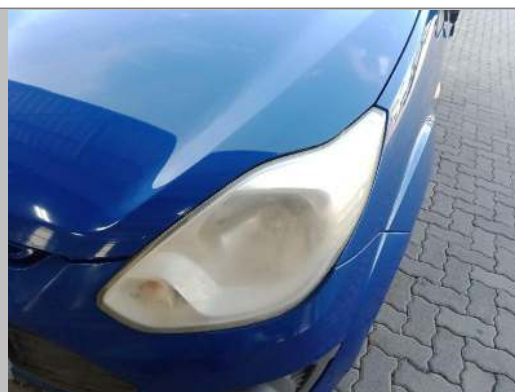
| | Damage | Repair Way |
|---|---|---|
| | Headlight Left Defective | Replace |

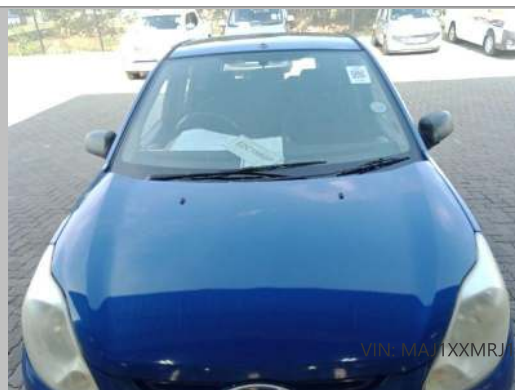
| Damage | Repair Way |
|---|---|
| Bonnet Residual Traces of Repair | Repair |

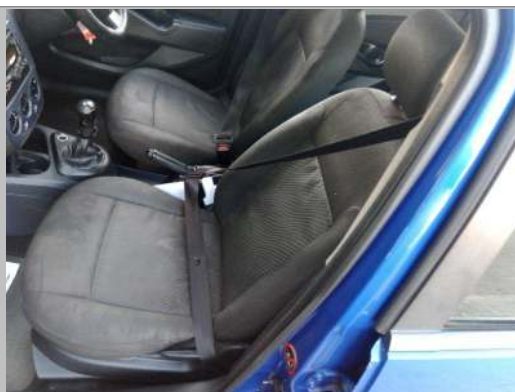
| | Damage | Repair Way |
|---|---|---|
| | Seat Front Left Defective | Repair |

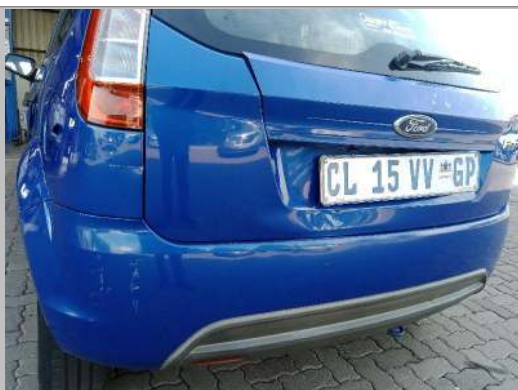
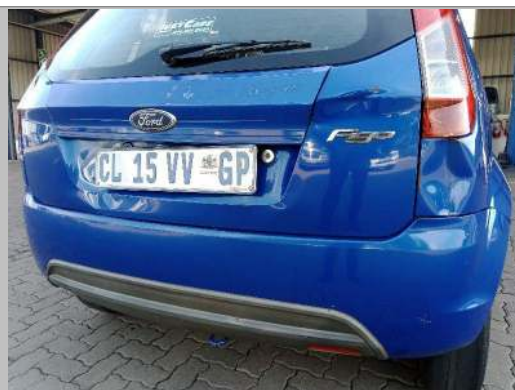
| Damage | Repair Way |
|---|---|
| Rear bumper Damaged | Repair |

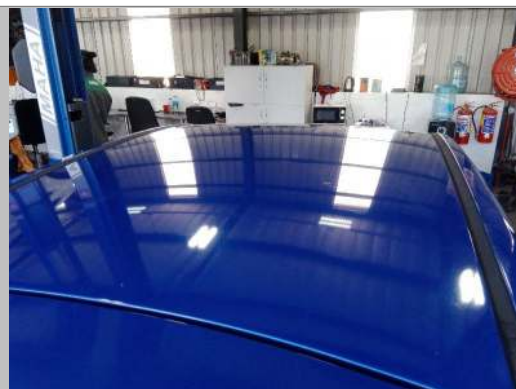
| Damage | Repair Way |
|---|---|
| Roof Dented | Repair |

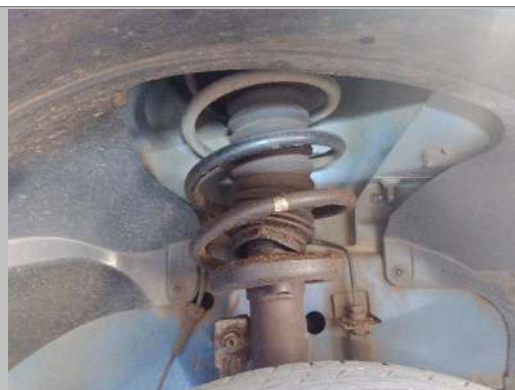
| Damage | Repair Way |
|---|---|
| Shock Absorber Front Right Leak | Replace |

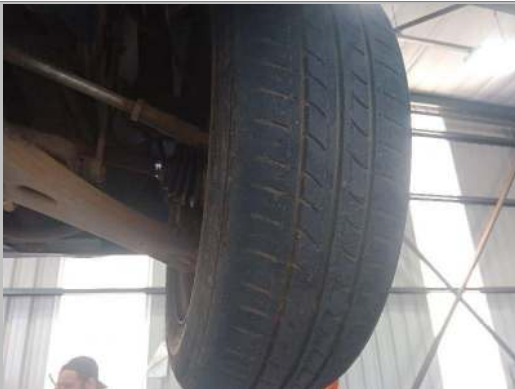
| Damage | Repair Way |
|---|---|
| Tyre Front Right Defective | Replace |

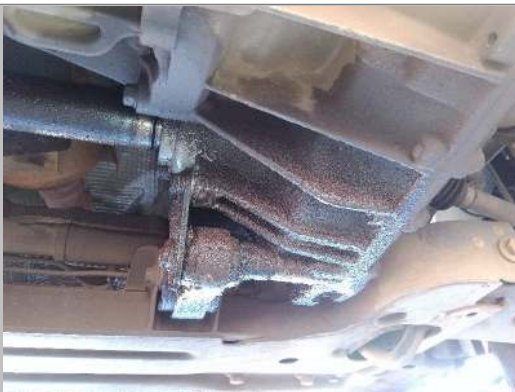
| Damage | Repair Way |
|---|---|
| Gearbox Oil Leak | Repair |

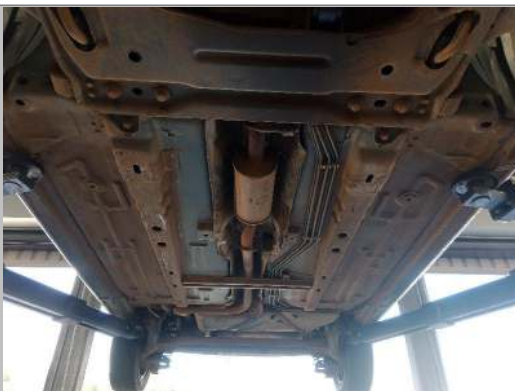
| Damage | Repair Way |
|---|---|
| Chassis Scratched | Repair |

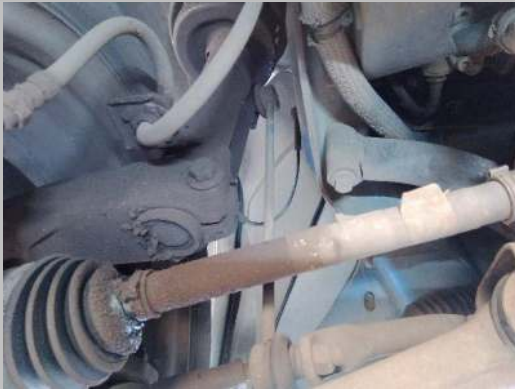
| Damage | Repair Way |
|---|---|
| Stabilizer Mounting Front Right Damaged | Replace |

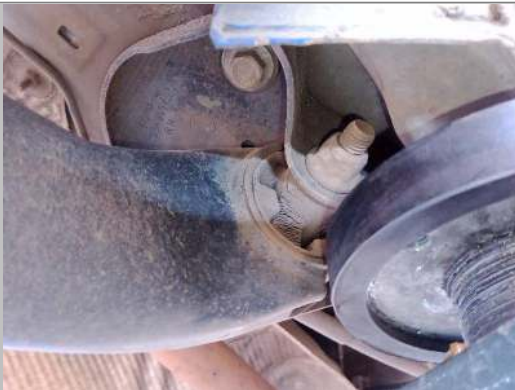
| Damage | Repair Way |
|---|---|
| Mounting Rubber(s) Rear Axle Right Cracked | Replace |

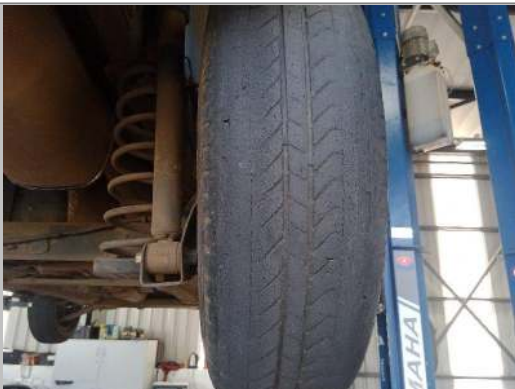
| Damage | Repair Way |
|---|---|
| Tyre Rear Right Damaged | Replace |

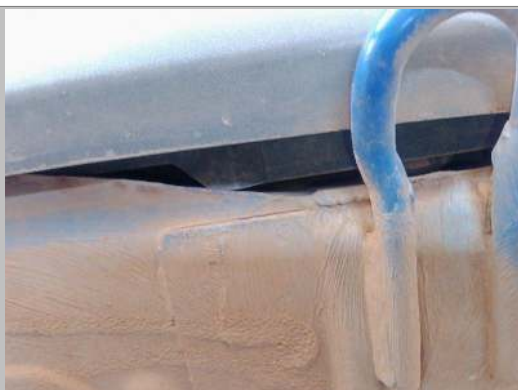
| Damage | Repair Way |
|---|---|
| Inner Boot Floor Pan and Spare Wheel Well Damaged | Repair |

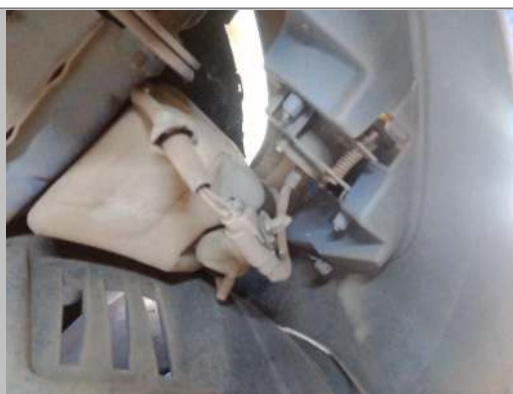
| | Damage | Repair Way |
|---|---|---|
| | Engine Wiring Defective | Repair |

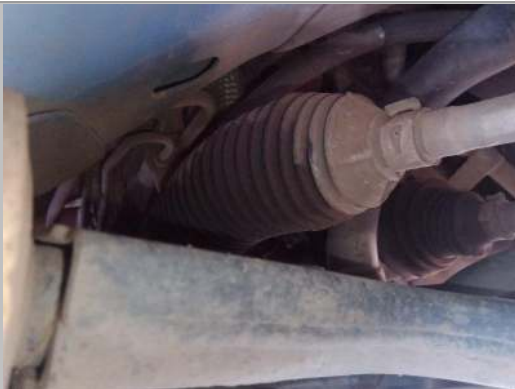
| Damage | Repair Way |
|---|---|
| Steering Rack Boot Right Leak | Replace |

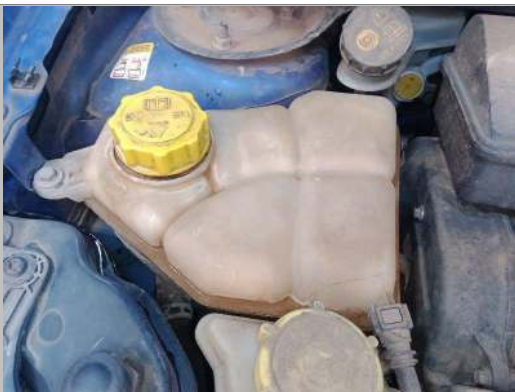
| | Damage | Repair Way |
|---|---|---|
| | Expansion Bottle Defective | Replace |
