## CONDITION REPORT

Report No: 2016205777

MFC Auction House  
M57 Pretoria Rd, Glenmarais, KEMPTON PARK  
Gauteng

| Manufacturer | FORD | Registration Number | FB66MHGP |

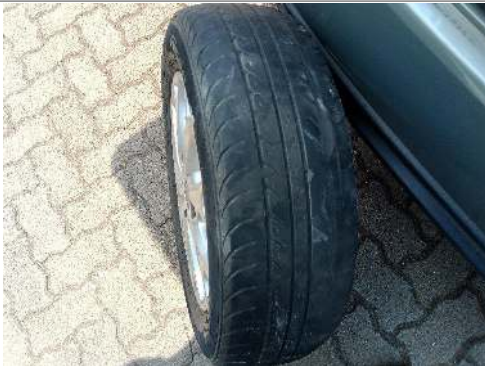
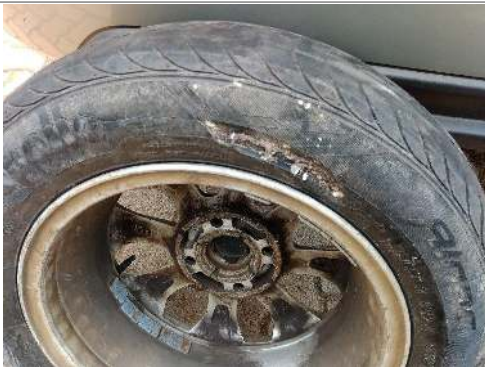
| Damage | Repair Way |
|---|---|
| Spare Tyre Damaged | Replace |

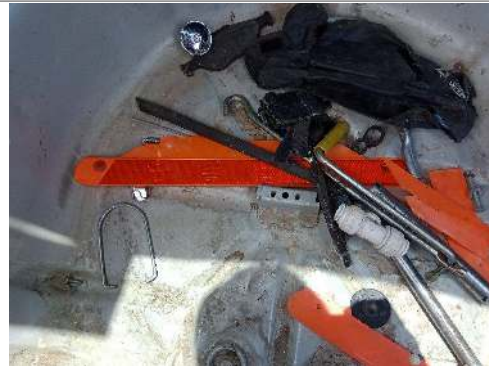
| Damage | Repair Way |
|---|---|
| Triangle Damaged | Replace |

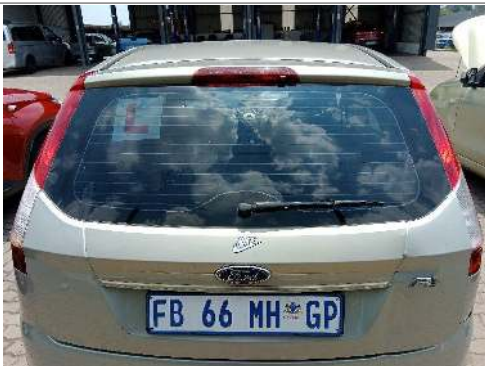
| Damage | Repair Way |
|---|---|
| Boot Lid / Hatch door Damaged | Repair |

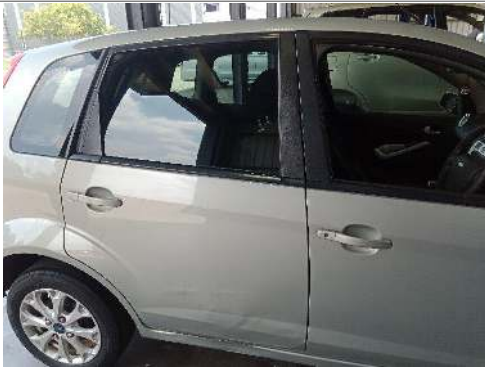
| Damage | Repair Way |
|---|---|
| Door Rear Right Damaged | Repair |

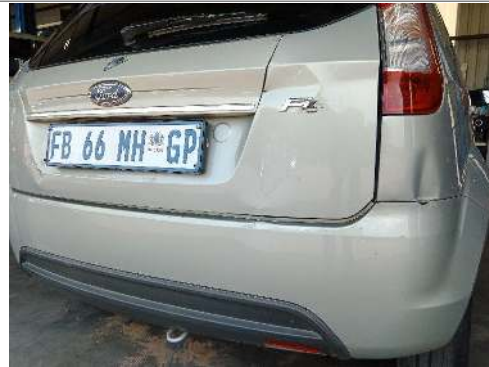
Rear bumper VIN: MAJ1XXMRJ1FE31579

| Damage | Repair Way |
|---|---|
| Rear bumper Paintwork • Scratched | Repair |

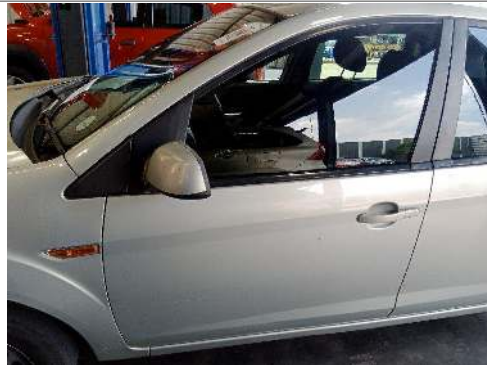
| Damage | Repair Way |
|---|---|
| Door Front Left Paintwork • Scratched | Repair |

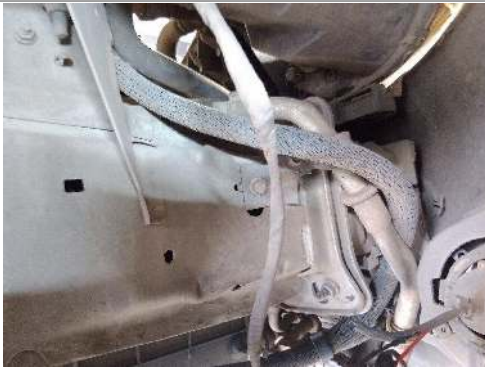
| Damage | Repair Way |
|---|---|
| Main Beam Right Damaged | Repair |

General Comments: ACCORDING TO THE AGE AND MILEAGE OF THE VEHICLE, NORMAL WEAR AND TEAR MARKS ARE VISIBLE ON THE INTERIOR, EXTERIOR, ELECTRICAL AND MECHANICAL PARTS.  
Engine Compartment: Engine bay dirty. Brake fluid level low. Bonnet level strapped with cables. Rust inside expansion bottle.  
Electrical Components and Instruments: Vehicle electronics malfunctioning.  
Interior: Vehicle interior dirty and some interior panels scratched. Boot lid sealing rubber damaged. Handbrake lever button damaged.  
Body • Exterior: Dents and scratches on some body panels. Spray work on some body panels. Some body panels misaligned. Stone chips on some body panels. Signs of hail damage on some body panels. Poor residual traces of repair on some body panels. Signs of impact damage to front and rear of vehicle. Boot does not close. Front left and right inner fender liners missing. Vehicle safety integrity comprised due to damaged front right main beam.

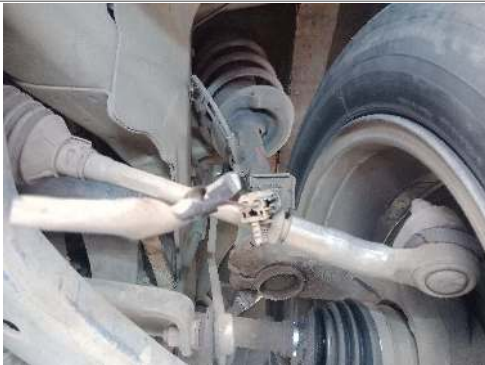
Speed Sensor

Brakes: Front left wheel binding. Front left and right speed sensors damaged. Front right brake piping loose and stay bracket missing.  
Axle and Suspension: Abnormal noise coming from front and rear suspension. Signs of vehicle grabbing.  
Tyres and Rims: Alloy rims scratched. Front left and rear right tyres have reached legal limit. Front left tyre deflated.  
Undercarriage: Vehicle undercarriage dirty.

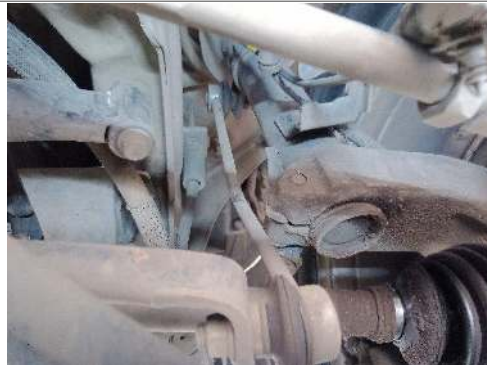
| Damage | Repair Way |
|---|---|
| Stabilizer Mounting Front Right Damaged | Replace |

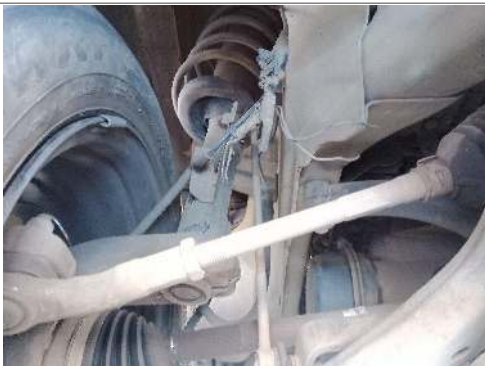
| Damage | Repair Way |
|---|---|
| Stabilizer Mounting Front Left Defective | Replace |

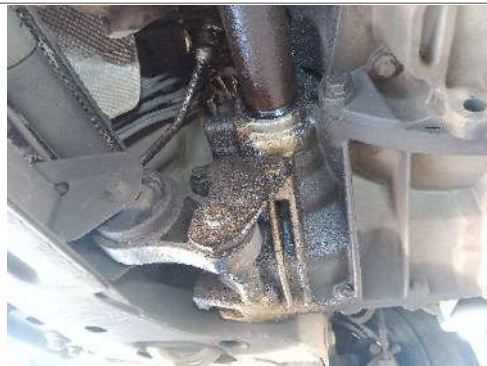
| Damage | Repair Way |
|---|---|
| Gearbox Oil Leak | Repair |

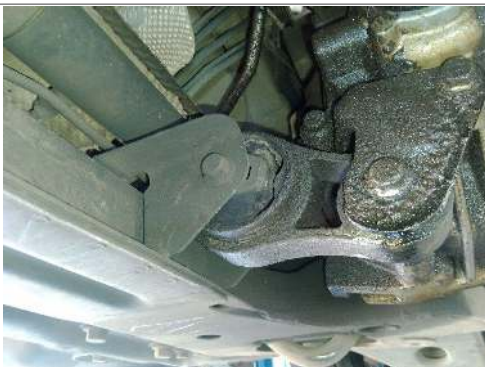
| Damage | Repair Way |
|---|---|
| Gearbox Mountings Cracked | Replace |

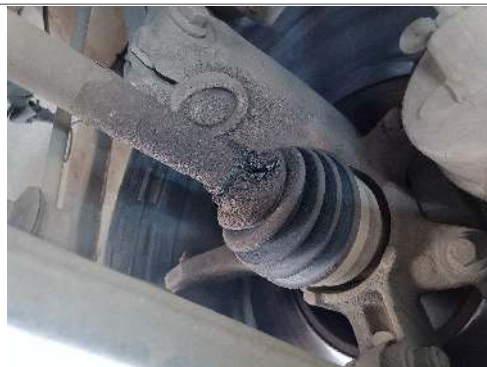
| Damage | Repair Way |
|---|---|
| CV Joint(s) Boot(s) Front Left (inner/outer) Damaged | Replace |

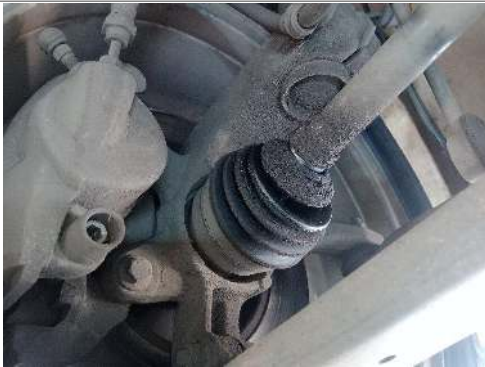
| Damage | Repair Way |
|---|---|
| CV Joint(s) Boot(s) Front Right (inner/outer) Damaged | Replace |

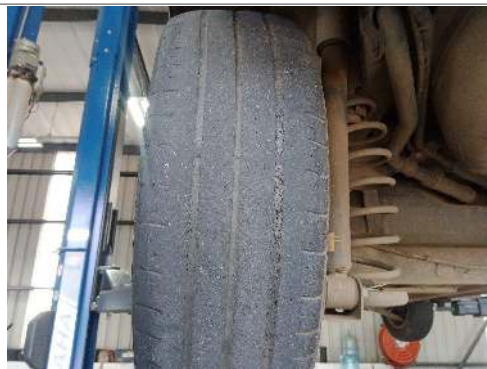
| Damage | Repair Way |
|---|---|
| Tyre Rear Left Damaged | Replace |

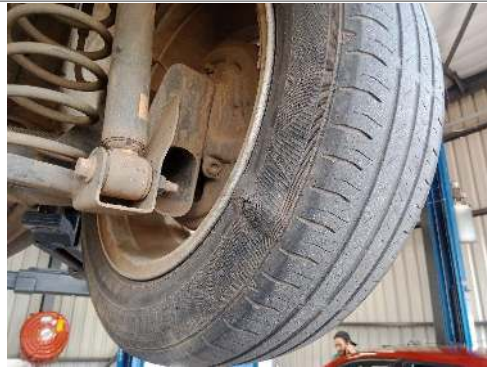
| Damage | Repair Way |
|---|---|
| Tyre Rear Right Damaged | Replace |

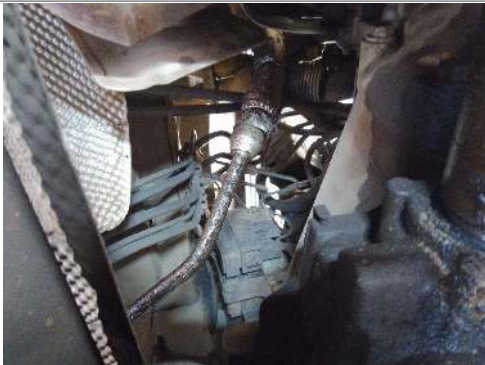
| Damage | Repair Way |
|---|---|
| Hoses Oil Leak | Repair |

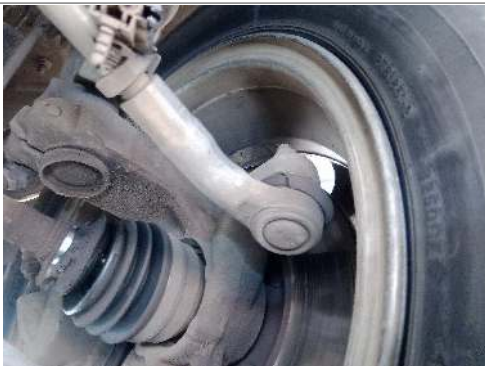
| Damage | Repair Way |
|---|---|
| Tie Rod End right Damaged | Replace |

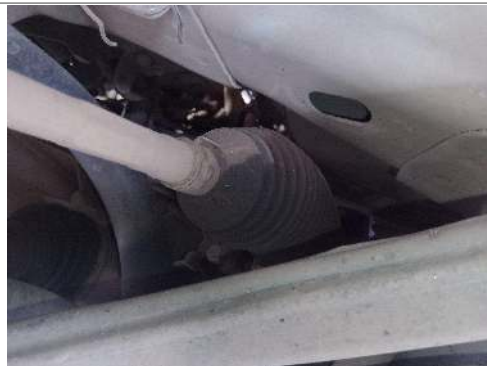
| Damage | Repair Way |
|---|---|
| Steering Rack Boot Left Sweat | Replace |

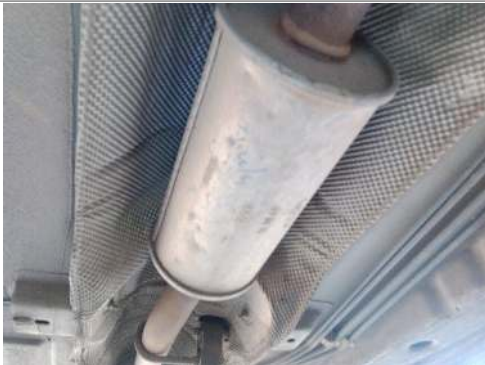
| Damage | Repair Way |
|---|---|
| Silencer Defective | Repair |

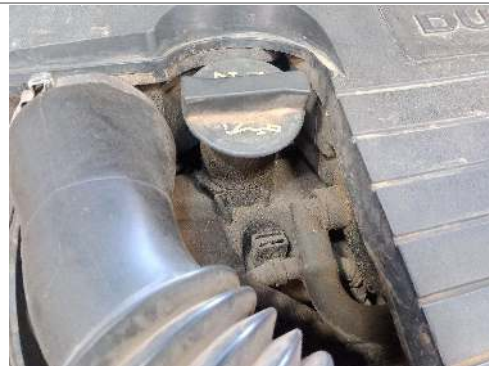
| Damage | Repair Way |
|---|---|
| Engine Oil Sweat | Repair |
