## CONDITION REPORT

Report No: 2016313096

| Manufacturer | FORD | Registration Number | JG91TYGP |
| Model | FIGO | Register Number | |

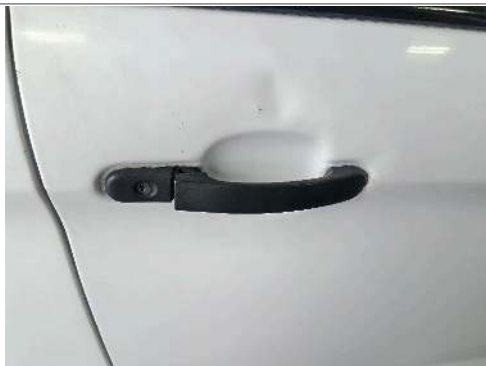
| Damage | Repair Way |
|---|---|
| Door Handle Front Right Damaged | Replace |

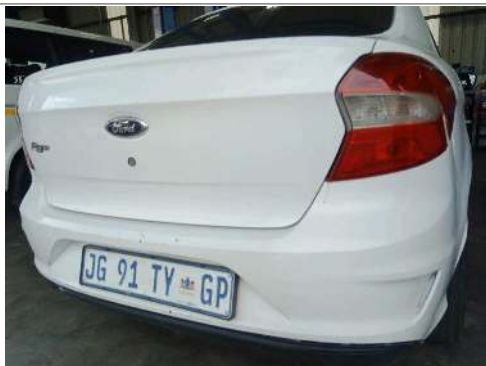
| Damage | Repair Way |
|---|---|
| Rear bumper Damaged | Replace |
| Body and Exterior | Impact damage to front and rear of vehicle |

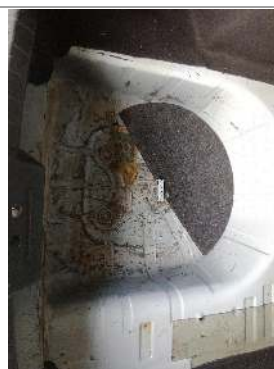
| Damage | Repair Way |
|---|---|
| Inner Boot Floor Pan and Spare Wheel Well Damaged | Repair |

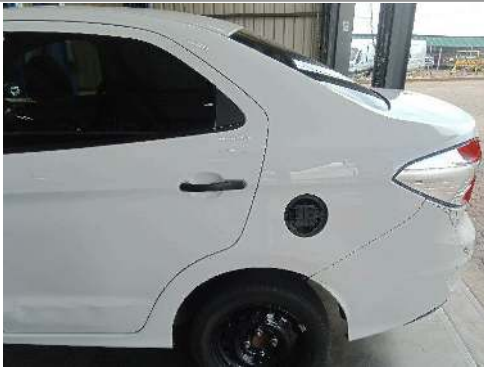
| Damage | Repair Way |
|---|---|
| Rear Fender Left Paintwork • Scratched | Repair |

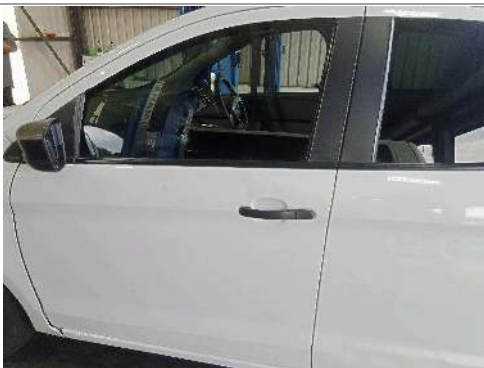
| Damage | Repair Way |
|---|---|
| Door Front Left Damaged | Repair |

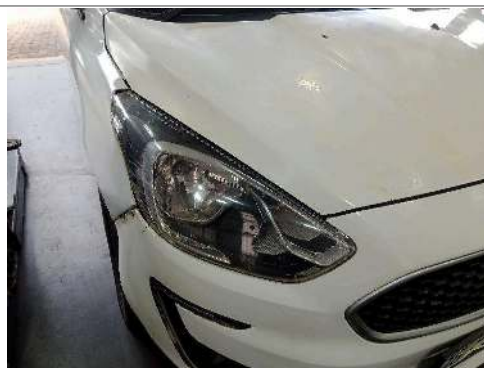
| Damage | Repair Way |
|---|---|
| Headlight Right Damaged | Replace |

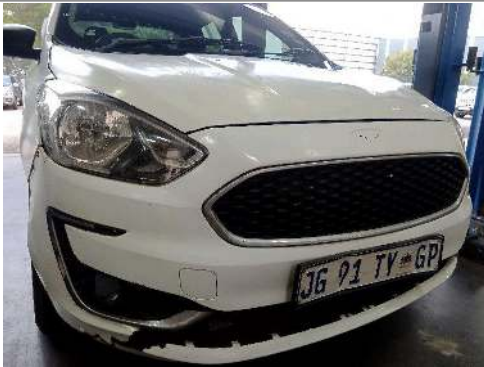
| Damage | Repair Way |
|---|---|
| Front Bumper Damaged | Replace |

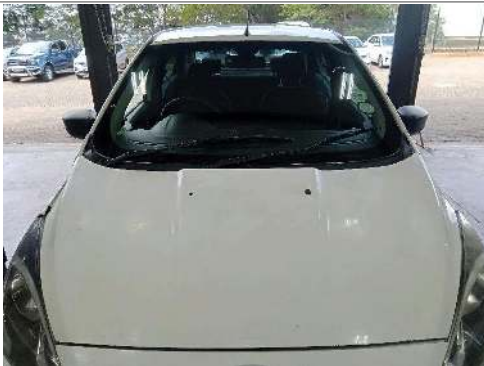
| Damage | Repair Way |
|---|---|
| Bonnet Damaged | Replace |

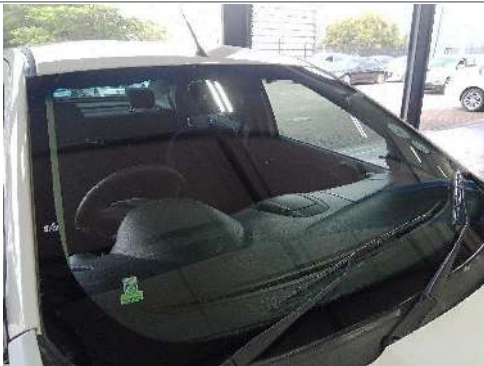
| Damage | Repair Way |
|---|---|
| Windscreen Chipped | Repair |

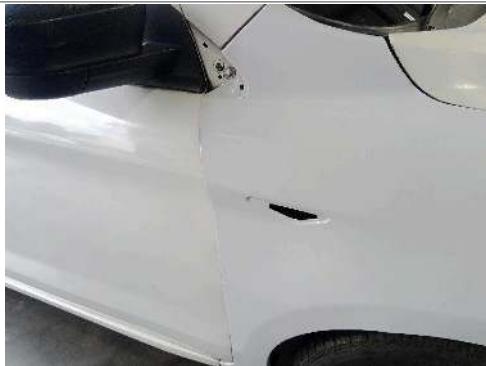
| Damage | Repair Way |
|---|---|
| Indicator Light Front Right Missing | Replace |

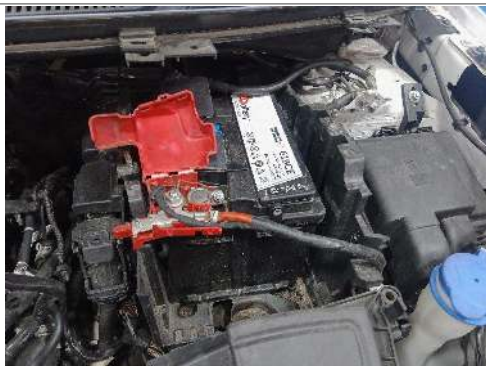
| Damage | Repair Way |
|---|---|
| Battery box Damaged | Replace |

| Damage | Repair Way |
|---|---|
| Engine | Engine bay dirty and battery loose |

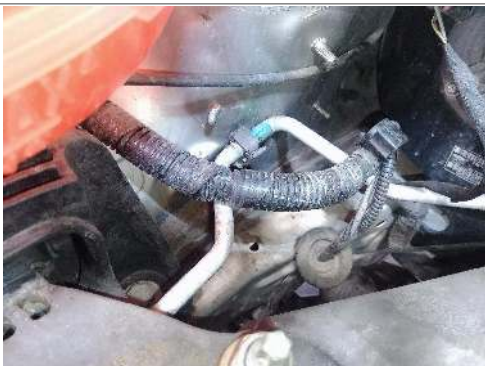
| Damage | Repair Way |
|---|---|
| Main Beam Right Welded | Repair |

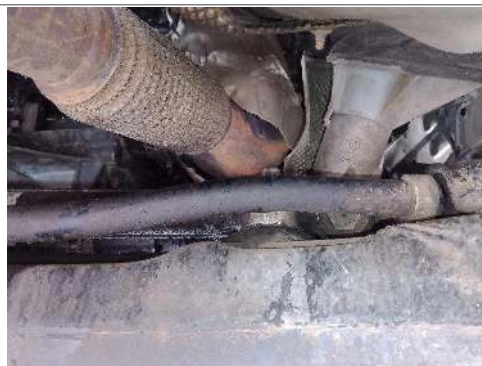
| Damage | Repair Way |
|---|---|
| Steering Rack Welded | Replace |

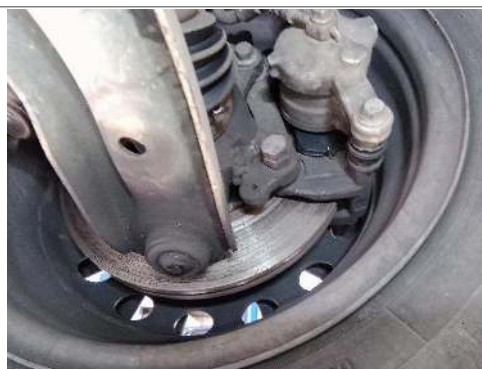
| Damage | Repair Way |
|---|---|
| Brake disc 1. Axle left Damaged | Replace |

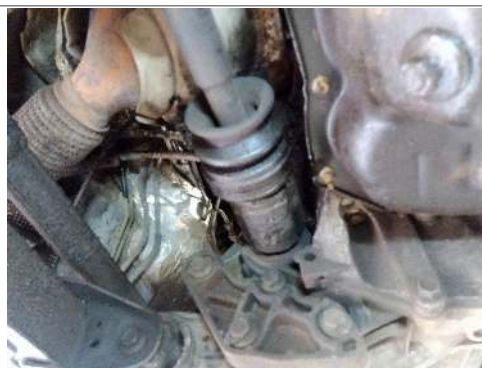
| Damage | Repair Way |
|---|---|
| CV Joint(s) Boot(s) Front Right (inner/outer) Damaged | Replace |

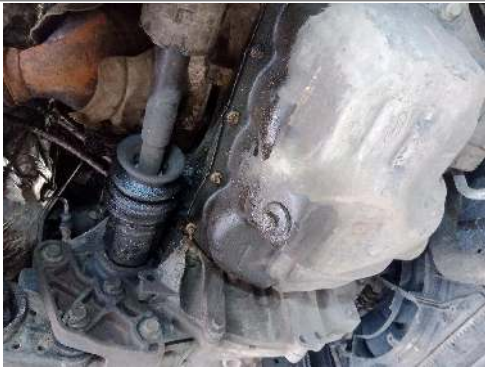
| Damage | Repair Way |
|---|---|
| Engine Oil Leak | Repair |

| Damage | Repair Way |
|---|---|
| Engine Noise Excessive | Repair |

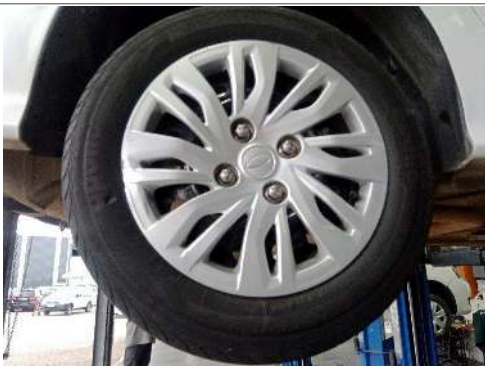
| Damage | Repair Way |
|---|---|
| Tyre Rear Right Damaged | Replace |

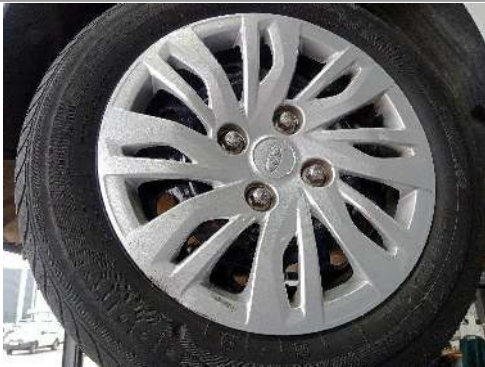
| Damage | Repair Way |
|---|---|
| Rim Rear Right Scratched | Repair |

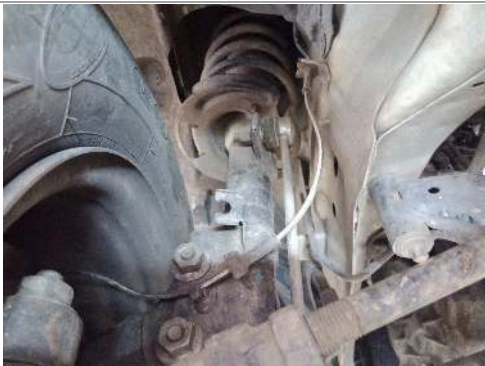
| Damage | Repair Way |
|---|---|
| Shock Absorber Front Left Defective | Repair |

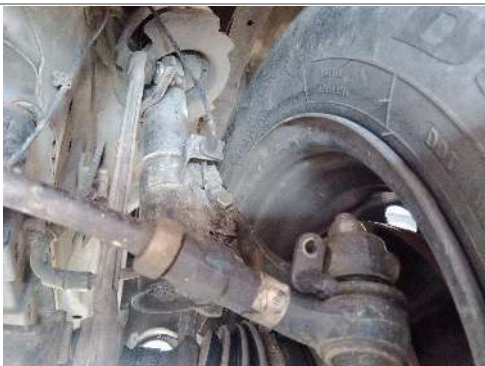
| Damage | Repair Way |
|---|---|
| Speed Sensor Damaged | Replace |

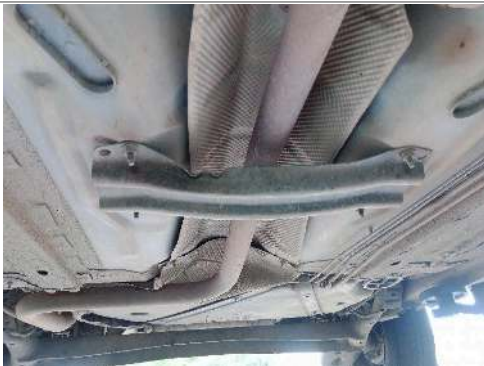
| Damage | Repair Way |
|---|---|
| Chassis Dented | Repair |

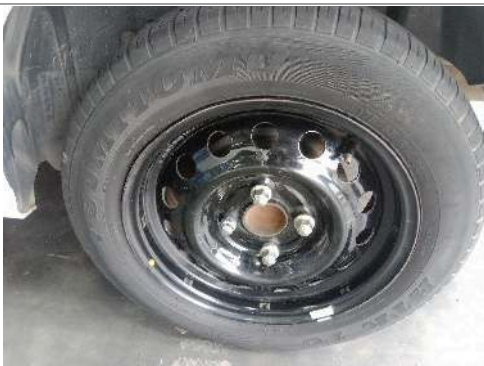
| Damage | Repair Way |
|---|---|
| Rim Rear Left Dented | Repair |

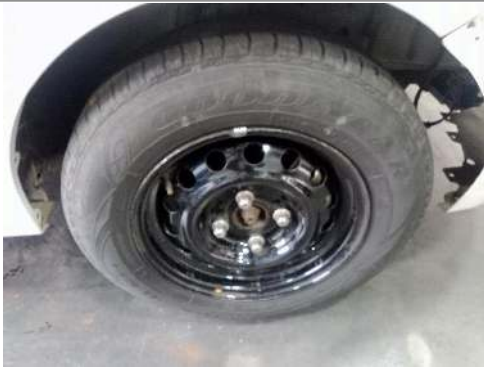
| Damage | Repair Way |
|---|---|
| Rim Front Right Dented | Repair |
