CONDITION REPORT

Report No: 2016289146

MFC Auction House
M57 Pretoria Rd, Glenmarais, KEMPTON PARK
Gauteng

| Manufacturer | HYUNDAI | Registration Number | FG67RCGP |

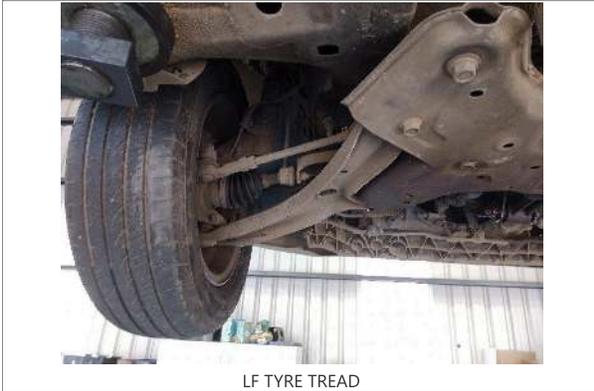
LF TYRE TREAD

| Damage | Repair Way |
|---|---|
| Tyre Front Left Damaged | Replace |

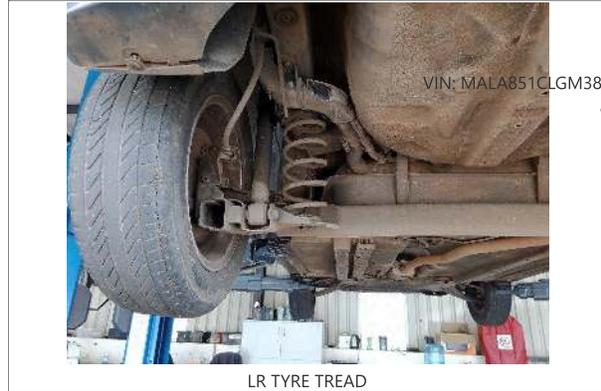
LR TYRE TREAD

| Damage | Repair Way |
|---|---|
| Tyre Rear Left Damaged | Replace |

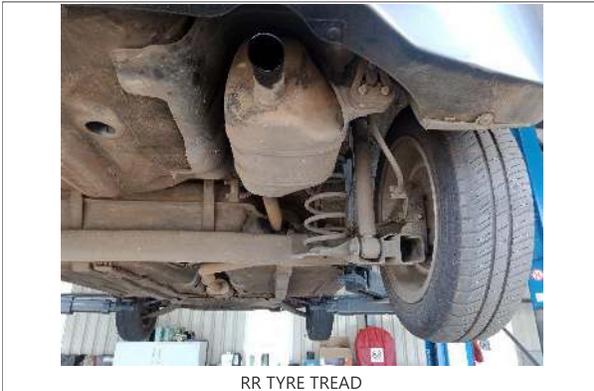
RR TYRE TREAD

| Damage | Repair Way |
|---|---|
| Tyre Rear Right Damaged | Replace |

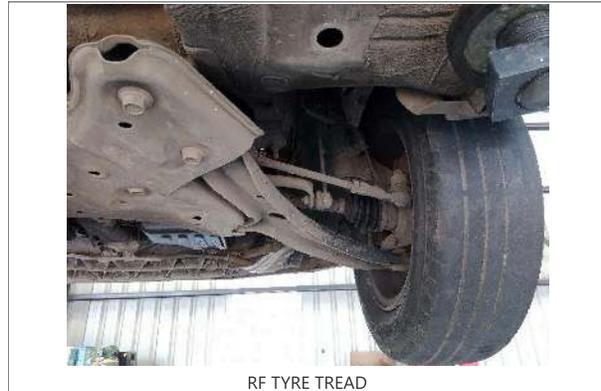
RF TYRE TREAD

| Damage | Repair Way |
|---|---|
| Tyre Front Right Damaged | Replace |

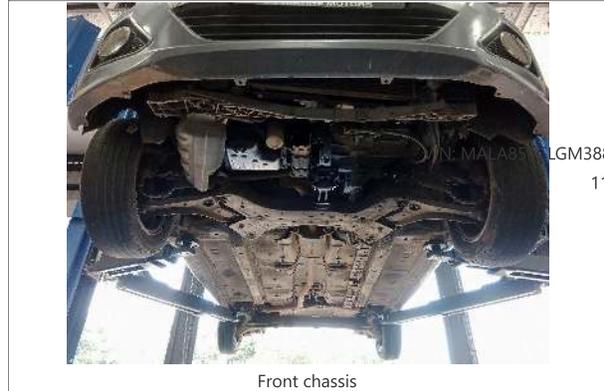
Front chassis

| Damage | Repair Way |
|---|---|
| Chassis Damaged | Repair |

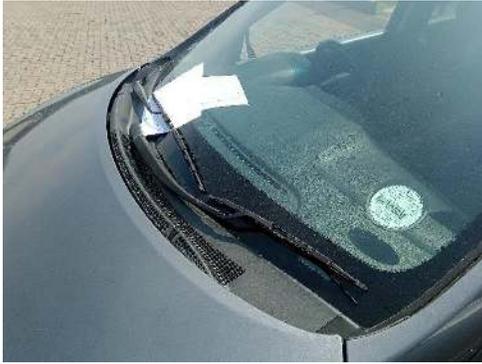
| Damage | Repair Way |
|---|---|
| Windscreen Wiper Damaged | Replace |

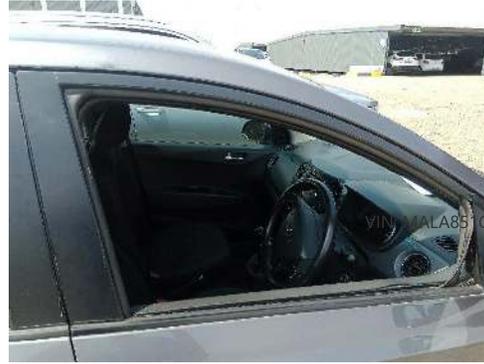
| Damage | Repair Way |
|---|---|
| Sealing Window Front Door Right Damaged | Replace |

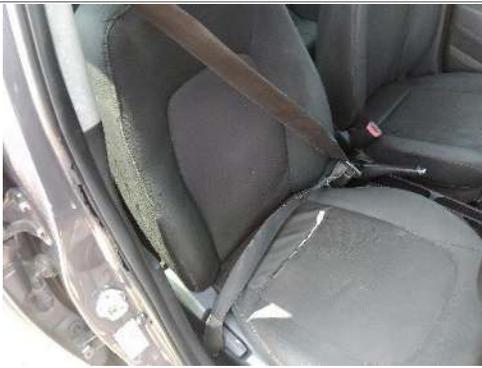
| Damage | Repair Way |
|---|---|
| Seat Belt Front Right Damaged | Replace |

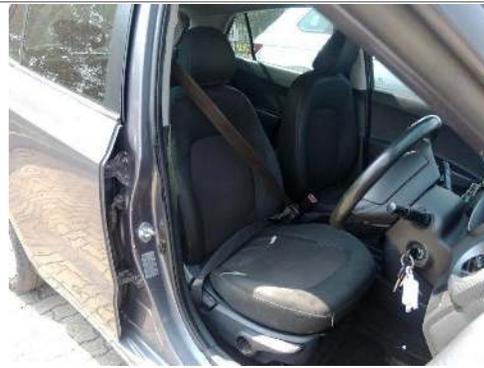
| Damage | Repair Way |
|---|---|
| Seat Front Right Damaged | Repair |

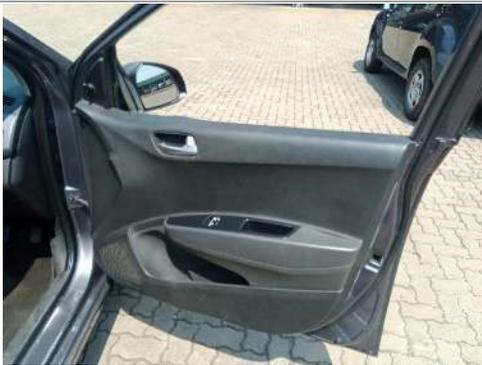
| Damage | Repair Way |
|---|---|
| Door Panel Front Right Defective | Replace |

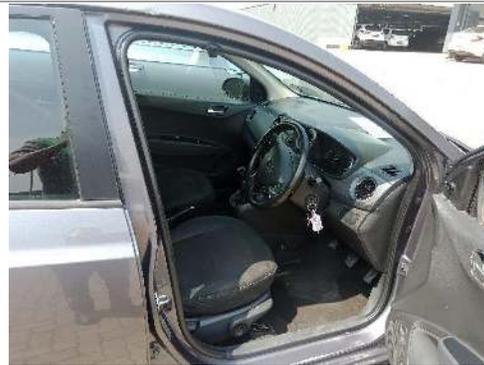
| Damage | Repair Way |
|---|---|
| Door Sealing Rubber Front Right Damaged | Replace |

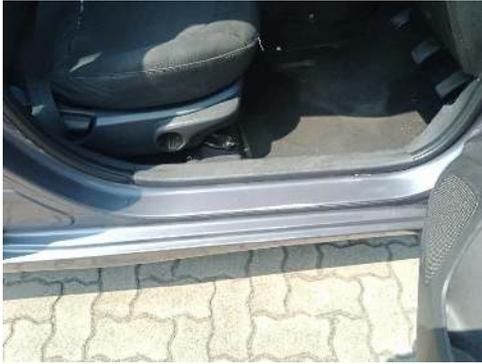
| Damage | Repair Way |
|---|---|
| Sill Panel Right Paintwork • Scratched | Repair |

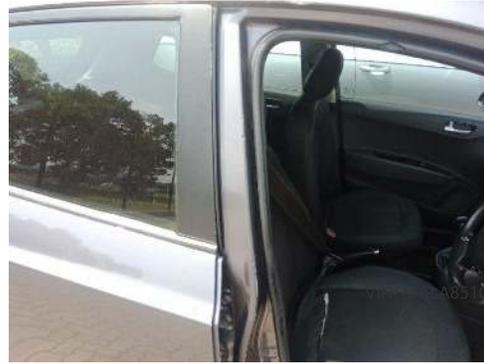
| Damage | Repair Way |
|---|---|
| B • Pillar Right Dented | Repair |

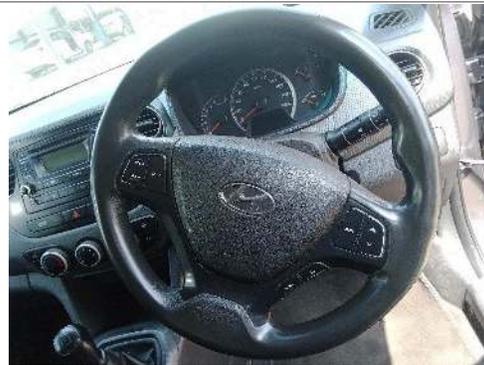
| Damage | Repair Way |
|---|---|
| Steering Wheel Trim Defective | Repair |

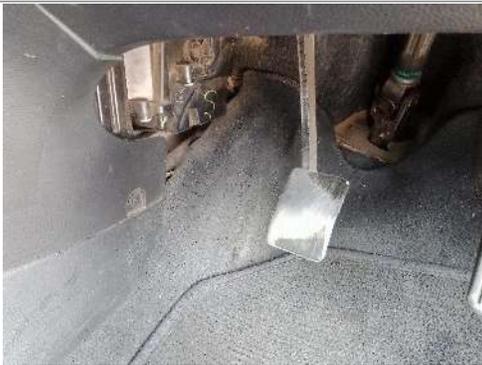
| Damage | Repair Way |
|---|---|
| Clutch Pedal Rubber Missing | Replace |

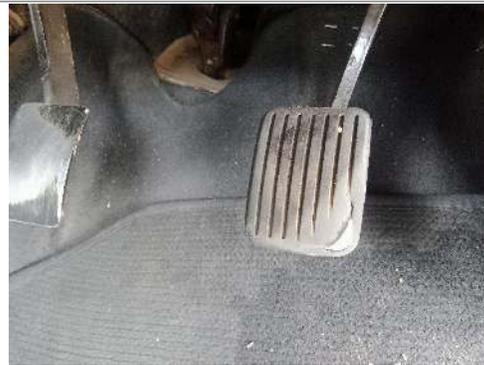
| Damage | Repair Way |
|---|---|
| Brake Pedal Rubber Torn / Cut | Replace |

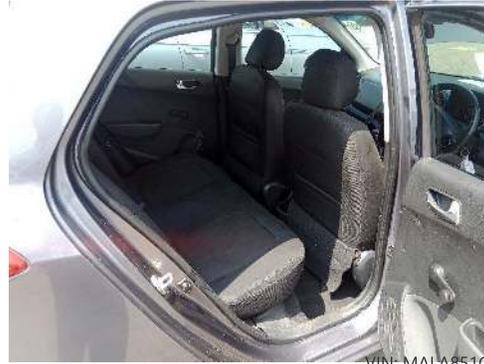
| Damage | Repair Way |
|---|---|
| Door Sealing Rubber Rear Right Damaged | Replace |

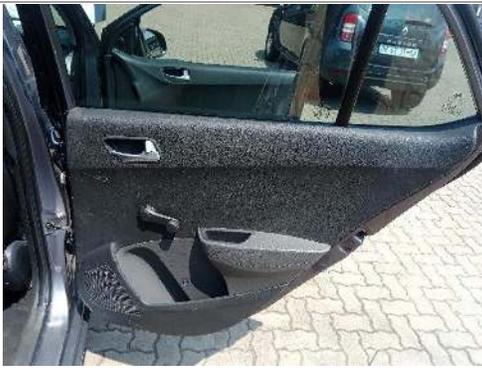
| Damage | Repair Way |
|---|---|
| Door Panel Rear Right Defective | Repair |

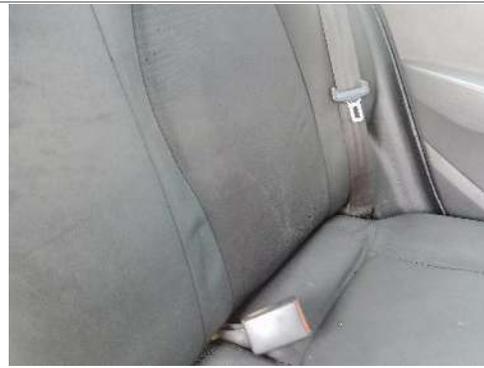
| Damage | Repair Way |
|---|---|
| Seat Belt Rear Left Damaged | Replace |

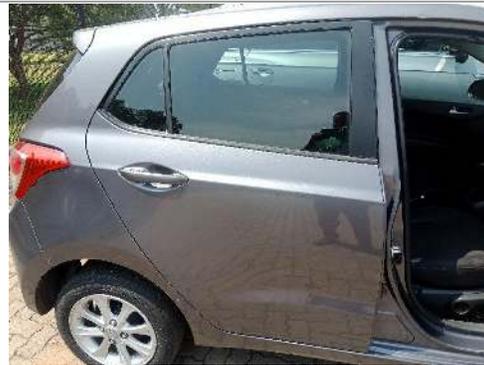
| Damage | Repair Way |
|---|---|
| Door Rear Right Paintwork • Scratched | Repair |

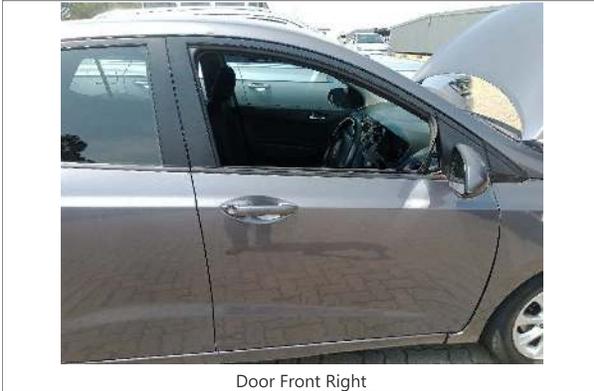
| Damage | Repair Way |
|---|---|
| Door Front Right Paintwork • Scratched | Repair |

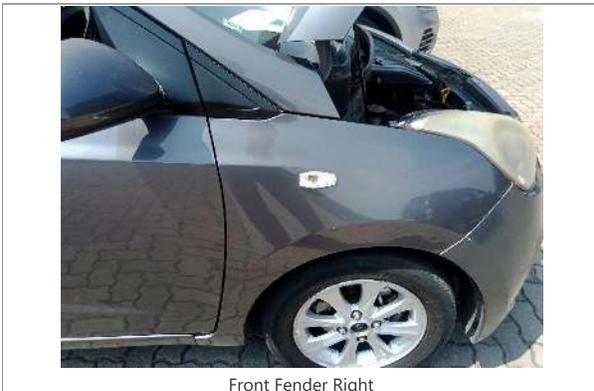
| Damage | Repair Way |
|---|---|
| Front Fender Right Dented | Repair |

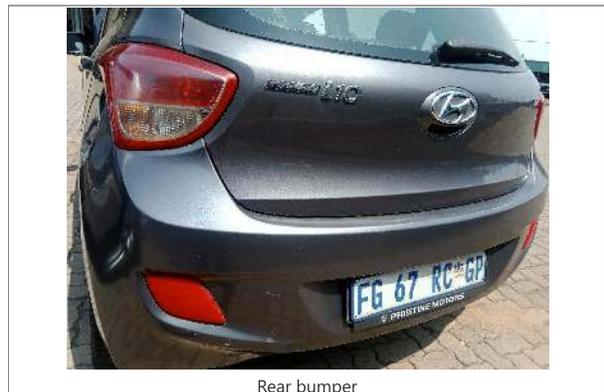
| Damage | Repair Way |
|---|---|
| Rear bumper Damaged | Repair |

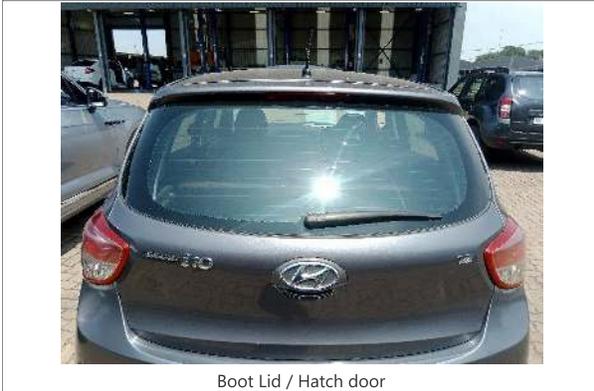
| Damage | Repair Way |
|---|---|
| Boot Lid / Hatch door Paintwork • Scratched | Repair |

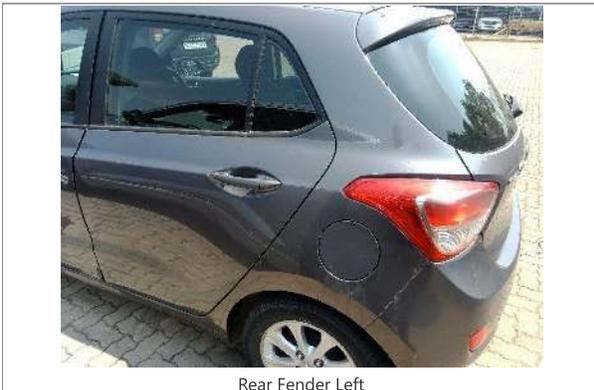
| Damage | Repair Way |
|---|---|
| Rear Fender Left Dented | Repair |

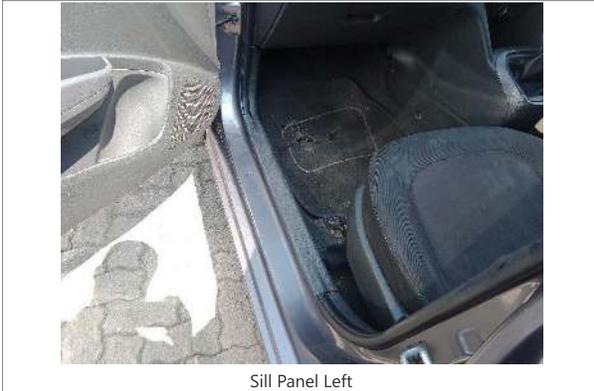
| Damage | Repair Way |
|---|---|
| Sill Panel Left Paintwork • Scratched | Repair |

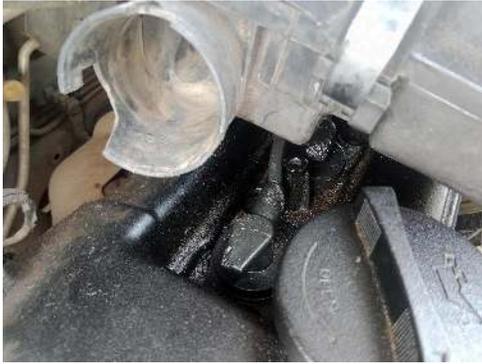
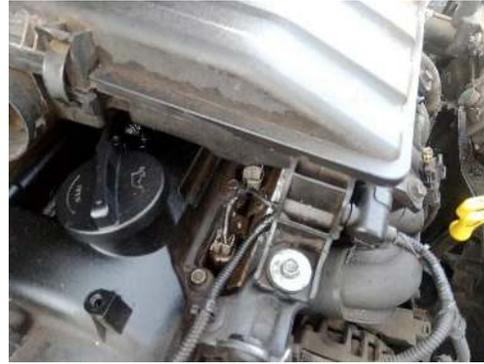
| Damage | Repair Way |
|---|---|
| Engine Wiring Defective | Replace |

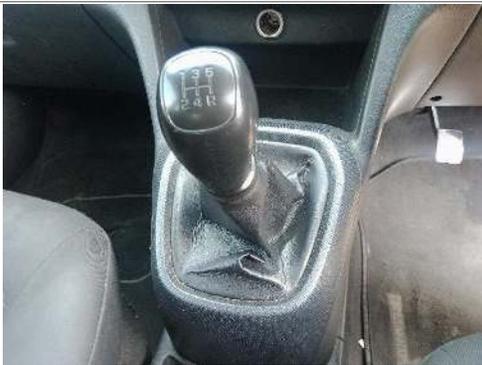
| Damage | Repair Way |
|--|--|
| Gear Selections Malfunction | Repair |

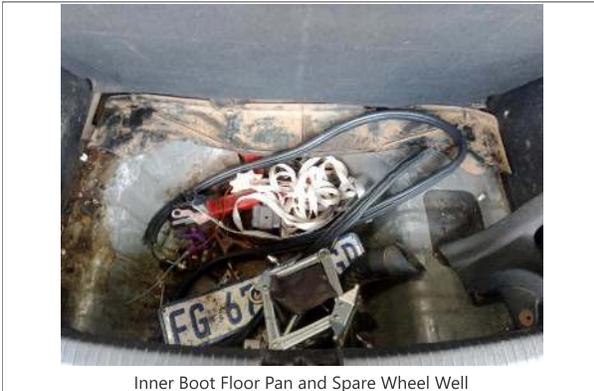
| Damage | Repair Way |
|---|---|
| Inner Boot Floor Pan and Spare Wheel Well Dented | Repair |

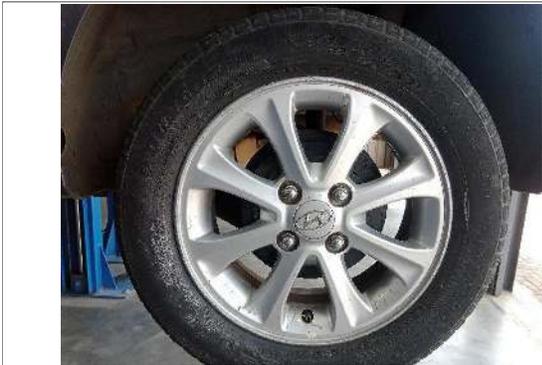
| Damage | Repair Way |
|---|---|
| Rim Rear Left Scratched | Repair |

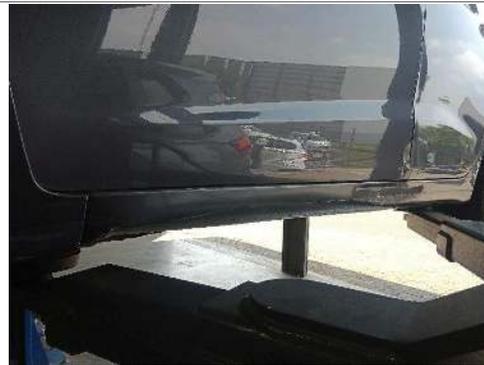
| Damage | Repair Way |
|---|---|
| Rocker Panel Left Damaged | Replace |

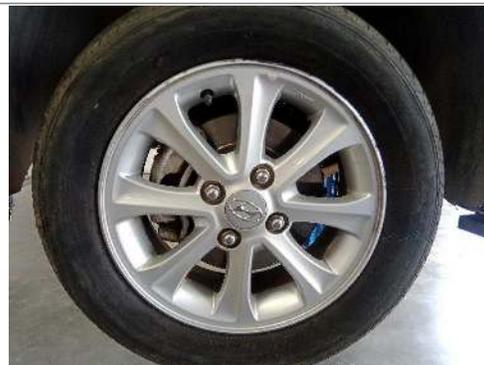
| Damage | Repair Way |
|---|---|
| Rim Front Left Scratched | Repair |

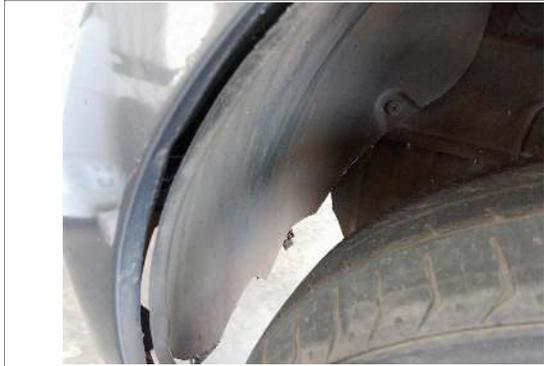
| Damage | Repair Way |
|---|---|
| Front Fender Left / Inner Tray Damaged | Replace |

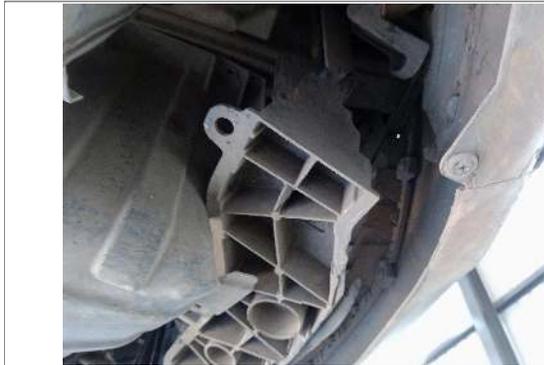
| Damage | Repair Way |
|--|--|
| Radiator Cradle Damaged | Replace |

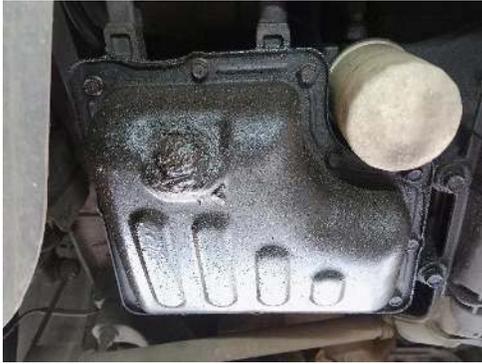
| Damage | Repair Way |
|---|---|
| Engine Oil Leak | Repair |

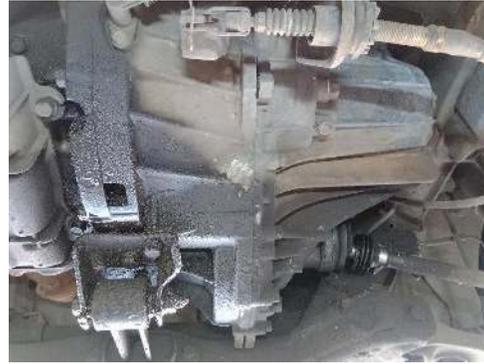
| Damage | Repair Way |
|---|---|
| Gearbox Oil Leak | Repair |

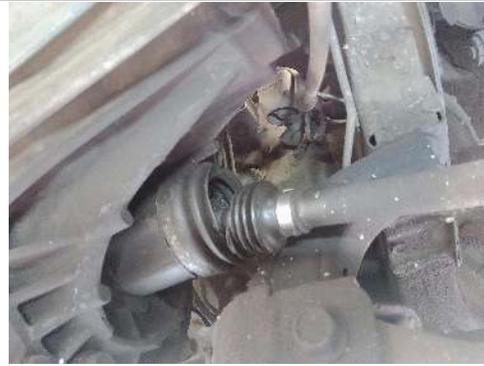
| Damage | Repair Way |
|--|--|
| CV Joint(s) Boot(s) Front Left (inner/outer) Damaged | Replace |

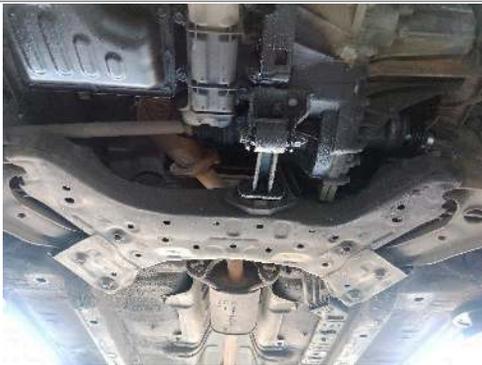
| Damage | Repair Way |
|---|---|
| Sub Frame Dented | Repair |

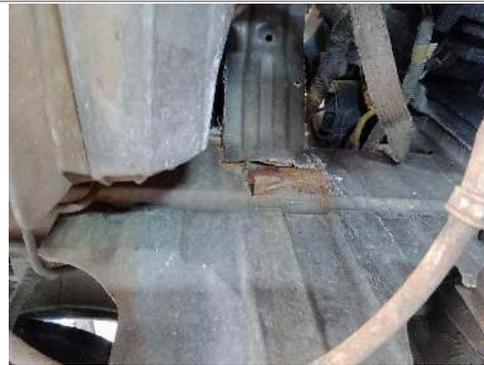
| Damage | Repair Way |
|---|---|
| Main Beam Left Defective | Repair |

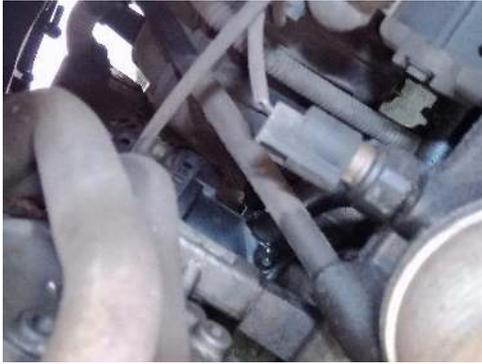
| Damage | Repair Way |
|---|---|
| Hoses Water Leak | Repair |

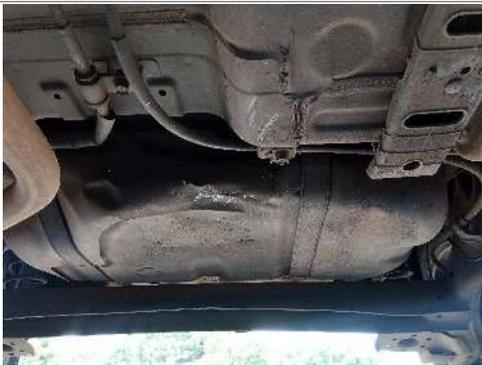
| Damage | Repair Way |
|---|---|
| Fuel Tank Damaged | Replace |

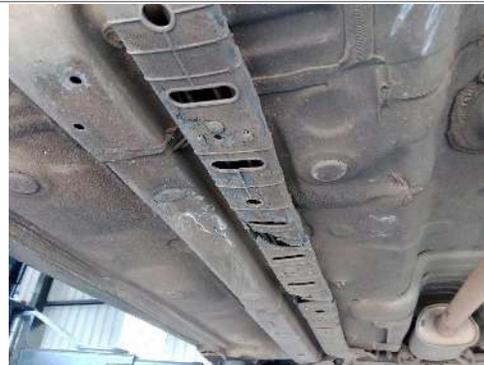
| Damage | Repair Way |
|---|---|
| Belly plates Damaged | Replace |

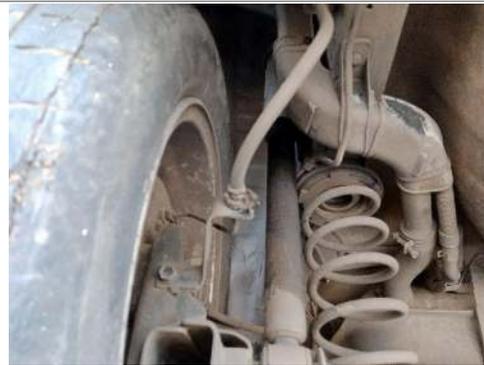
| Damage | Repair Way |
|---|---|
| Shock Absorber Rear Left Leak | Replace |
