## CONDITION REPORT

Report No: 2016880319

| Manufacturer | HYUNDAI | Registration Number | HN50CWGP |
| Model | I20 | Register Number | |

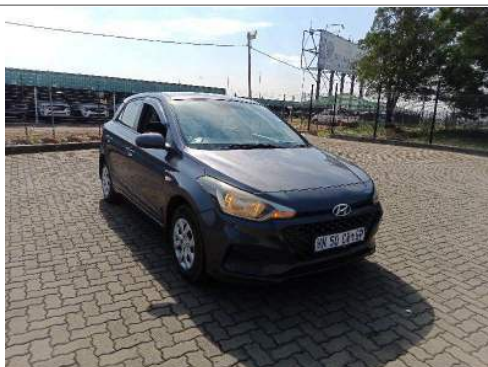
FRONT RIGHT CORNER

| Damage | Repair Way |
|---|---|
| Body and Exterior | Signs of impact damage to front of vehicle |

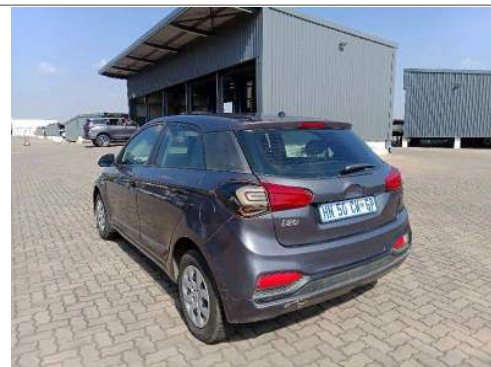
REAR LEFT CORNER

| Damage | Repair Way |
|---|---|
| Body and Exterior | Signs of impact damage to rear of vehicle |

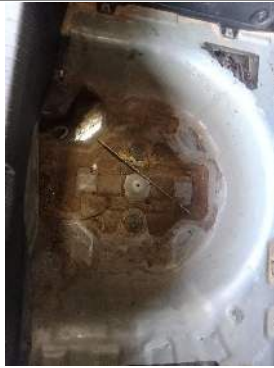
| Damage | Repair Way |
|---|---|
| Inner Boot Floor Pan and Spare Wheel Well Damaged | Repair |

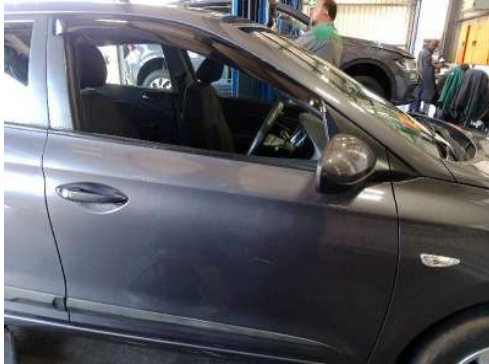
| Damage | Repair Way |
|---|---|
| Door Front Right Damaged | Repair |

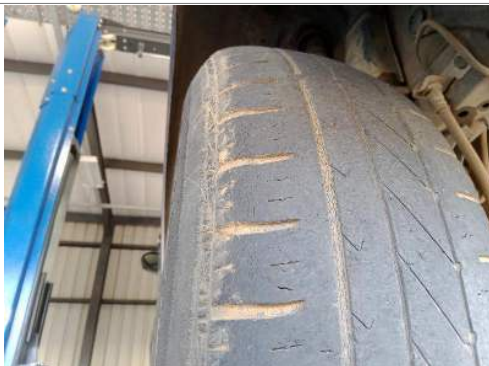
| Damage | Repair Way |
|---|---|
| Tyre Rear Left Damaged | Replace |
