## CONDITION REPORT

Report No: 2016295086

| Manufacturer | TATA | Registration Number | DH46FYGP |
| Model | INDICA | Register Number | |

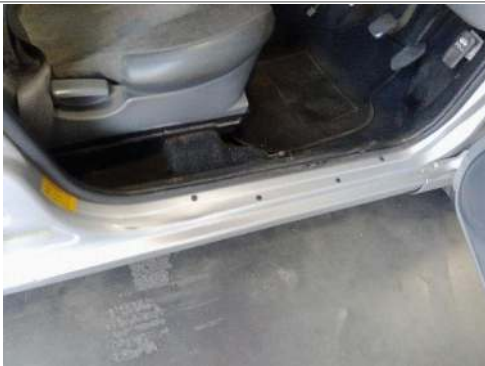
| Damage | Repair Way |
|---|---|
| Sill Panel Right Dented | Repair |

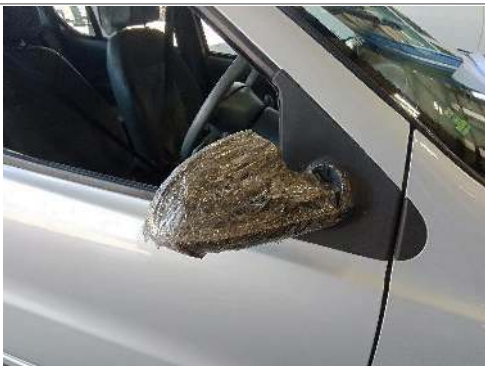
| Damage | Repair Way |
|---|---|
| Side Mirror Right Damaged | Replace |

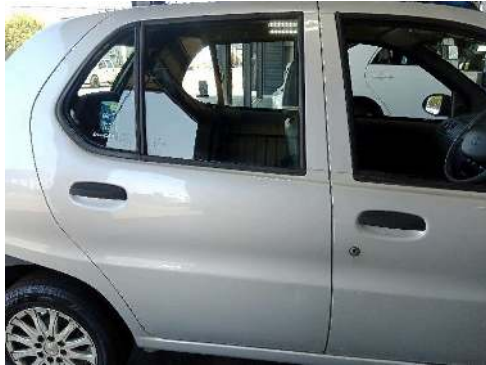
| Damage | Repair Way |
|---|---|
| Door Rear Right Dented | Repair |

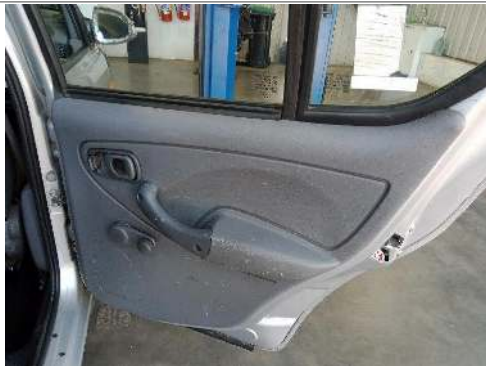
| Damage | Repair Way |
|---|---|
| Door Panel Rear Right Defective | Repair |

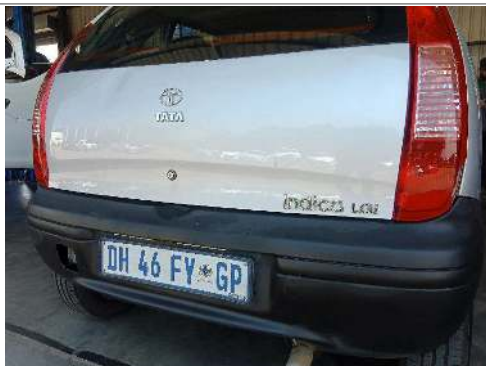
| Damage | Repair Way |
|---|---|
| Rear bumper Paintwork • Scratched | Repair |

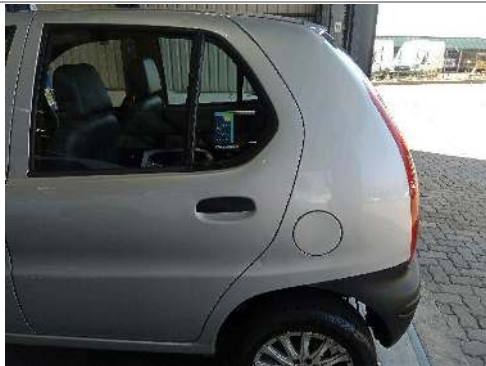
| Damage | Repair Way |
|---|---|
| Rear Fender Left Dented | Repair |

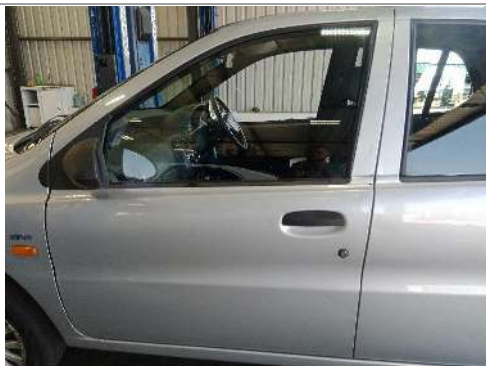
| Damage | Repair Way |
|---|---|
| Door Front Left Dented | Repair |

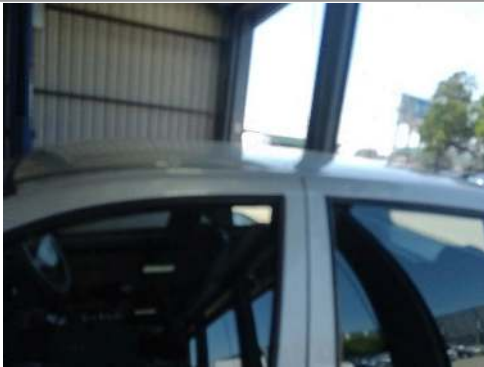
| Damage | Repair Way |
|---|---|
| B • Pillar Left Dented | Repair |

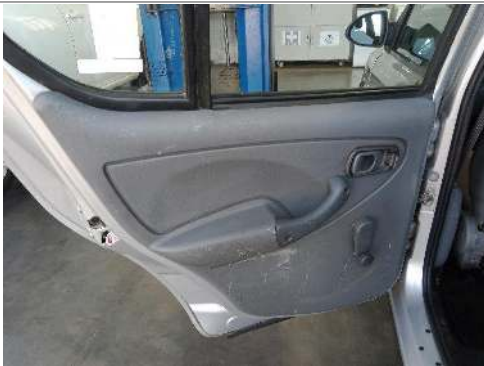
| Damage | Repair Way |
|---|---|
| Door Panel Rear Left Defective | Repair |

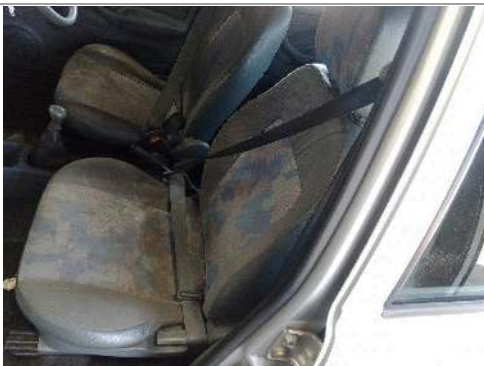
| Damage | Repair Way |
|---|---|
| Seat Front Left Dirty | Repair |

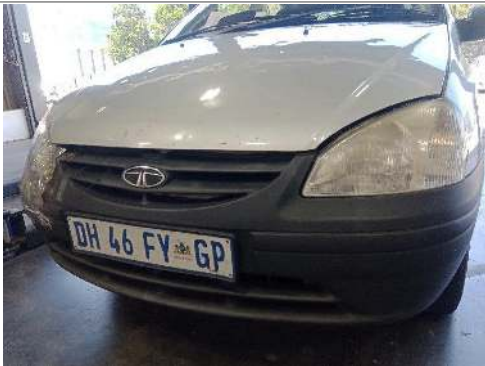
| Damage | Repair Way |
|---|---|
| Front Bumper Damaged | Repair |

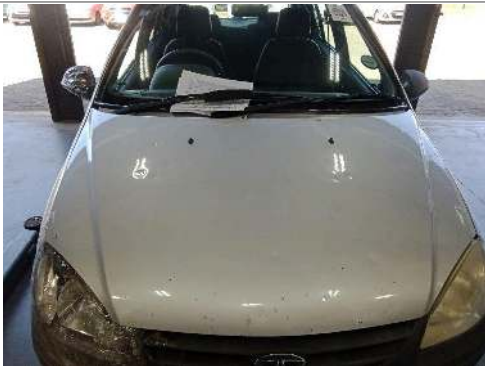
| Damage | Repair Way |
|---|---|
| Bonnet Damaged | Repair |

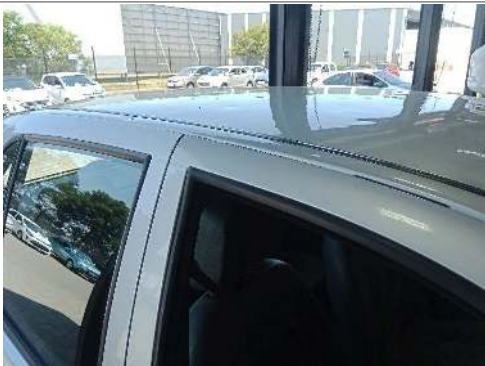
| Damage | Repair Way |
|---|---|
| B • Pillar Right Dented | Repair |

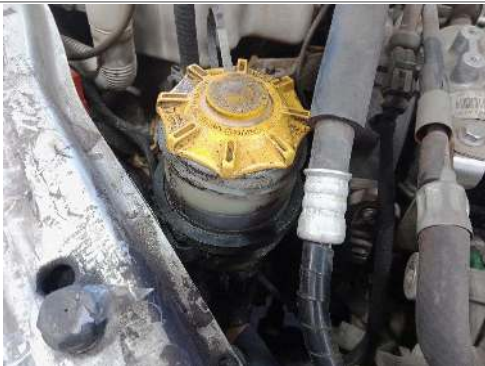
| Damage | Repair Way |
|---|---|
| Power Steering Pump / Electronic Unit Leak | Repair |

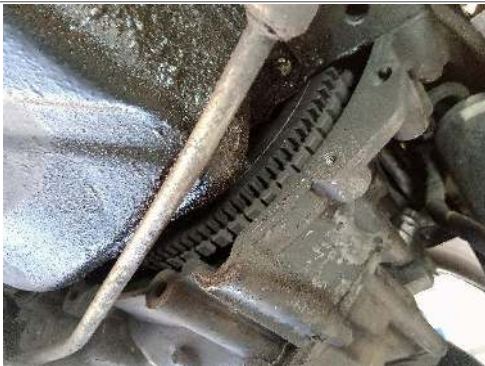
| Damage | Repair Way |
|---|---|
| Engine Oil Leak | Repair |

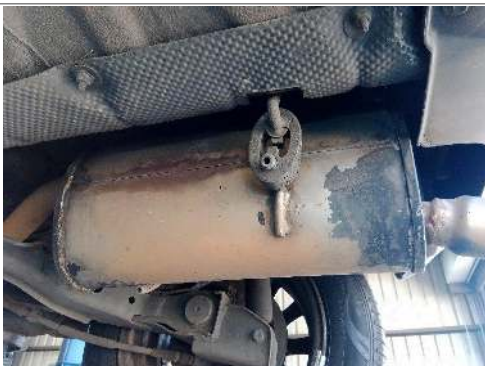
| Damage | Repair Way |
|---|---|
| Silencer Corrosion | Replace |

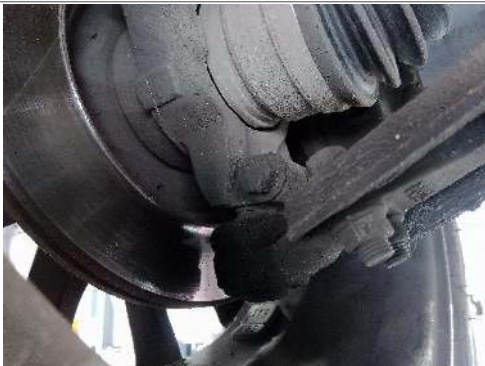
| Damage | Repair Way |
|---|---|
| Ball Joint(s) Front Axle Left Cracked | Replace |

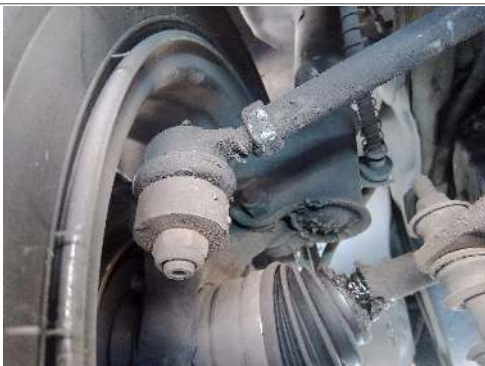
| Damage | Repair Way |
|---|---|
| Tie Rod End left Cracked | Replace |

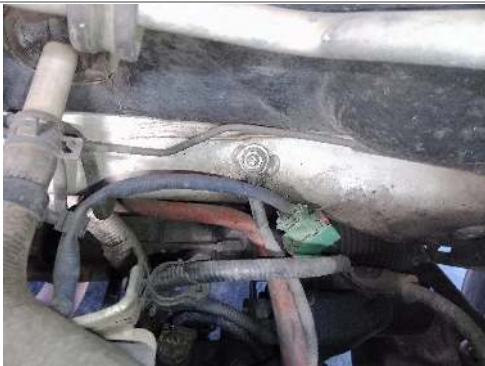
| Damage | Repair Way |
|---|---|
| Engine Wiring Defective | Repair |

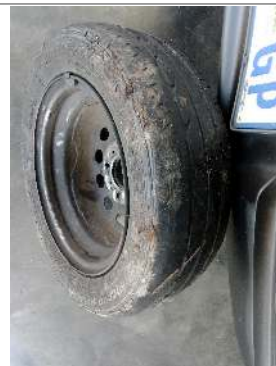
| Damage | Repair Way |
|---|---|
| Spare Tyre Damaged | Replace |
