## CONDITION REPORT

Report No:  
2016987079  
DATE  
29/08/2025

| Manufacturer | DATSUN | Registration Number | LY71NJGP |
| Model | GO | Register Number | |

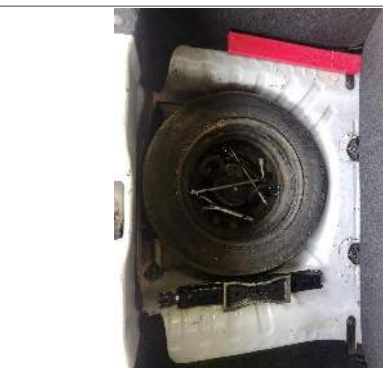
Spare wheel and Accessories

| Spare Tyre Damaged | Replace |

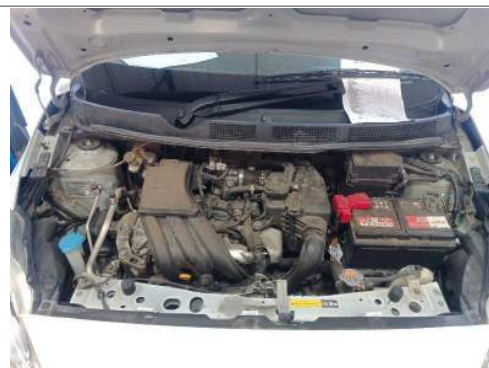
ENGINE 1

General Comments: ACCORDING TO THE AGE AND MILEAGE OF THE VEHICLE, NORMAL WEAR AND TEAR MARKS ARE VISIBLE ON THE INTERIOR, EXTERIOR, ELECTRICAL AND MECHANICAL PARTS. REAR RIGHT TYRE REGROOVED. REAR LEFT AND RIGHT TYRE SIZES DIFFERENT. NON STANDARD DROP SPRINGS FITTED TO FRONT AND REAR OF VEHICLE. Engine Compartment: Engine bay dirty and battery loose

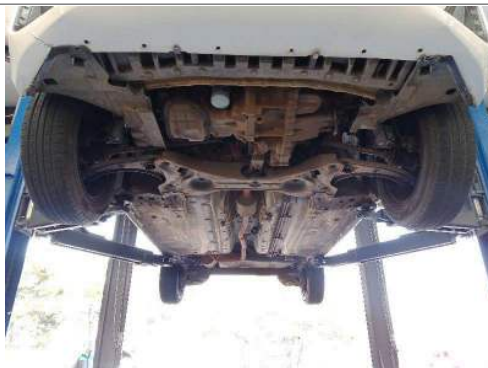
### Front Chassis

| Chassis Dented | Repair |
