## CONDITION REPORT

Report No:  
2016908254  
DATE  
10/06/2025

| Manufacturer | FORD | Registration Number | BC08PFGP |
| Model | FIESTA 1.4 AMBIENTE 5-DR [2010-2012] | Register Number | |

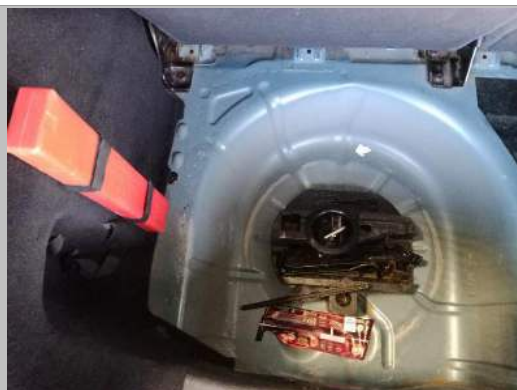
Spare wheel Accessories

| Damage | Repair Way |
|---|---|
| Tyres and rims | Spare wheel missing |

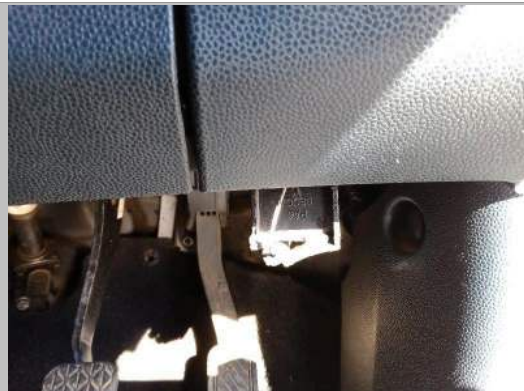
| Damage | Repair Way |
|---|---|
| Interior | Bonnet release handle damaged |

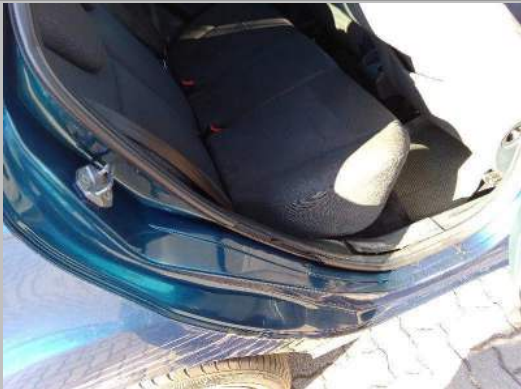
| Damage | Repair Way |
|---|---|
| Door Sealing Rubber Rear Right Damaged | Replace |

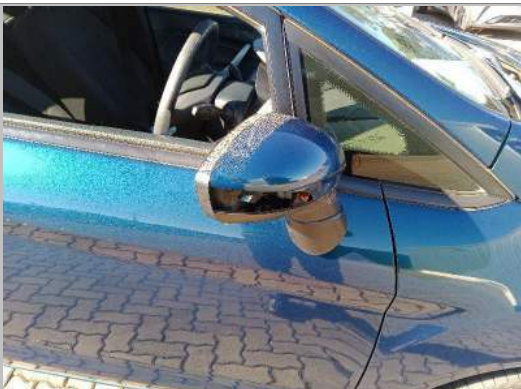
| Damage | Repair Way |
|---|---|
| Indicator Light Front Right Damaged | Replace |

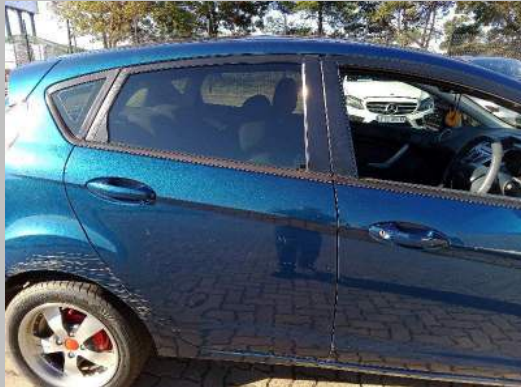
| Damage | Repair Way |
|---|---|
| Door Rear Right Damaged | Repair |

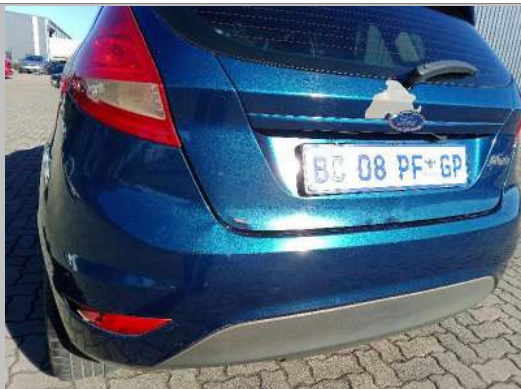
| Damage | Repair Way |
|---|---|
| Rear bumper Damaged | Repair |

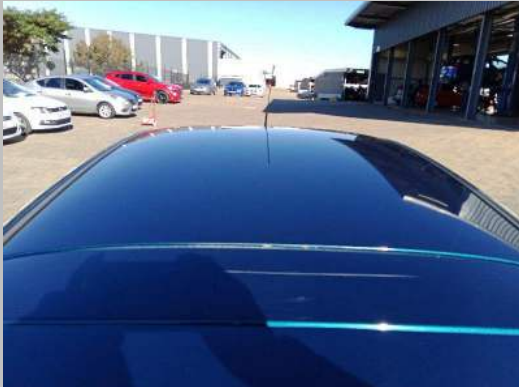
| Damage | Repair Way |
|---|---|
| Roof Dented | Repair |

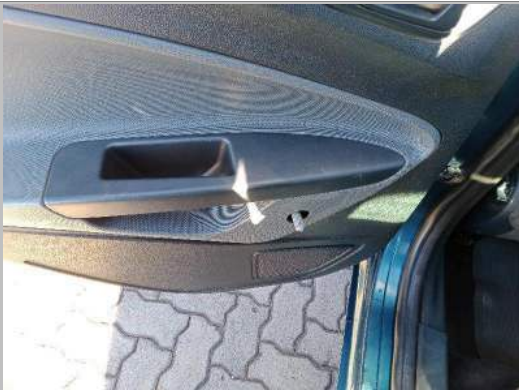
| Damage | Repair Way |
|---|---|
| Window Winder rear left Missing | Replace |

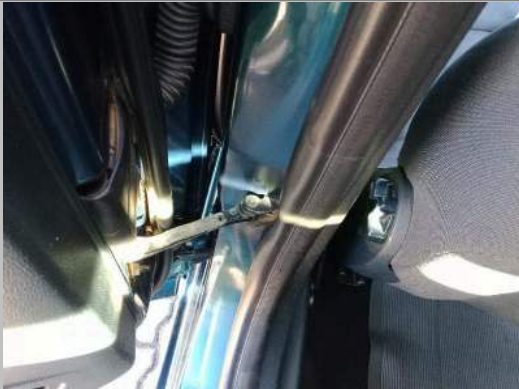
| Damage | Repair Way |
|---|---|
| Doorstopper Rear Left Defective | Replace |

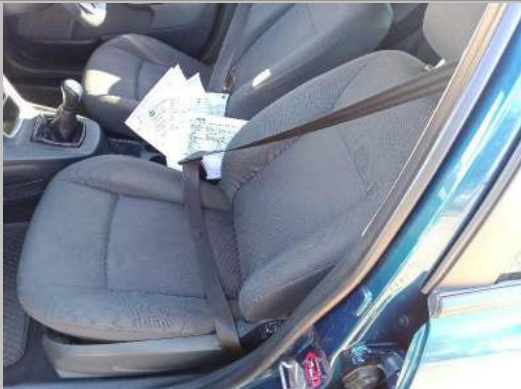
| Damage | Repair Way |
|---|---|
| Seat Front Left Damaged | Repair |

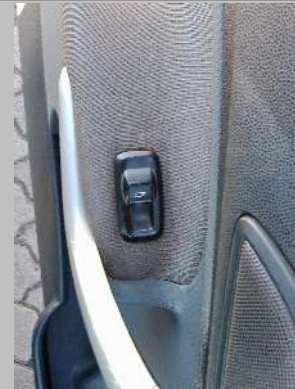
| Damage | Repair Way |
|---|---|
| Switch Electrical Window Winder front left Damaged | Replace |

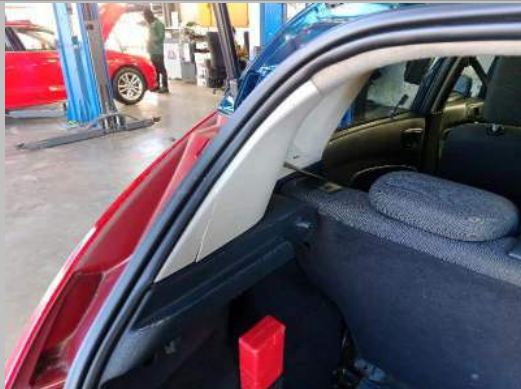
| Damage | Repair Way |
|---|---|
| Boot Panel Left Damaged | Repair |

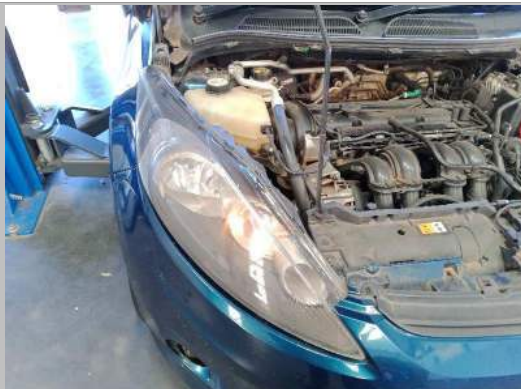
| Damage | Repair Way |
|---|---|
| Headlight Right Damaged | Replace |

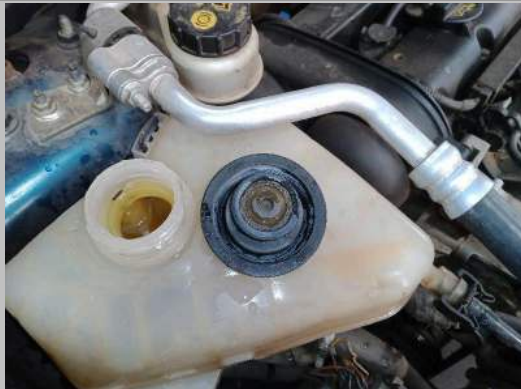
| Damage | Repair Way |
|---|---|
| Caps Damaged | Replace |

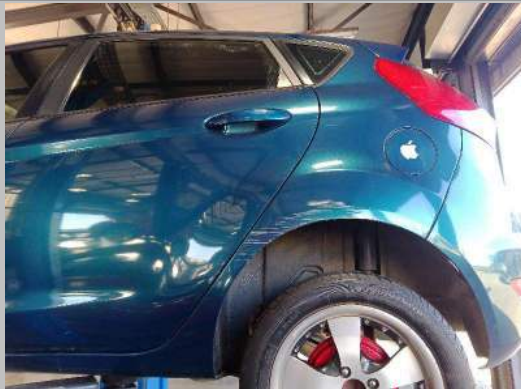
| Damage | Repair Way |
|---|---|
| Rear Fender Left Damaged | Repair |

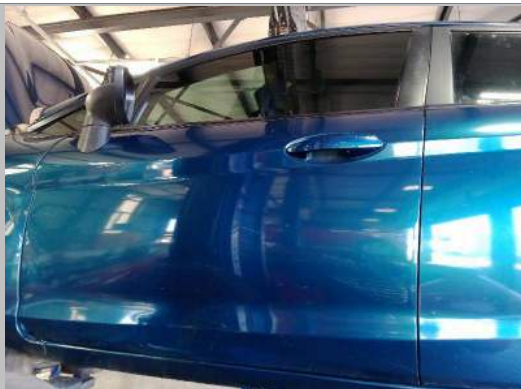
| Damage | Repair Way |
|---|---|
| Door Front Left Damaged | Repair |

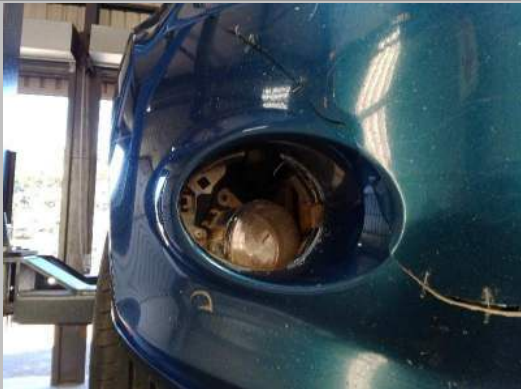
| Damage | Repair Way |
|---|---|
| Fog Light Front Right Damaged | Replace |

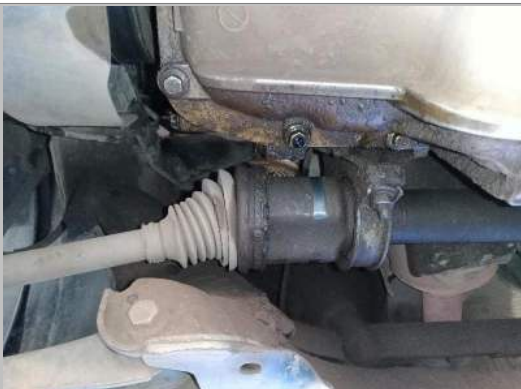
| Damage | Repair Way |
|---|---|
| CV Joint(s) Boot(s) Front Right (inner/outer) Damaged | |

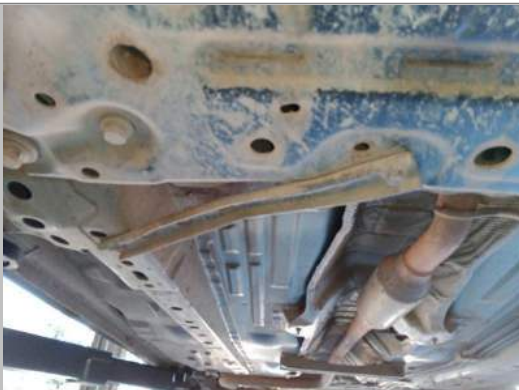
| Damage | Repair Way |
|---|---|
| Cross Member Front Right Damaged | Repair |

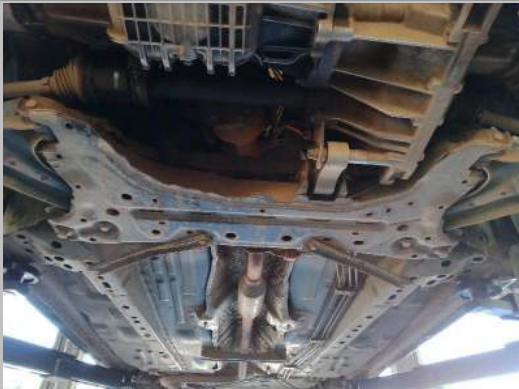
| Damage | Repair Way |
|---|---|
| Sub Frame Dented | Repair |

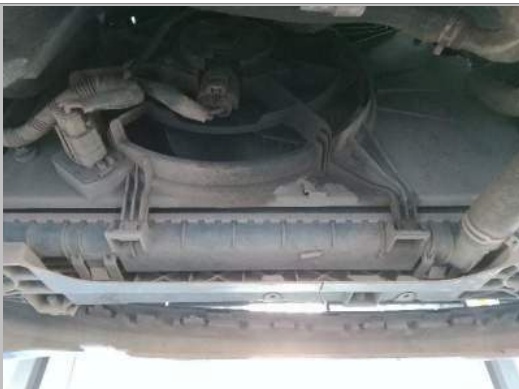
| Damage | Repair Way |
|---|---|
| Radiator Cradle Damaged | Replace |
