CONDITION REPORT

Report No: 2016598816

MFC Auction House  
M57 Pretoria Rd, Glenmarais, KEMPTON PARK  
Gauteng

| Manufacturer | NISSAN | Registration Number | CS47JJGP |

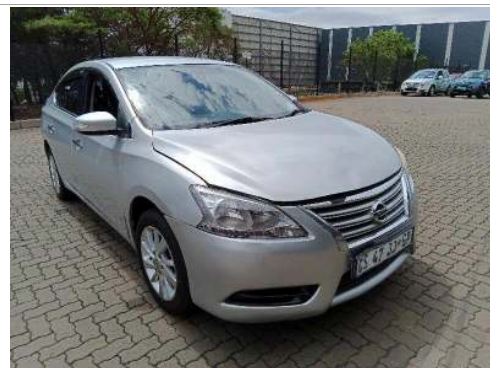
FRONT RIGHT CORNER

| Damage | Repair Way |
|---|---|
| Body and Exterior | Signs of impact damage to front of vehicle. |

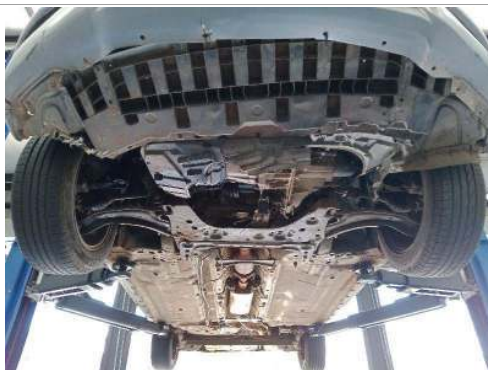
Front chassis

| Damage | Repair Way |
|---|---|
| Chassis Damaged | Repair |

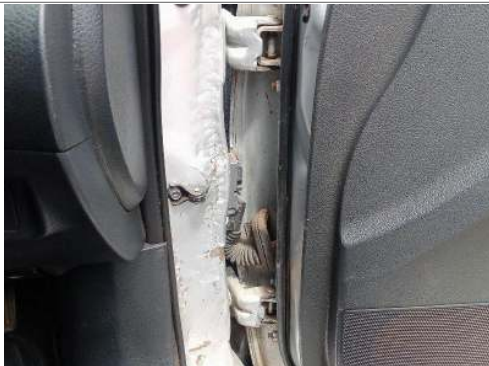
| Damage | Repair Way |
|---|---|
| Doorstopper Front Right Damaged | Replace |

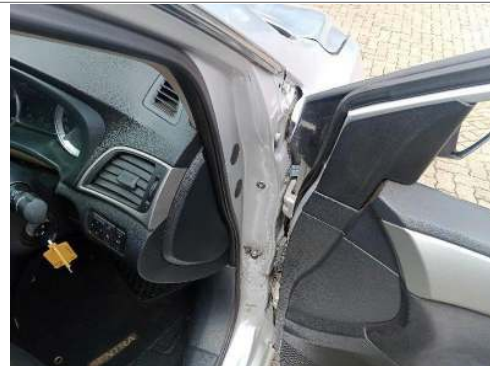
| Damage | Repair Way |
|---|---|
| A • Pillar Right Damaged | Repair |

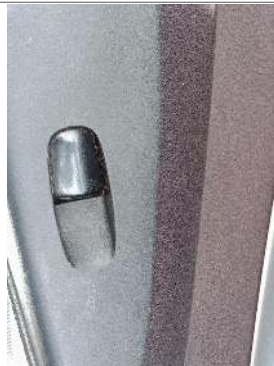
| Damage | Repair Way |
|---|---|
| Switch Electrical Window Winder rear left Malfunction | Replace |

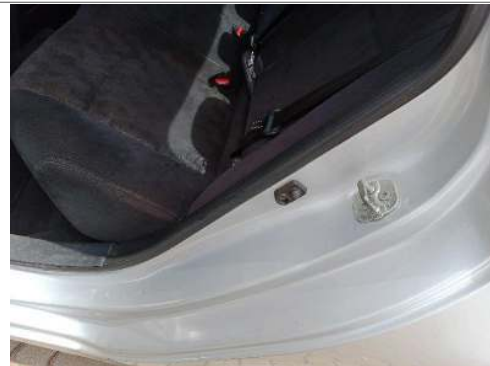
| Damage | Repair Way |
|---|---|
| Door Sealing Rubber Rear Left Damaged | Replace |

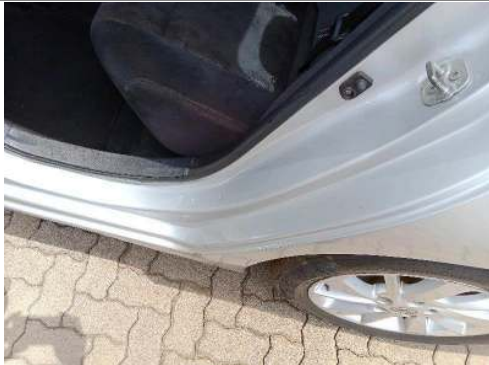
| Damage | Repair Way |
|---|---|
| C • Pillar Left Dented | Repair |

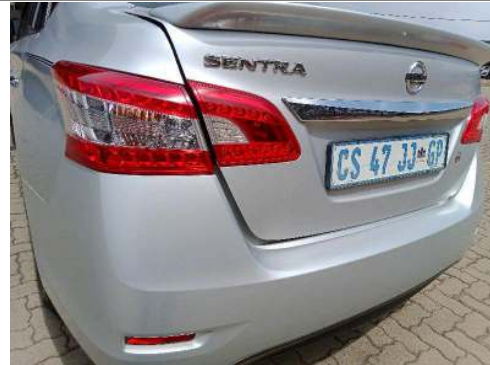
| Damage | Repair Way |
|---|---|
| Rear bumper Damaged | Repair |

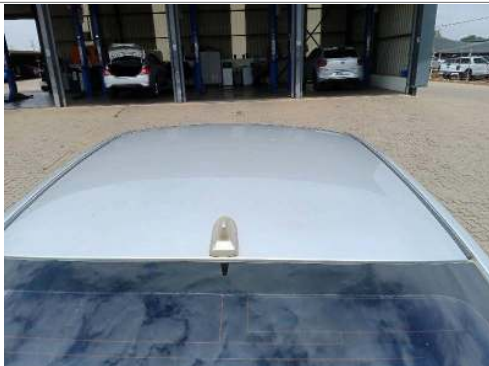
| Damage | Repair Way |
|---|---|
| Roof Damaged | Repair |

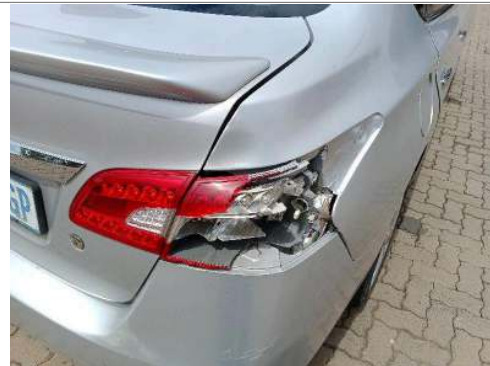
| Damage | Repair Way |
|---|---|
| Tail Light Right Damaged | Replace |

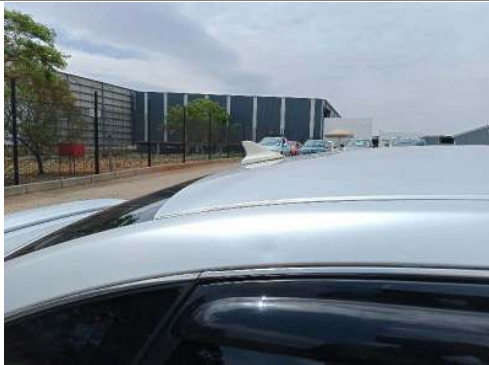
| Damage | Repair Way |
|---|---|
| C • Pillar Right Dented | Repair |

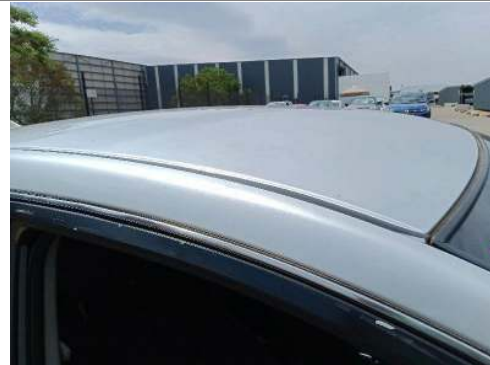
| Damage | Repair Way |
|---|---|
| B • Pillar Right Dented | Repair |

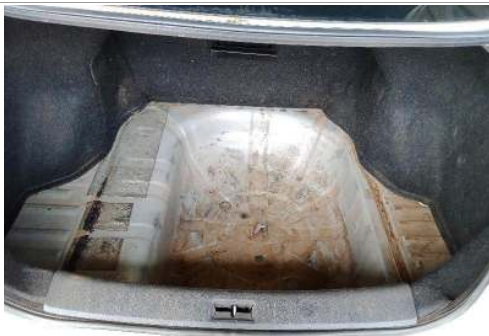
| Damage | Repair Way |
|---|---|
| Inner Boot Floor Pan and Spare Wheel Well Damaged | Repair |

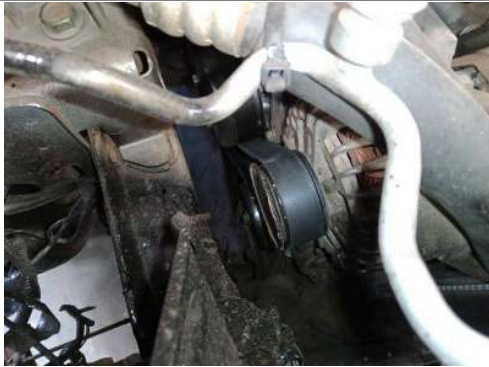
| Damage | Repair Way |
|---|---|
| Alternator Defective | Repair |

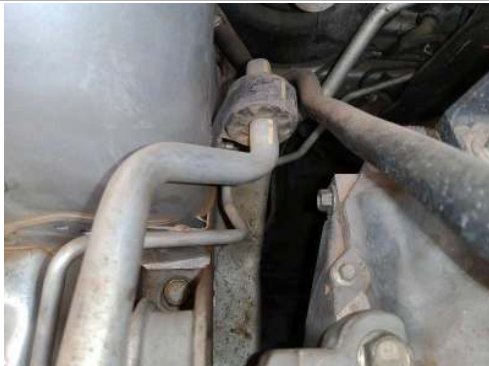
| Damage | Repair Way |
|---|---|
| Main Beam Right Damaged | Repair |

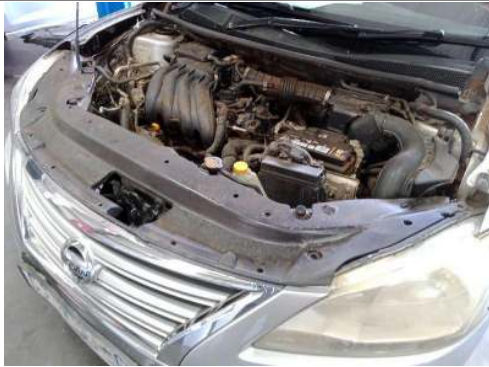
| Damage | Repair Way |
|---|---|
| Bonnet slam plate (Shock tower/ Inner tray) Damaged | Repair |

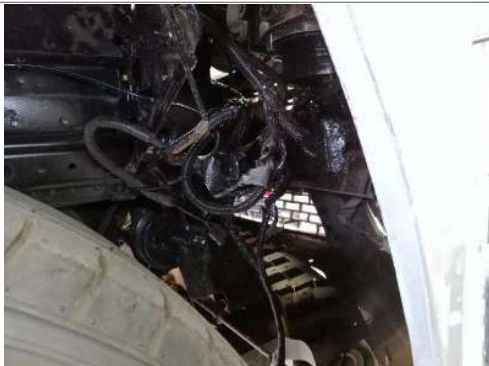
| Damage | Repair Way |
|---|---|
| Engine Wiring Defective | Repair |

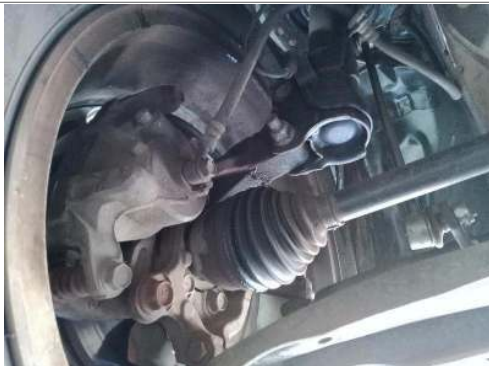
| Damage | Repair Way |
|---|---|
| CV Joint(s) Boot(s) Front Right (inner/outer) Damaged | Replace |

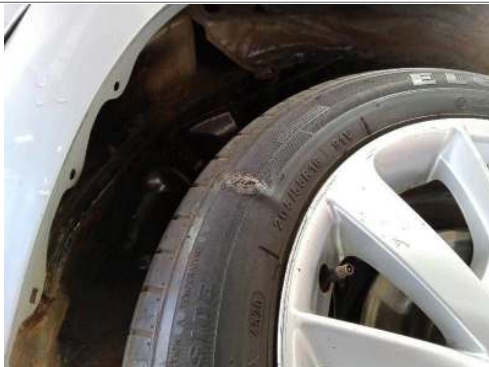
| Damage | Repair Way |
|---|---|
| Tyre Front Right Damaged | Replace |

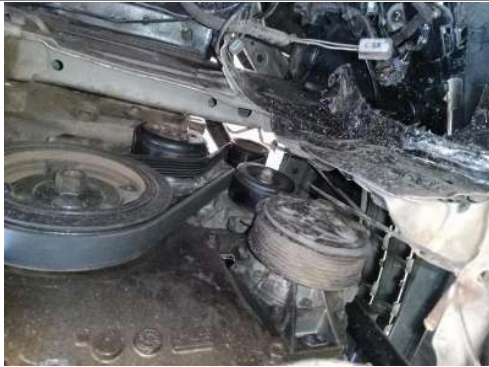
| Damage | Repair Way |
|---|---|
| Fan Belt Missing | Replace |

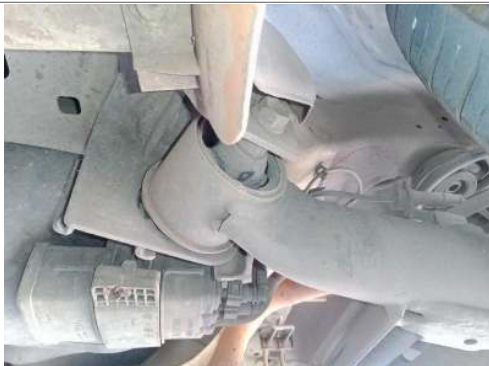
| Damage | Repair Way |
|---|---|
| Mounting Rubber(s) Rear Axle Left Cracked | Replace |

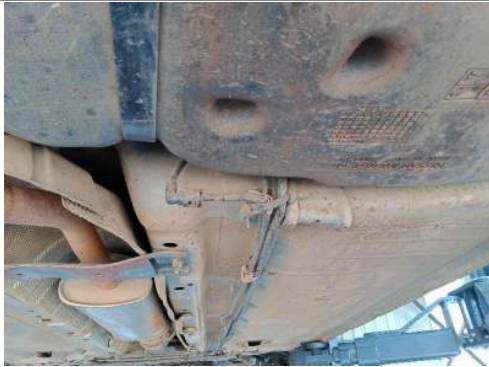
| Damage | Repair Way |
|---|---|
| Fuel Lines Defective | Repair |

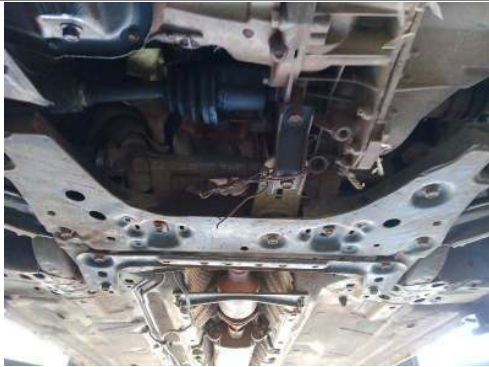
| Damage | Repair Way |
|---|---|
| Sub Frame Dented | Repair |

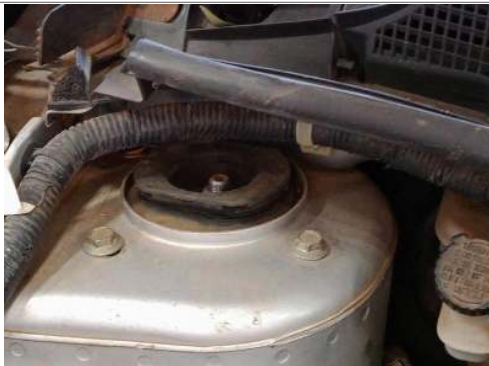
| Damage | Repair Way |
|---|---|
| Shock Absorber Mounting Front Right Cracked | Replace |

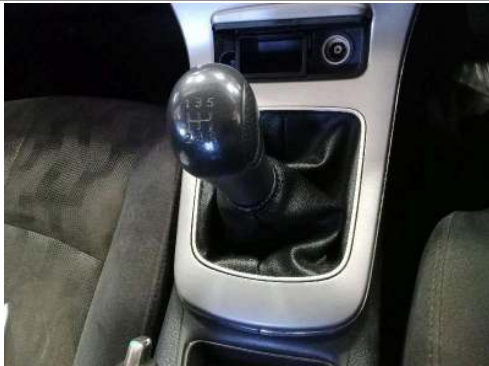
| Damage | Repair Way |
|---|---|
| Gear Selections Malfunction | Repair |

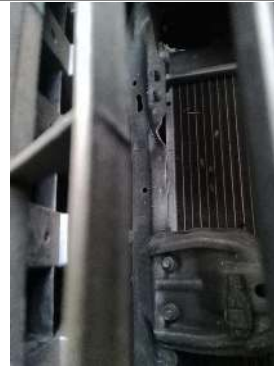
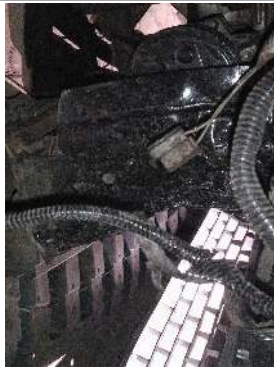
| Damage | Repair Way |
|---|---|
| Radiator Cradle Damaged | Replace |
