## CONDITION REPORT

Report No: 2016274450

DATE  
20/02/2024

| Manufacturer | RENAULT | Registration Number | JD79RVGP |

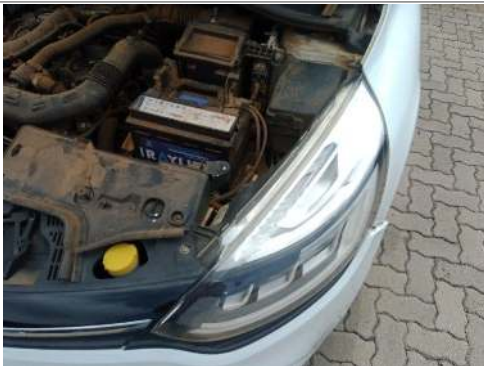
| Damage | Repair Way |
|---|---|
| Headlight Left Damaged | Replace |

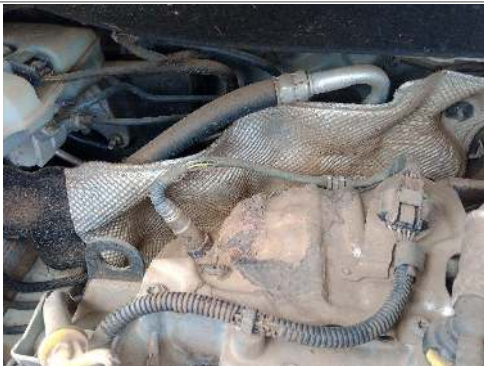
| Damage | Repair Way |
|---|---|
| Engine Wiring Defective | Repair |

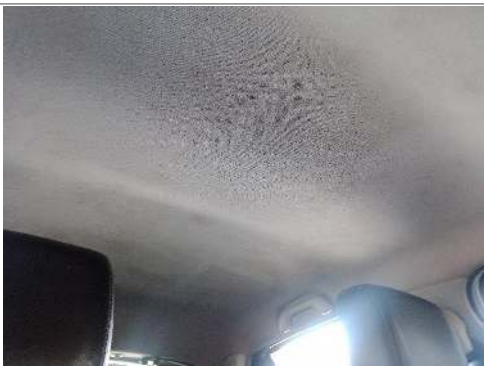
| Damage | Repair Way |
|---|---|
| Hood Lining Dirty | Repair |

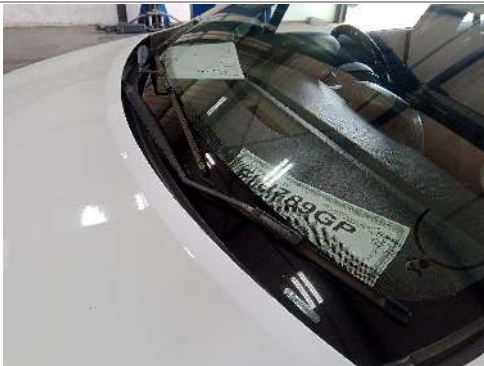
| Damage | Repair Way |
|---|---|
| Windscreen Wiper Damaged | Replace |

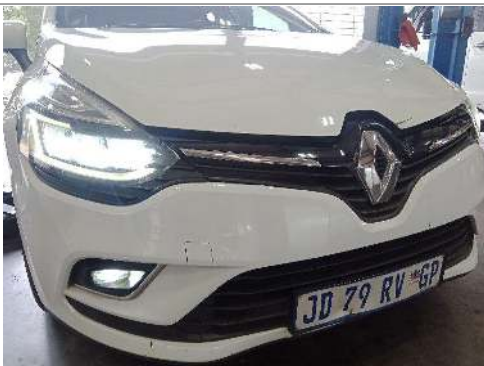
| Damage | Repair Way |
|---|---|
| Front Bumper Damaged | Repair |

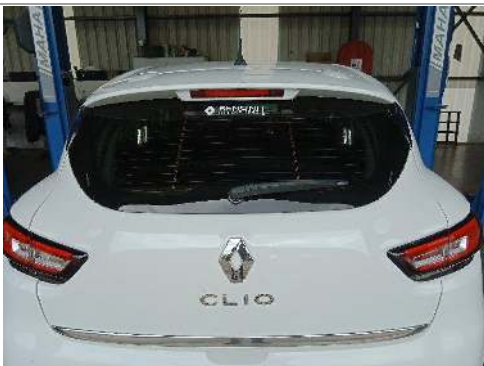
| Damage | Repair Way |
|---|---|
| Boot Lid / Hatch door Paintwork • Scratched | Repair |
