MFC Auction House  
M57 Pretoria Rd, Glenmarais, KEMPTON PARK  
Gauteng

| Manufacturer | BMW | Registration Number | HD63LBGP |

## CONDITION REPORT

Report No: 2016208595

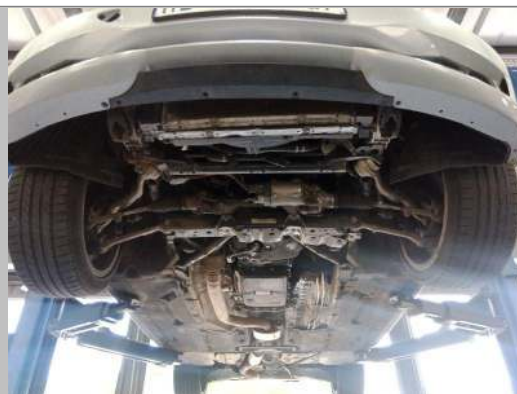
Front chassis

| Damage | Repair Way |
|---|---|
| Chassis Dented | Repair |

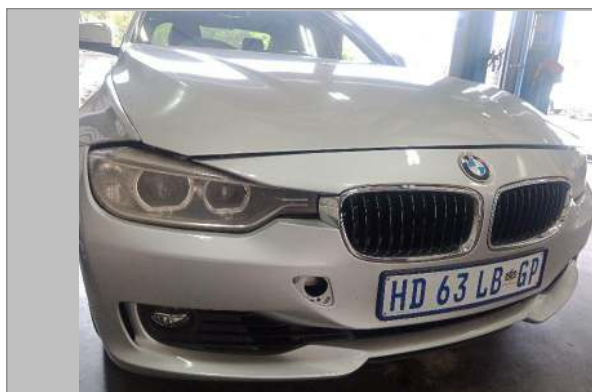
| | Damage | Repair Way |
|---|---|---|
| | Front Bumper Damaged | Repair |

Poor residual traces of repair on some body panels. Bonnet struggles to open. Signs of impact damage to front and rear of vehicle.

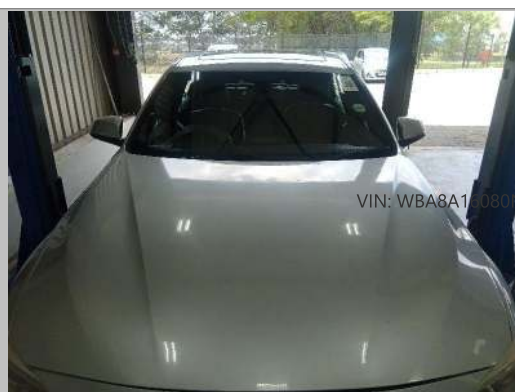
| | Damage | Repair Way |
|---|---|---|
| | Bonnet Residual Traces of Repair | Repair |

Engine Compartment: Engine bay dirty. Brake fluid level ok. Oil level checked electronically. Left and right bonnet latches faulty. Radiator and Aircon condenser dented. Engine splash plate missing. Engine cover damaged. Computer box cover cracked.

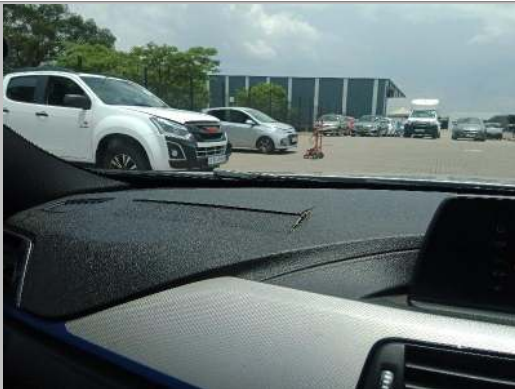
| | Damage | Repair Way |
|---|---|---|
| | Dash Padding Damaged | Repair |

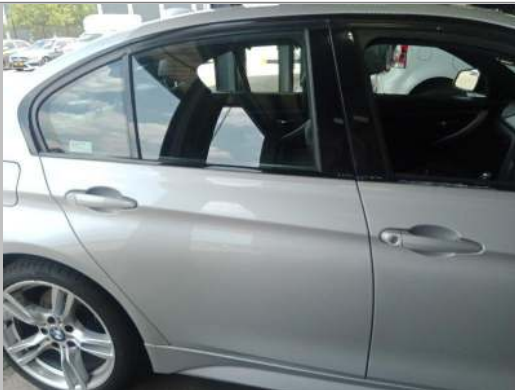
| | Damage | Repair Way |
|---|---|---|
| | Door Rear Right Paintwork • Scratched | Repair |

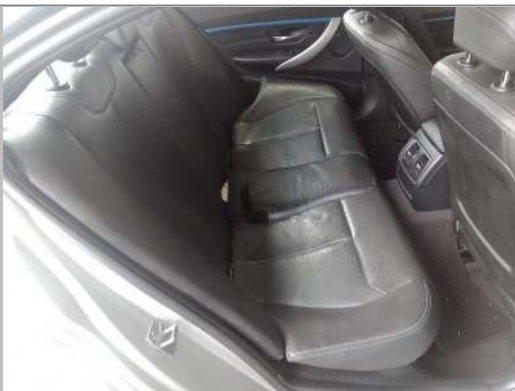
| | Damage | Repair Way |
|---|---|---|
| | Seat Rear Defective | Repair |

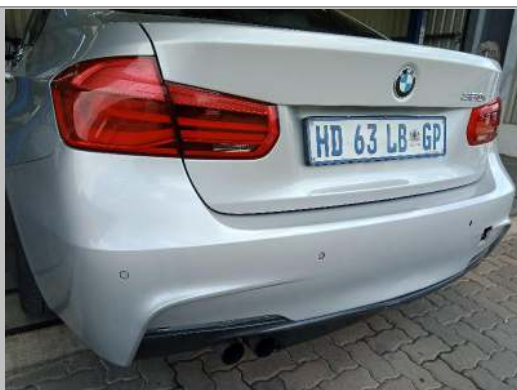
| Damage | Repair Way |
|---|---|
| Rear bumper Residual Traces of Repair | Repair |

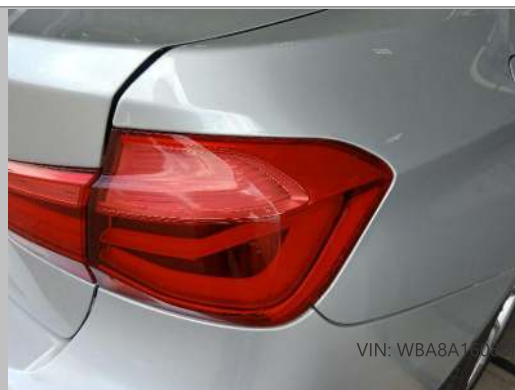
| | Damage | Repair Way |
|---|---|---|
| | Tail Light Left Cracked | Replace |

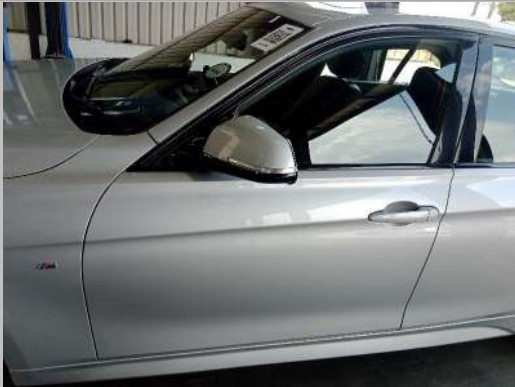
| | Damage | Repair Way |
|---|---|---|
| | Door Front Left Paintwork • Scratched | Repair |

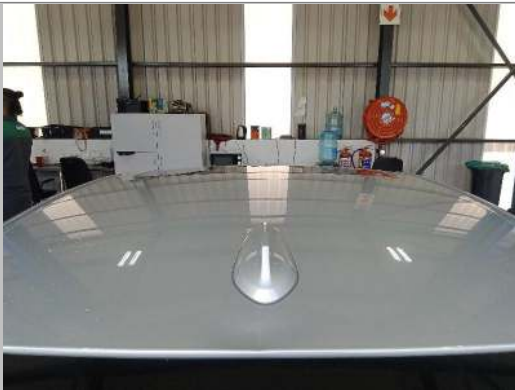
| Damage | Repair Way |
|---|---|
| Roof Damaged | Repair |

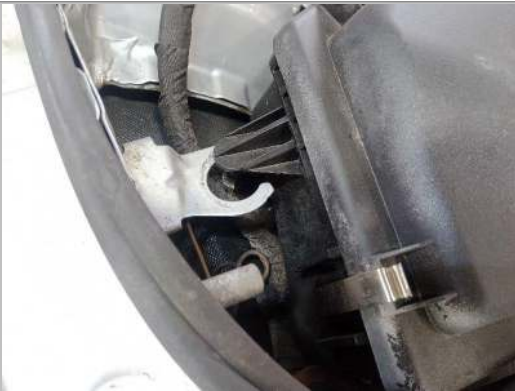
| | Damage | Repair Way |
|---|---|---|
| | Air cleaner Broken | Repair |

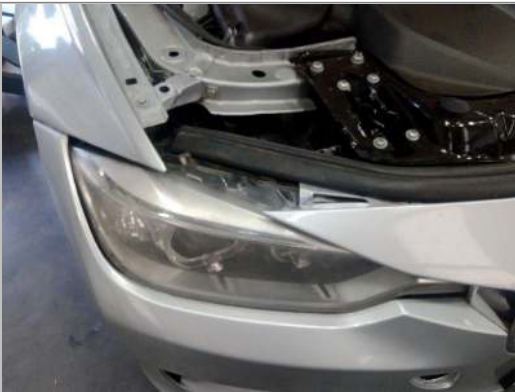
Headlight Right

Lights: Vehicle has no lights working on front left and right headlights. Front right headlight bracket damaged.

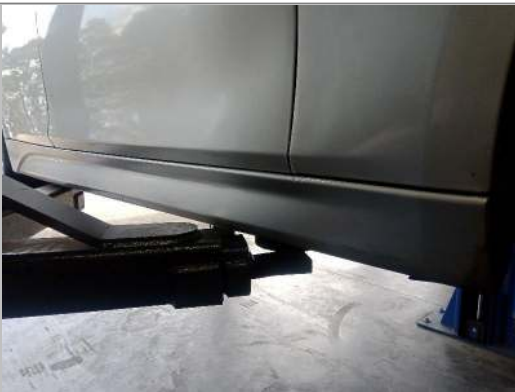
| Damage | Repair Way |
|---|---|
| Rocker Panel Right Residual Traces of Repair | Repair |

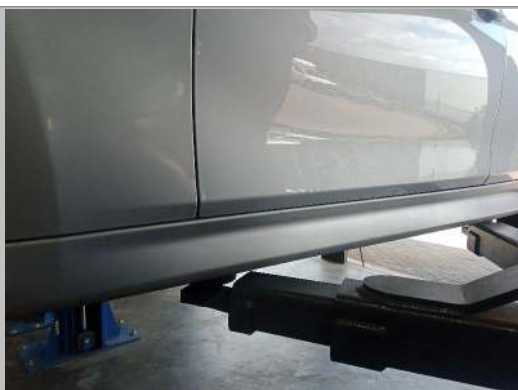
| Damage | Repair Way |
|---|---|
| Rocker Panel Left Residual Traces of Repair | Repair |

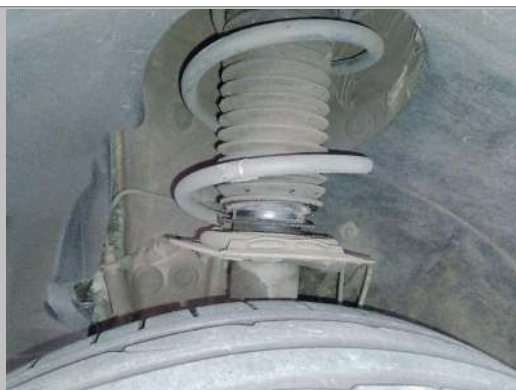
| Damage | Repair Way |
|---|---|
| Shock Absorber Front Left Leak | Replace |

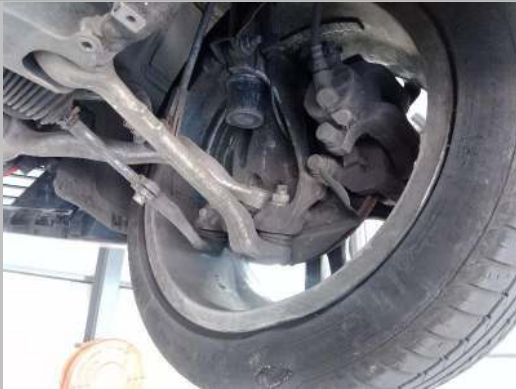
| Damage | Repair Way |
|---|---|
| Rim Front Right Dented | Repair |

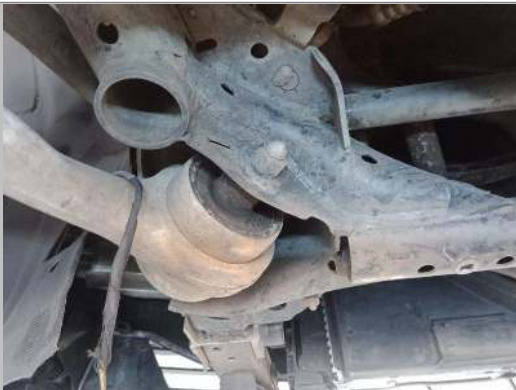
| Damage | Repair Way |
|---|---|
| Control Arm Bush(es) Front Axle Left Cracked | Replace |

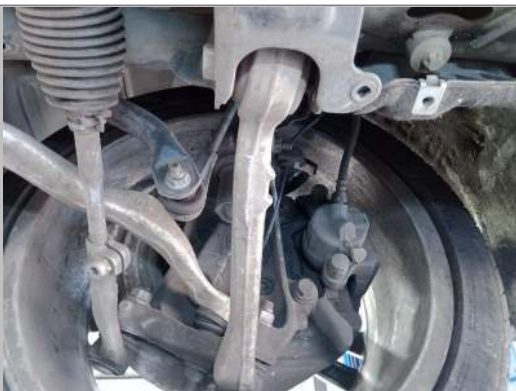
| Damage | Repair Way |
|---|---|
| Control Arm(s) Front Axle Right Damaged | Replace |

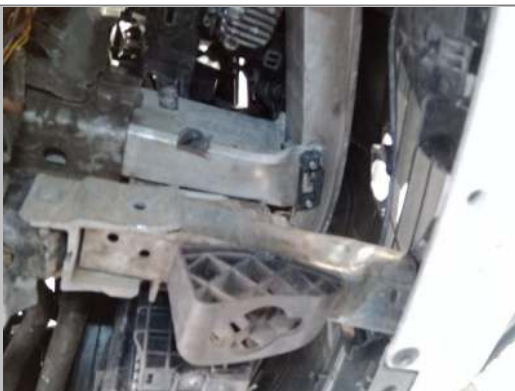
| Damage | Repair Way |
|---|---|
| Radiator Cradle Damaged | Replace |

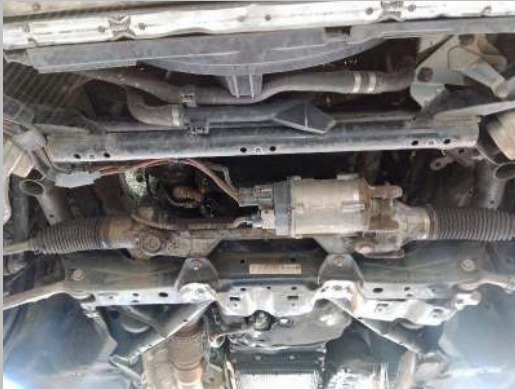
| Damage | Repair Way |
|---|---|
| Sub Frame Dented | Repair |

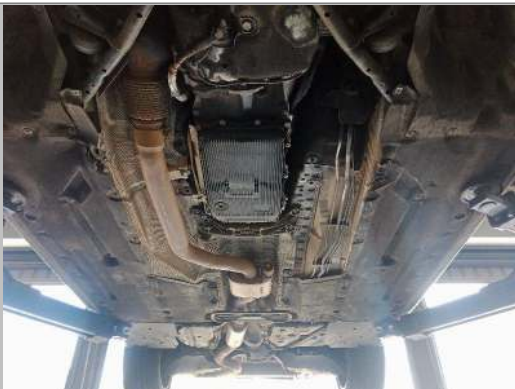
| Damage | Repair Way |
|---|---|
| Belly plates Damaged | Repair |

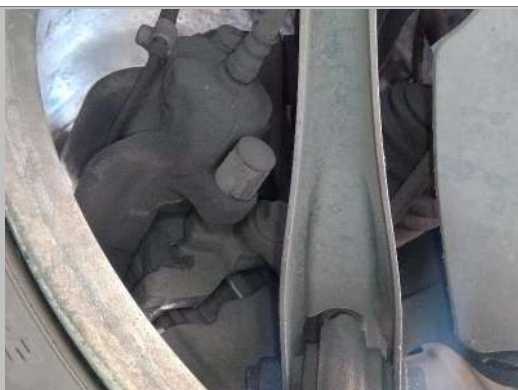
| Damage | Repair Way |
|---|---|
| Wheel Cylinder / Caliper 2. Axle right Sweat | Repair |

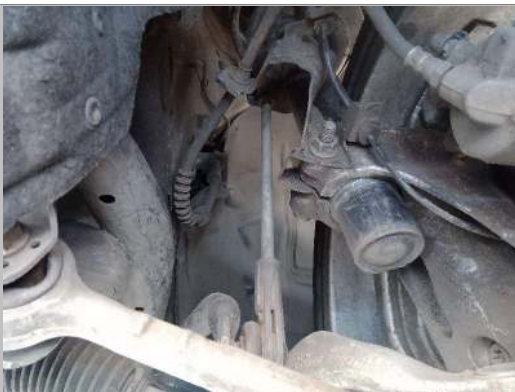
| Damage | Repair Way |
|---|---|
| Stabilizer Mounting Front Right Defective | Replace |
