## CONDITION REPORT

Report No: 2016355407

MFC Auction House  
M57 Pretoria Rd, Glenmarais, KEMPTON PARK  
Gauteng

| Manufacturer | BMW | Registration Number | BR61CYGP |

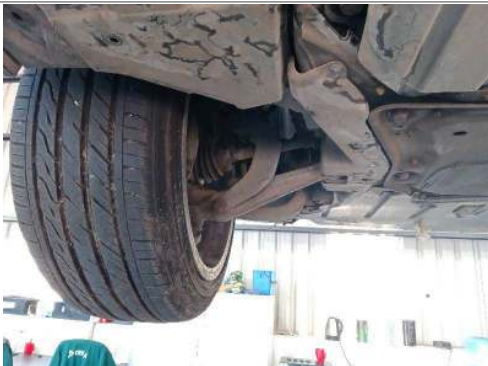
LF TYRE TREAD

| Damage | Repair Way |
|---|---|
| Tyre Front Left Defective | Repair |

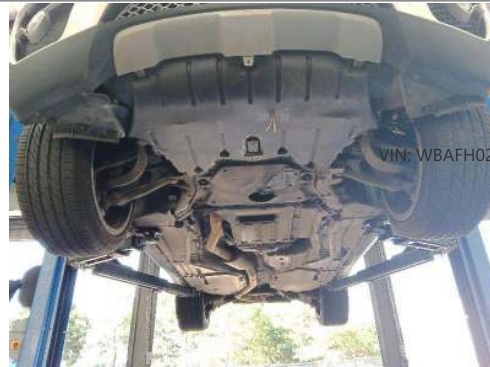
Front chassis

| Damage | Repair Way |
|---|---|
| Undercarriage | Signs of surface rust on undercarriage |

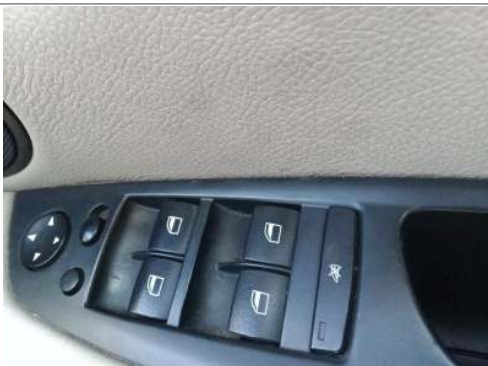
| Damage | Repair Way |
|---|---|
| Switch Electrical Window Winder rear right Damaged | Replace |

| Damage | Repair Way |
|---|---|
| Electrical instruments and components | F/R electrical window switch mechanism damaged |

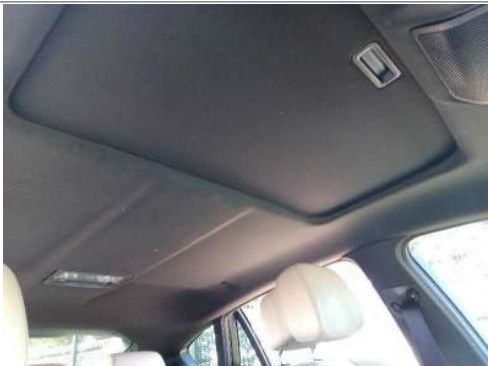
| Damage | Repair Way |
|---|---|
| Hood Lining Dirty | Repair |

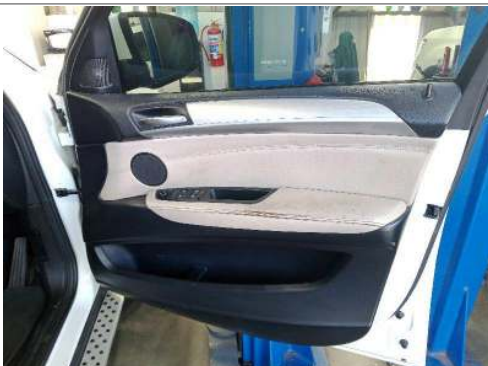
| Damage | Repair Way |
|---|---|
| Door Panel Front Right Defective | Repair |

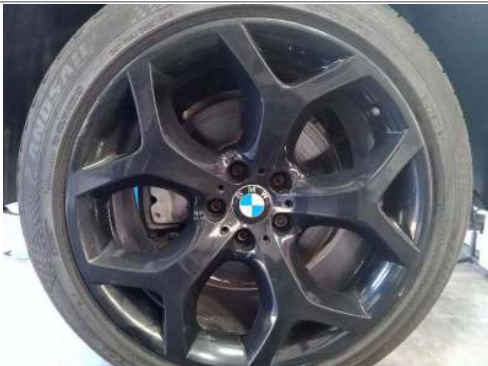
| Damage | Repair Way |
|---|---|
| Rim Front Right Scratched | Repair |

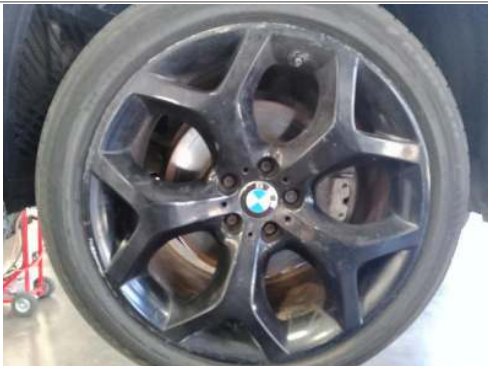
| Damage | Repair Way |
|---|---|
| Rim Front Left Scratched | Repair |
