## CONDITION REPORT

Report No: 2016871497

| Manufacturer | MERCEDES-BENZ | Registration Number | HT29KVG |
| Model | C250 CDI BLUEEFFICIENCY DSL 7-SP AT (2011-2014) | Register Number | |

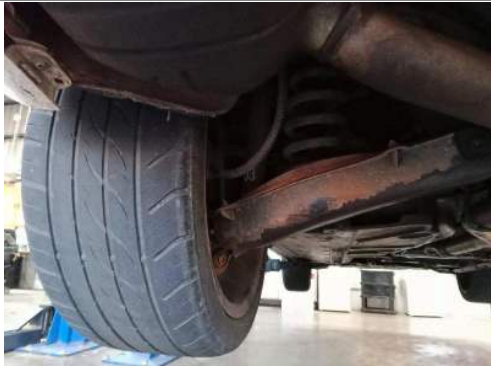
LR TYRE TREAD

| Damage | Repair Way |
|---|---|
| Tyre Rear Left Damaged | Replace |

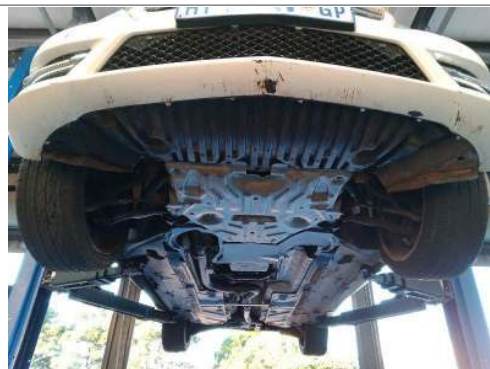
Front chassis

| Damage | Repair Way |
|---|---|
| Main Beam Right Welded | Repair |

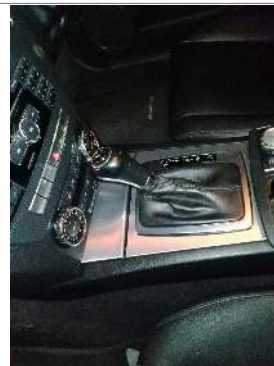
Automatic Transmission

| Damage | Repair Way |
|---|---|
| Gearbox Oil Leak | Repair |
| Gear Selections Malfunction | Repair |

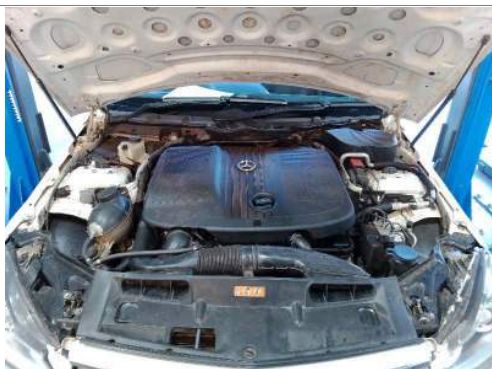
ENGINE 1

| Damage | Repair Way |
|---|---|
| Engine Oil Leak | Repair |
| Engine Wiring Defective | Repair |

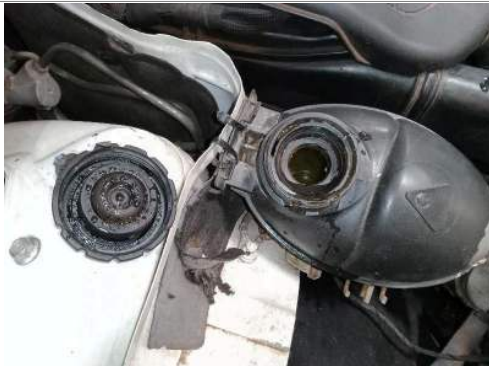
Water level

| Damage | Repair Way |
|---|---|
| Expansion Bottle Damaged | Replace |
