CONDITION REPORT

Report No: 2016249247

MFC Auction House  
M57 Pretoria Rd, Glenmarais, KEMPTON PARK  
Gauteng

| Manufacturer | FORD | Registration Number | KP86BBGP |

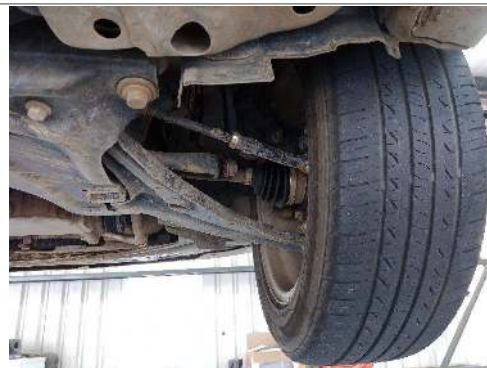
RF TYRE TREAD

| Damage | Repair Way |
|---|---|
| Tyre Front Right Damaged | Replace |

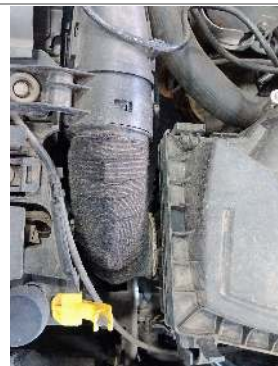
| Damage | Repair Way |
|---|---|
| Air cleaner Defective | Repair |

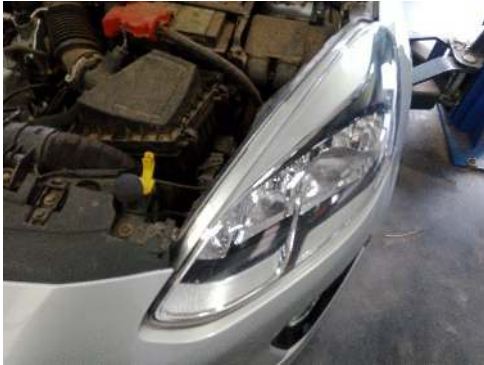
| Damage | Repair Way |
|---|---|
| Headlight Left Damaged | Replace |

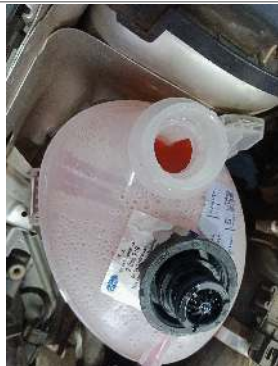
Water level

| Damage | Repair Way |
|---|---|
| Radiator Water Leak | Replace |

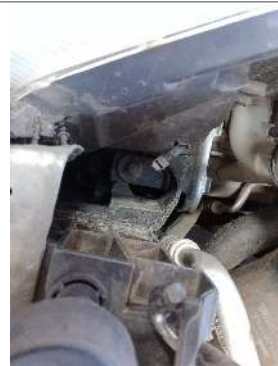
| Damage | Repair Way |
|---|---|
| Radiator Cradle Defective | Replace |
